## Assistance of New York State Department of Transportation to Railroad in Solving Soils and Foundation Problems

Harry E. Schultz and Taylor J. McDermott, Delaware and Hudson Railway Company  
Stephen E. Lamb, New York State Department of Transportation

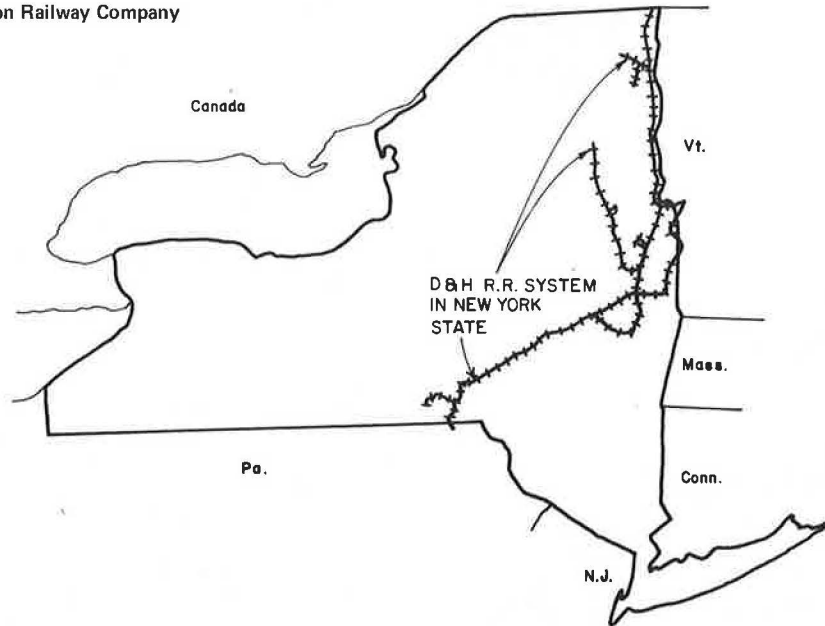
Figure 1. Delaware and Hudson Railway Company system in New York State.

The D and H RR system in New York State extends from Pennsylvania to the Canadian border, as shown in Figure 1. New York is a glaciated state, and the major valleys contain soils deposited by large quantities of glacial-melt water as the ice sheet receded northward. The northern portion of the D and H RR is located in the
