## SOME CONSIDERATIONS IN WIDENING AND REHABILITATION OF BRIDGES

M. H. Soto, Chief Bridge Engineer, Gannett Fleming Corddry and Carpenter, Inc.

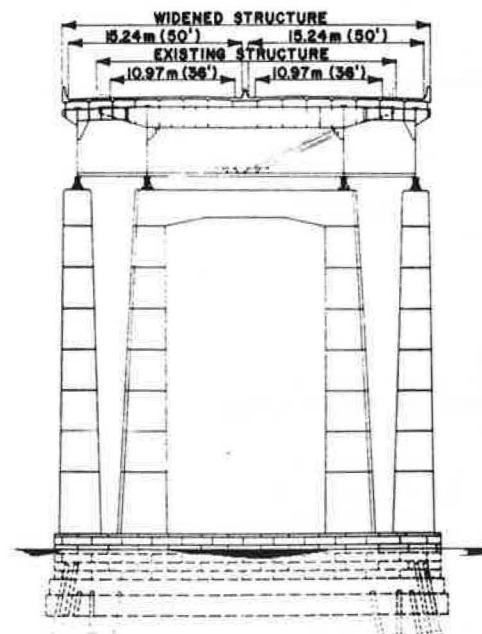
Figure 1.

Widening the Hackensack River Bridge carrying the New Jersey Turnpike is an example of maintaining the center-line alignment and widening the structure symmetrically. See Figures 1 & 2.

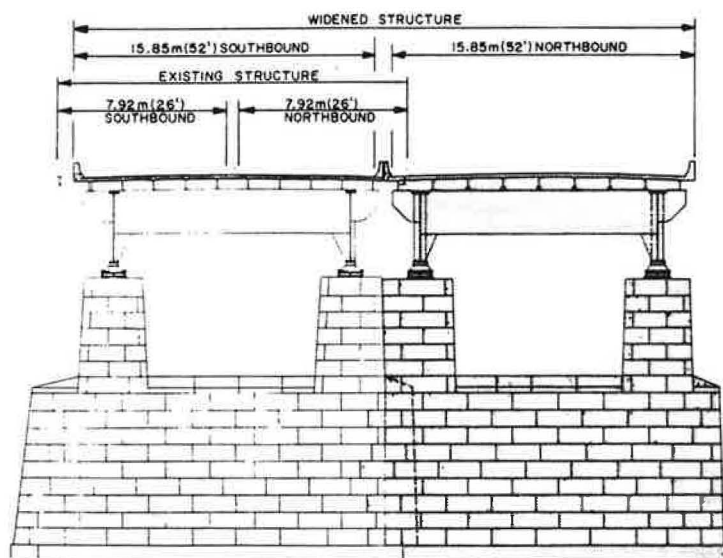
Widening the John Harris Bridge, which carries I-83 over the Susquehanna River in Harrisburg, PA, is an example of a realignment and widening all on one side. See Figures 3 & 4. These two widening schemes and their associated structural design considerations will be discussed.

The Safety Update for the John Harris Memorial Bridge carrying Interstate 83 over the Susquehanna River at Harrisburg, Pennsylvania will convert the existing four-lane two-direction crossing to a three-lane plus shoulder southbound crossing. An all-new separated superstructure, roughly a twin to the existing one, will accommodate northbound traffic lanes and shoulders. See Figure 3.

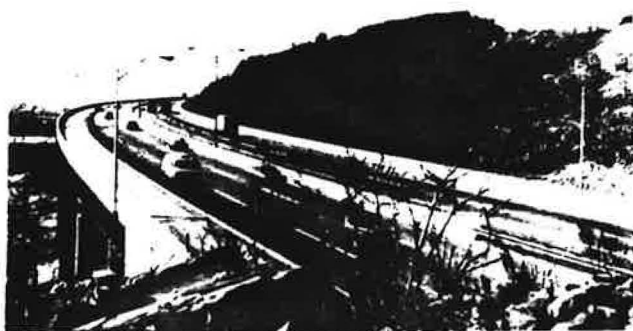
Figure 15.

Figure 15 shows the completed widening.
