RENOVATION OF LIONS' GATE BRIDGE NORTH VIADUCT

Peter R. Taylor, Buckland & Taylor Ltd., Consulting Structural Engineers, Vancouver, Canada

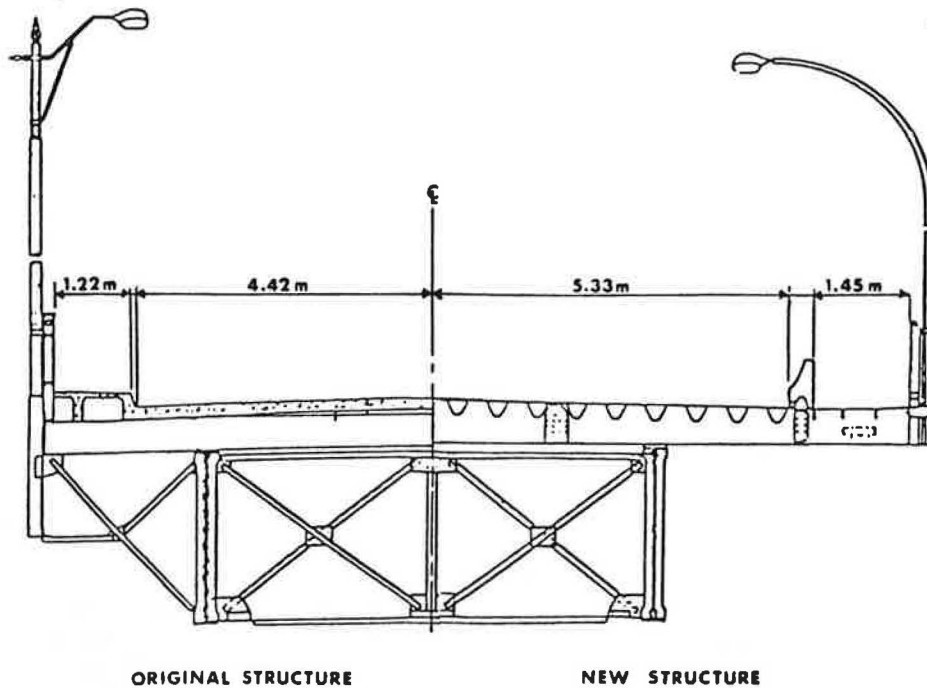
Figure 2. Half sections of original and new structure.

One key to success in this project was the careful design of the numerous new deck to existing girder connections. They were required to be of adequate strength and stiffness, but also simple to connect and tolerant of misalignments in any planar or rotational direction. In order to provide realistic tolerances for the connection of new steel to existing, the new cross beams are attached by field welding to oversize shims which in turn are connected by countersunk bolts through existing rivet holes in the main girders. As mentioned earlier, extra reserve strength was attained by making the new deck composite for live load. The necessary shear connections at the end of each span were obtained by inserting 3 or 4 panels of plate diaphragms between the cross beams and aligned over the main girders. The steel orthotropic deck used was the conventional arrangement of U troughs. Congresive® epoxy asphalt was selected after testing due to its outstanding abrasion resistance under studded tires. Other improvements incorporated in the new deck scheme included traffic barriers protecting the widened sidewalks, maintenance catwalks and gantries, telephone trunk cable trays, and a new electrical power distribution system, lighting system, overhead traffic sign bridges and stand-by generator. Half sections of the original and new design are shown in Figure 2.
