## RETROFITTING FATIGUE DAMAGED BRIDGES

John W. Fisher, Alan W. Pense, Robert E. Slockbower,  
and Hans Hausammann, Lehigh University

This paper examines continuing laboratory and field studies on ways to retrofit fatigue damaged members. Results of a pilot field study on two bridge structures with known fatigue cracks at the ends of cover plates are reviewed. Fatigue damaged members were retrofitted by peening and gas tungsten arc remelting the weld toe. The initial retrofit is summarized and the results of subsequent inspection after 1½ years is reviewed. Also discussed is the retrofitting of several more bridges by peening weld toes on a more extensive scale. In recent years many highway and bridge structures have experienced fatigue damage from out-of-plane displacements. This has resulted in web cracking at the ends of transverse stiffeners and floor beam connection plates which were not welded to tension flanges. Cracking as a result of out-of-plane movement is reviewed and several examples of cracking in a number of bridges is discussed. Nearly all of these fatigue damaged members have been repaired and retrofitted by drilling holes in the web plate at the ends of the hori

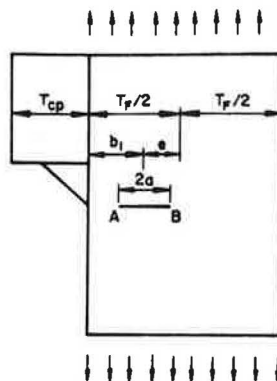
Figure 11. Stress intensity model for embedded cracks

The shape of the large embedded cracks at the west primary detail of Beam 3 (eastbound bridge) and at the west detail of Beam 7 (eastbound bridge) are shown in Figure 10. The stress intensity model for these embedded cracks is shown in Figure 11. This approximate model combines the solution for an eccentric crack (8) with the stress gradient correction factor,  $F_G$ , defined in Ref. 9. Utilizing this model and the crack growth rate  $da/dN = 3.8 \times 10^{-9} \Delta K^3$  ( $\Delta K$  in units of  $\text{MPa}/\sqrt{\text{mm}}$ ,  $da/dN$  in units of  $\text{mm}/\text{cycle}$ ), the number of cycles necessary for the crack to propagate through the retrofit weld toward the weld toe was estimated. It was assumed that when the embedded crack penetrated the exterior flange face it would quickly become an elliptical surface crack with the major semidiameter axis being defined by the crack shape ratio prior to retrofitting.

For this study the retrofit weld penetration was assumed to be 4.8 mm (3/16 in.). The estimated number of cycles necessary to propagate the embedded cracks through the retrofit weld at a stress range of 13.1 MPa (1.9 ksi) for Beams 3 and 7 were 7.0 and 6.7 million cycles, respectively. The elliptical surface cracks for both beams were approximately 13.5 mm (0.53 in.) deep at the beginning of the final stage of crack growth. An additional 1.0 and 2.7 million cycles would be necessary for the cracks to grow through the flange thickness for Beams 3 and 7, respectively.
