## REPAIR OF POPLAR STREET COMPLEX BRIDGES IN EAST ST. LOUIS

Wei Hsiung, Illinois Department of Transportation

The web cracks found in the Poplar Street Complex Bridges were located at the top of the web-to-bottom flange fillet weld near the end floor beams. The buckled web was observed at the end of the girders behind the bearing stiffener. This report summarizes the results of the study which intends to determine the proper causes of the distress. It is believed that the main cause of the web crack was due to the out-of-plane movement of the web; and that the cause of the web buckling was from the eccentric reaction induced by the seized bearing pin. The repair method was developed mainly to stiffen the section and to carry the secondary stress induced from the out-of-plane movement of the web and to resist the distortion of the girder due to differential deflection of the main girders. Suggested details for future design are also included.

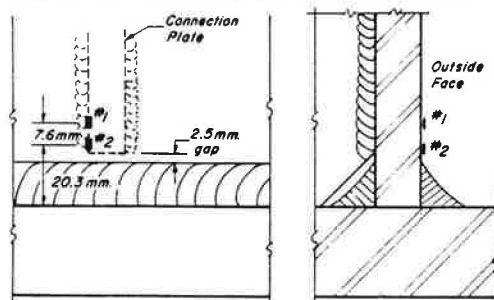
Figure 9. Strain gages at Pier C-26NW.

Two strain gauges were installed in the lower gap region at the northwest bearing of pier 26, ramp C, identified as C-26NW. See Fig. 9. Gauge readings indicated very little out-of-plane movement of the web at this location. This was due to the fact that the gap in the web is very small, about 2.5 mm (0.1 in.), and the tight fit joint may provide enough friction to reduce the movement. No web cracking was observed.

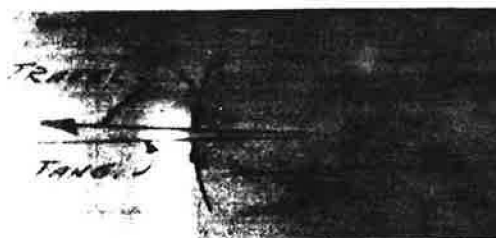
Figure 10. Strain gages at gap near top flange at Pier B-27 NW inside face.

A few of the end floor beams are connected to the bearing stiffeners. The bearing stiffeners had a tight fit end at the top and mill-to-bear end at the bottom. Four strain gauges were installed, two at the top and two at the bottom at location B-27 NW. See Fig. 10 and Fig. 11. It was found while installing the strain gauges that the tight fit end of the bearing stiffeners had a larger gap between stiffeners and the top flange than was anticipated. The top gauge readings, shown in Fig. 12, clearly indicated that the web was pushed out-of-plane by the rotation of the end floor beam. The stress in the web as computed from strain gauge readings is shown in Fig. 13. The web is subject to this high stress every time there is a live load on the floor beam. After many occurrences, web cracking due to fatigue is inevitable and a crack was observed. The measurement at the bottom indicated that the stress in the web was smaller. See Figs. 14 and 15.

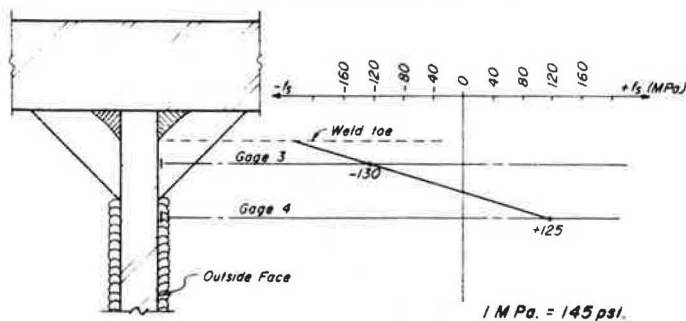
Figure 14. Typical strain response at B-27 NW, C-26 NW.

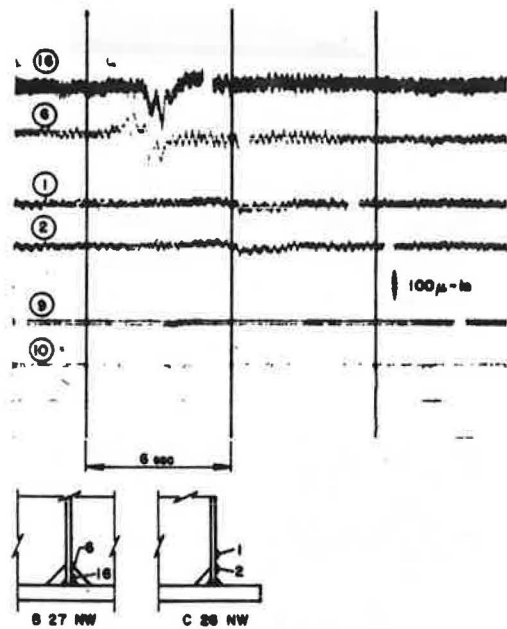
Figure 15. Stress gradient at bottom gap B-27 NW.

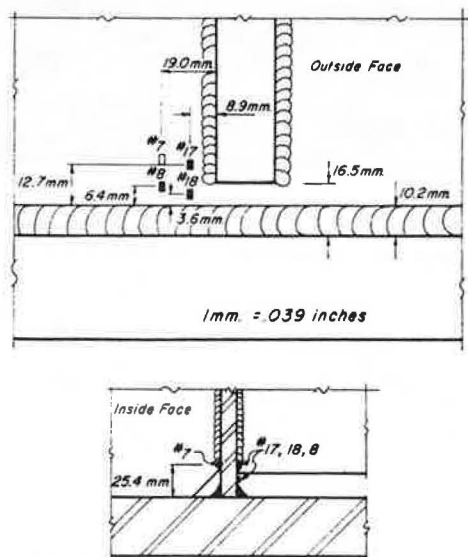
Strain gauges were installed at location B-27FBI-W, the first interior floor beam west of pier 27, ramp B. See Fig. 16. Some of the gauge readings are shown in Fig. 17, others are shown in Fig. 12. There was very little movement in the web at this location. This is due to the inability of the flange to resist lateral movement because of lack of torsional stiffness, thereby relieving substantially the strain which might be introduced in the web gap. No crack was observed. None will likely develop in the future.

Figure 17. Typical strain response at B-27 NW, B-27 FBI-W.

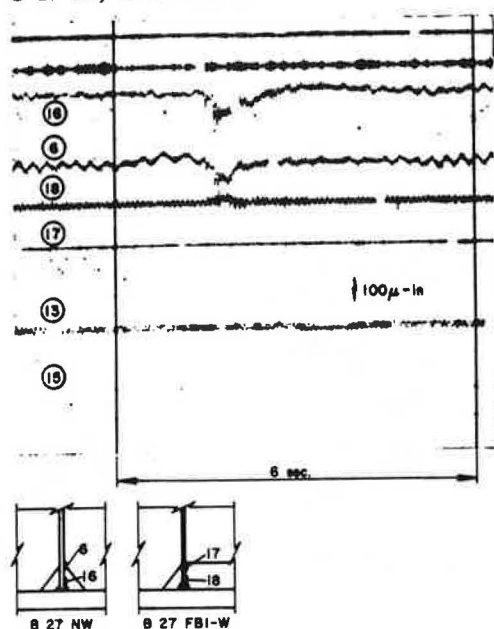
Figure 18. Strain gages near web gap at interior floorbeam B-26 FBI-W.

The connecting plates in the negative moment region were welded to the bottom flange and had a tight fit at the top. Web cracks at the top were observed at several locations. The strain gauges installed at location B-26FBI-W (see Fig. 18), showed some movement in the web. The stress in the web induced by the movement is shown in Fig. 19. The stress is less than the fatigue limit of category C. However, since web cracking at the upper end of the connecting plate was observed on the inside face of the web, it was apparent that the large web bending stress, which was even larger than measured by strain gauge, had been present at some time.

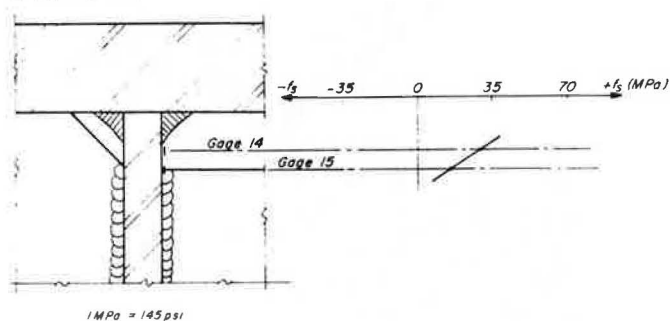
It is interesting to note that two types of deformations at the web gap region are possible. One is translation which creates double curvature bending; the other, single curvature bending as shown in Figure 20. This variance is not clearly understood from the limited test data. A tentative explanation

Figure 20. Possible movement at gap region.

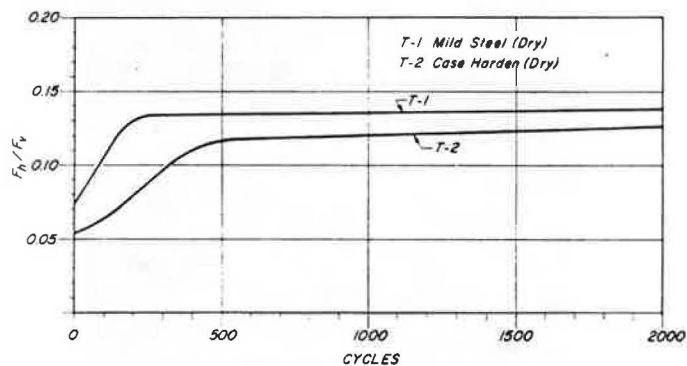
It was interesting to learn that the coefficient of friction for specimen T-1, T-2 and T-4 increased with increases in the number of cycles of movement and gradually tapered off after 200 to 300 cycles. However, the coefficient of friction for specimen T-3 which had the heavy grease lubricant was constant throughout the test and about one-half of the value obtained for pins without grease lubricant. See Figs. 24 and 25.

Figure 24. Coefficient of friction of dry, mild and case hardened pins.

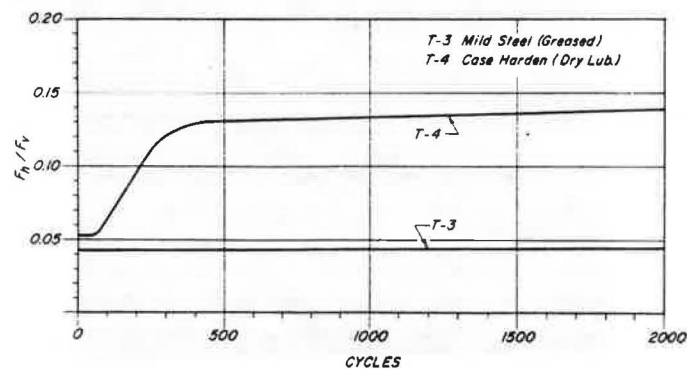
Figure 25. Coefficient of friction of lubricated, mild and case hardened pins.
