# Embankment Stabilization by Use of Horizontal Drains

Stephen E. Lamb

An embankment 24 m (about 80 ft) high that traverses a narrow valley on I-81 about 56 km (35 miles) south of Syracuse, New York, began to fail several years after construction. In the spring of 1973, the pavement dropped several centimeters to bring the cumulative patch to 46 cm (about 18 in). Complete failure of the embankment was anticipated for the spring of 1974 because past movements had been largest during the spring and recent monitoring had indicated an increase in the rate of movement. A design for a stabilization project to counteract the effects of the hydrostatic pressure that was believed to be causing the failure was prepared that consisted of a berm and shear key at the toe of the embankment. Implementation of this design, however, could not be completed before spring. Therefore, it was decided to stabilize the embankment by decreasing the excess hydrostatic pressure by installing a system of horizontal drains, a project that could be completed before spring and at a cost saving of \$1 000 000. The project was completed in early spring of 1974, and the embankment has been stable since then. This

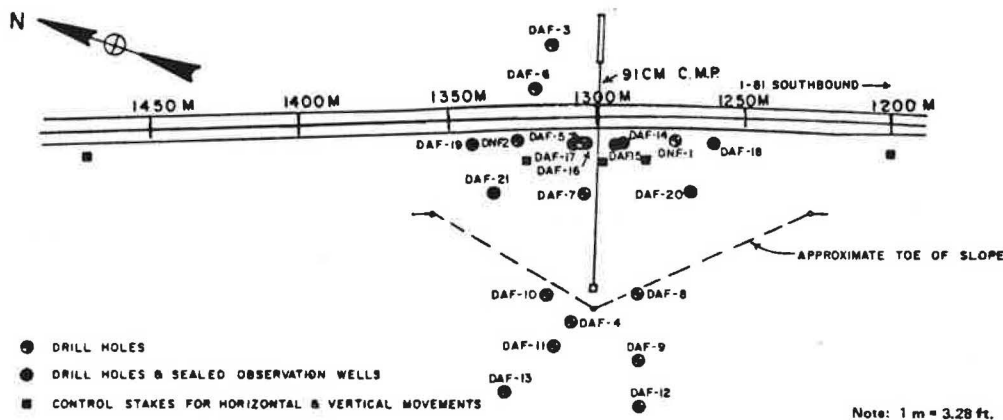
Figure 2. Plan view.

The investigation of the area consisted of a survey, a drilling program, and establishment of horizontal-movement-control stakes. The drilling program consisted of 21 borings. In 17 of the borings, observation wells were established to monitor groundwater fluctuations and to locate the depth of movement in the foundation soils (1). A plan of the site is shown in Figure 2.

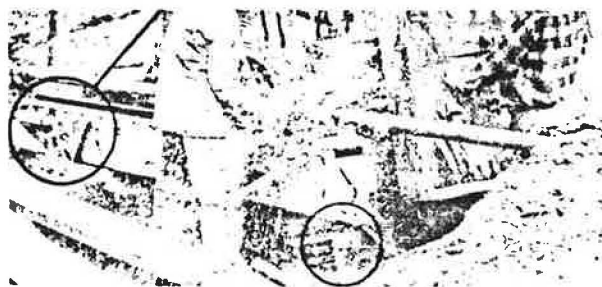
Figure 5. Vertical alignment of drilling equipment.

Before drilling was begun, the equipment was leveled on a timber mat. The horizontal alignment was established by sighting along stakes located at the top and toe of the slope, and the vertical alignment was established by loosening the swivels and adjusting the leveling jacks by using a 15-cm (6-in) machinist's level on the initial length of drilling rod (see Figure 5; note scissor swivel and adjustable jack on ends of carriage). The 0.1-0.15 m<sup>3</sup>/min (30-40 gal/min) water required for drilling was obtained by damming the culvert outlet.
