Evaluation of the Durability of Metal Drainage Pipe

RICHARD W. KINCHEN

Preliminary results are presented of a 10-year field study undertaken in Louisiana to determine the ability of aluminum and galvanized-steel culverts to resist corrosion in moderate, acidic, and low-electrical-resistivity environments. In 1973, 10 types of aluminum and galvanized-steel culverts were installed, generally as side drains, at 10 test locations. One pair of each type of culvert was installed at each site. Every two years, investigators are removing one designated culvert of each of the pairs and subjectively rating the condition of the metal and protective coating. Field samples of the culverts are evaluated in the laboratory, and the test culverts are installed again after each inspection.

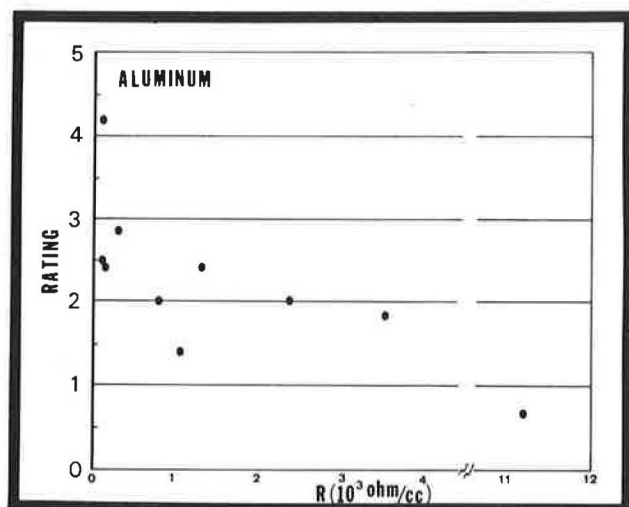
Figure 5. Six-year panel ratings of aluminum-alloy culvert versus electrical resistivity of environment.

If one assumes that electrical resistivity can be isolated as a dominant factor in the corrosion of aluminum alloy, one can develop an interesting plot of six-year panel ratings of this culvert from Table 2 versus critical resistivity values from Table 1 (see Figure 5). The rate of corrosion among the aluminum-alloy test culverts increases as the resistivity of the environment decreases. LADOTD policy states that the aluminum-alloy culvert will be excluded from consideration when the resistivity of the surrounding soil and water is less than 1500 Ω/cm . This minimum level is considered to be conservative but comfortable.
