The Rural Mailbox: A Little-Known Roadside Hazard

HAYES E. ROSS, JR., KENNETH C. WALKER, AND W. J. LINDSAY

The results of seven full-scale crash tests conducted at the Texas Transportation Institute to evaluate the impact behavior of rural mailbox installations are reported. Three of the seven tests—two of single-box installations and one of a four-box installation—involved commonly used wood-post supports. Two tests of single-box installations involved promising new support concepts that use standard steel pipe with a breakaway mechanism. The final two tests involved a steel-pipe, multiple-box support in the shape of an inverted U. The results showed that installations with multiple boxes mounted on boards pose a serious hazard to motorists because the board can easily penetrate the windshield. The inverted-U design eliminated the penetration problem, but the change in vehicle momentum on impact exceeded the recommended limit. The results also showed that, for a single-box installation, a pipe post performs better than a wood post. Careful attention must be given to the box-to-post attachment to prevent separation during impact and thus minimize the potential for windshield pene

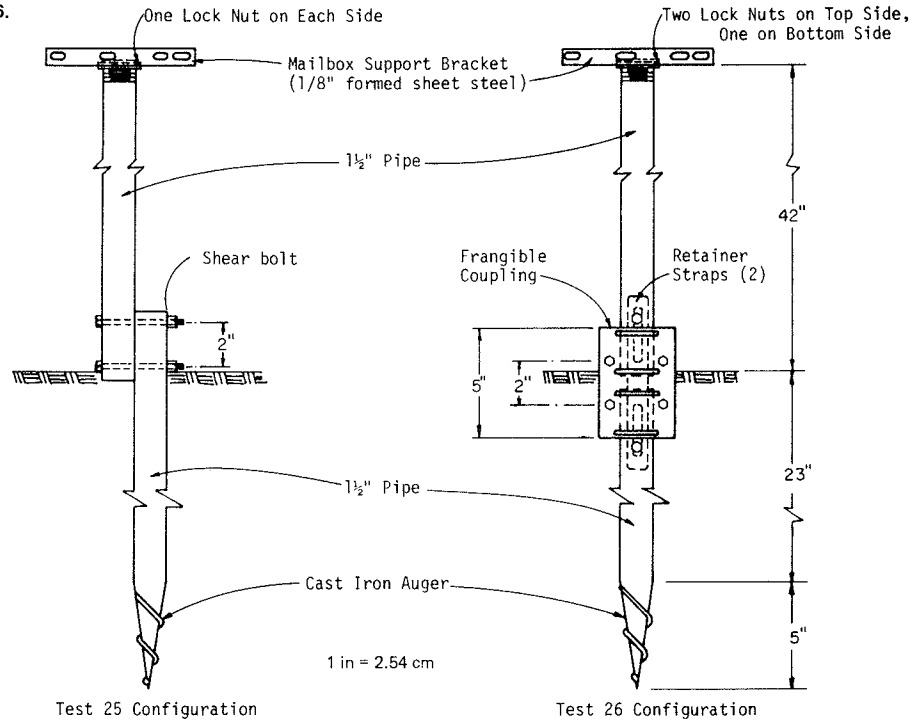
Figure 9. Installation details, tests 25 and 26.

In test 25, a lap-spliced steel pipe with bolted shear connection, shown in Figure 9, was evaluated. The lower bolt was a 0.375x4.5-in (0.95x11.4-cm) retainer bolt, and the other was a 0.3125x4.5-in (0.79x11.4-cm) shear bolt with a short section machined down to the minor thread diameter of 0.2524 in (0.64 cm).

In test 26, the frangible coupling broke, and the retainer straps held the post after fracture as desired. The mailbox remained with the support until the vehicle rode over the box and the support. Note that two lock nuts were used on the top side of the bracket to attach the bracket to the post (Figure 9). The retainer straps functioned as designed, preventing translational movement of the support post.

velocity approximately equal to that of the vehicle. As a result, the mailbox rode along on the hood and harmlessly fell away. Investigation of the bracket-to-post connection showed that the lock-nut threads stripped, allowing the box to separate from the post. Two lock nuts on the top of the bracket would probably have prevented this separation (see the description of test 26). The support and the mailbox were too badly damaged to be reused. The anchor post, however, was not damaged and could be reused. The shear bolt fractured as it was designed to do, retaining the post but allowing it to rotate downward. Vehicle damage was minimal.

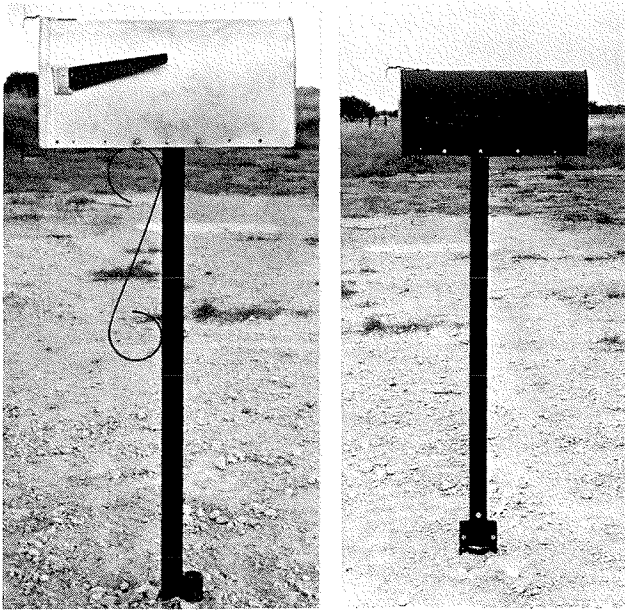
Figure 10. Test installations with standard steel pipe supports.

nuts were used. In addition, an ornamental S-brace was used in test 25 to connect the bracket and support post. For both pipe tests, six 0.1875x0.75-in (0.48x1.91-cm) bolts with lock washers were used to attach the mailbox to the bracket. A No. 1-A mailbox was used in test 25, and a No. 1 mailbox was used in test 26. The completed installations can be seen in Figure 10.

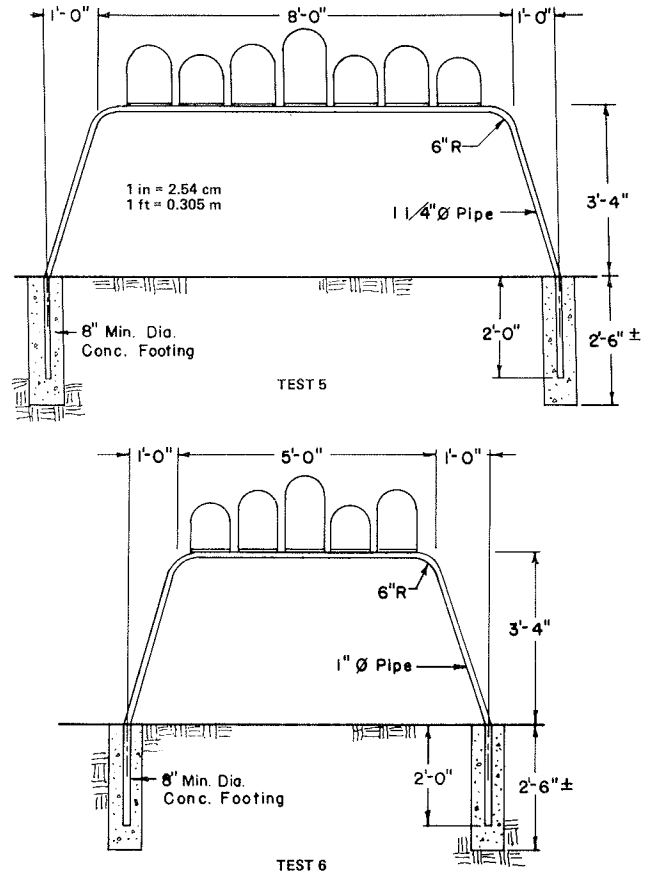
Figure 11. Mailbox support configurations, tests 5 and 6.

Details of the mailbox installations for tests 5 and 6 are shown in Figure 11. Details of the mailbox-to-support attachment are shown in Figures 12 and 13. The smaller boxes were attached to the brackets by four 0.1875x0.75-in (0.48x1.91-cm) bolts with lock washers. The middle-sized boxes and

In test 5, at impact the support formed a hook and the pipe wrapped around the hood of the vehicle. Continued forward vehicle movement broke the lead support post. The boxes and the remaining portion of the support were then ridden down, and the boxes

The impact behavior of the vehicle and the support in test 6 was similar to that in test 5. In this case, the lead support did not fracture and the boxes were not stripped from the pipe as the vehicle rode over the support. The vehicle yawed about 180° before coming to a stop. Although the change in vehicle momentum exceeded the recommended limit, this design represents a step in the right direction and is a vast improvement over the design evaluated in test 24.

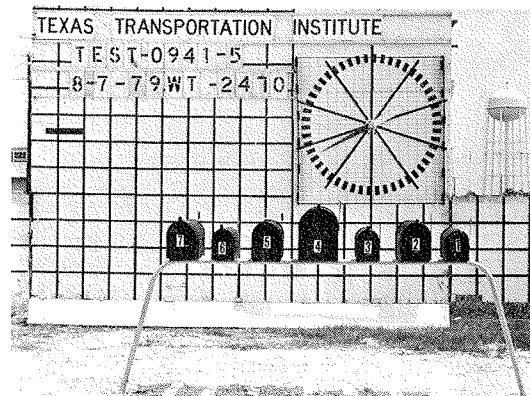
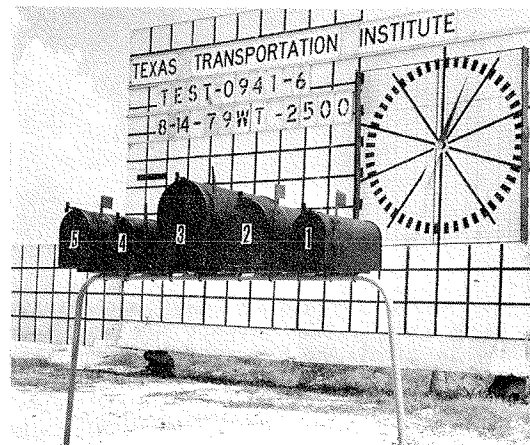
Figure 14. Completed installation, tests 5 and 6.

larger boxes were attached to the brackets by six 0.1875x0.75-in bolts with lock washers. The completed installations are shown in Figure 14.
