## Restoration of Meem's Bottom Covered Bridge

KENNETH M. SMITH AND JOHN E. ANDREWS

On October 28, 1976, the Meem's Bottom Covered Bridge in Shenandoah County, Virginia, was set on fire. Listed as a historical landmark on the Virginia Landmarks Register, the structure is the longest covered bridge in the state and is one of two that still carry traffic. At the direction of the Virginia General Assembly, the Virginia Department of Highways and Transportation undertook the task of rebuilding the structure and restoring it to service in such a manner as to maintain its historical significance. The conclusions derived from a structural analysis of the Burr arch-truss design and the novel procedures undertaken by the department to restore the bridge are presented. In completing the task, the department successfully maintained the 80-year-old structure's historical significance and satisfied the mandate of the General Assembly. Although completely destroyed, the load-carrying joints were rebuilt through extensive use of epoxy. Specially treated lumber, fire retardant varnishes, and stainless-steel roofing were used in the restoration to meet the need for fire protection and to minimize

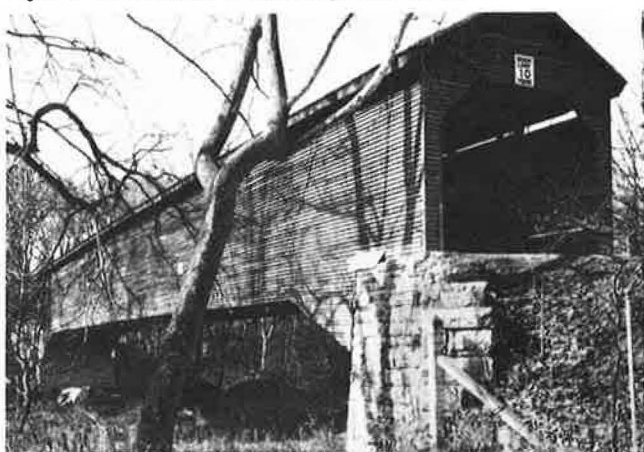
The Meem's Bottom Covered Bridge, shown in Figure 1, was built on private property in the mid-1890s. Little concerning its history can be found in public records. Emory Kemp and Charles E. Daniels of the Department of Civil Engineering, West Virginia University, gave some of its history in a report (1) compiled following its near destruction on October 28, 1976.

Figure 1. Meem's Bottom Covered Bridge before the fire.

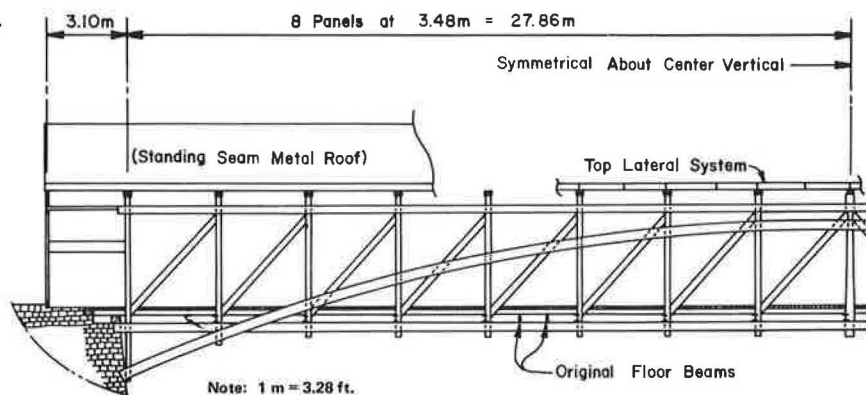
When John Woods built the bridge 80 years earlier, he had no idea of the problems his masterpiece of bridge architecture would present to the bridge engineers of the department. Woods chose to erect a covered timber bridge of the Burr arch-truss system (Figure 3) that incorporated the same skills and craftsmanship in fitting the individual members together as master boatwrights used in building yesteryear's tall sailing ships. Ship lap-splice joints, mortise and tenon joints, and keyed-butt joints fitted together as tightly as joints do in the finest reproduction furniture available today.

Figure 3. Schematic of the Burr arch-truss.
