Effect of Moving Traffic on Fresh Concrete During Bridge-Deck Widening

HOWARD L. FURR AND FOUAD H. FOUAD

Traffic in lanes adjacent to a deck that is being widened or reconstructed causes deflections and vibrations in the fresh concrete deck. A study of the effects of

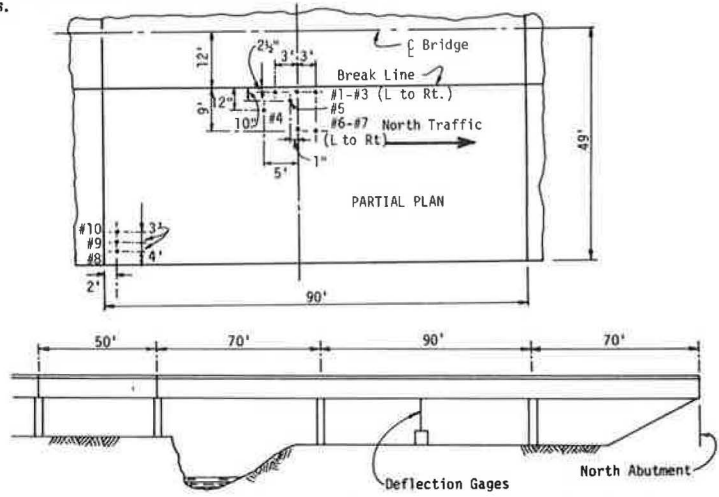
Figure 8. US-75 and White Rock Creek, northbound: core locations.

determining the condition of the concrete and to detect any differences that might be evident in the concrete from different areas of the deck. A total of 109 nominal 4-in-diameter cores was taken from nine bridges. Five of these bridges had been in service for some time when cored, but no traffic had been permitted on the new parts of the other four. More than half of the cores were taken from the mid-span disturbed areas, as defined earlier, and the others were taken from the undisturbed regions at or near supports. A schedule of the cores is given in Table 1, and Figure 8 shows locations of cores removed from one deck.
