Vehicle Impact Tests of Breakaway Wood Supports for Dual-Support Roadside Signs

ROGER L. STOUGHTON, J. ROBERT STOKER, AND ERIC F. NORDLIN

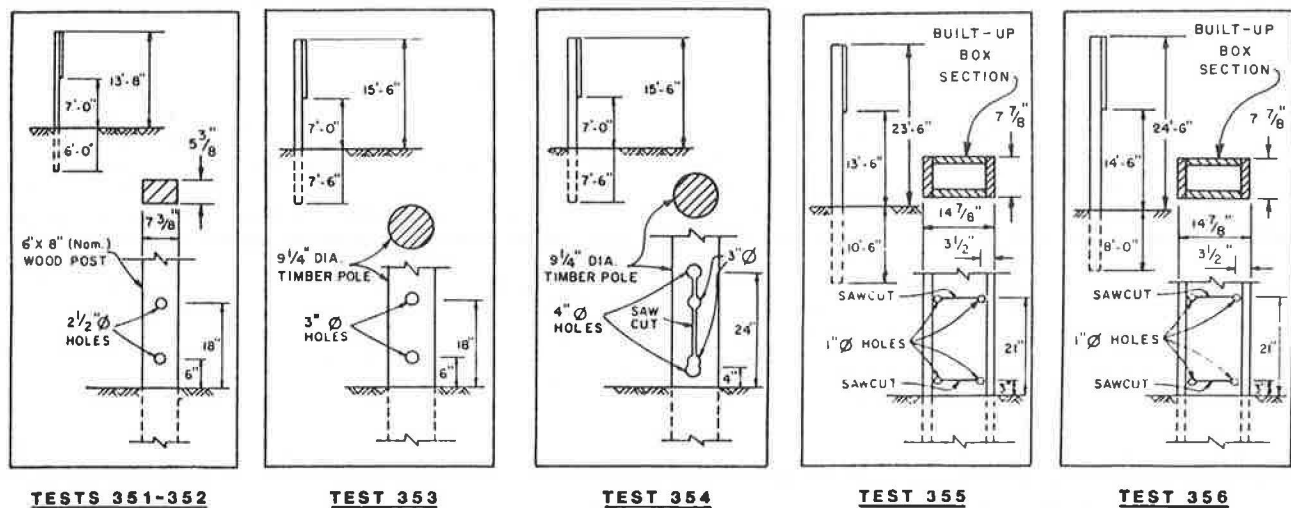
Figure 1. Hole patterns for breakaway supports: crash tests 351-356.

One hole pattern that was pendulum tested at SwRI looked promising and was used for crash test 354. The timber-pole supports in test 353 had been virtually undamaged; therefore, they were reused for test 354, except that the opposite pole was impacted. The 4-in-diameter holes and connecting sawcut shown in Figure 1 were added to the existing 3-in-diameter holes.

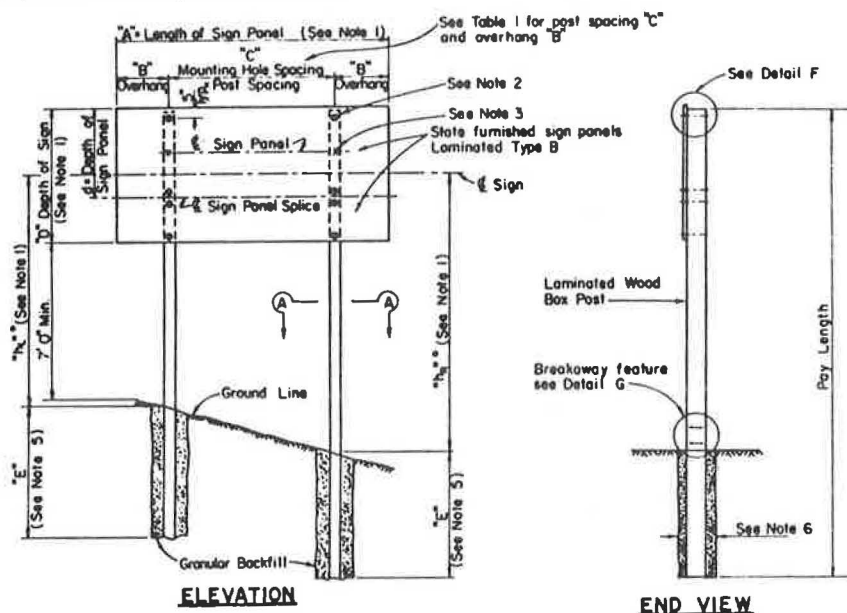
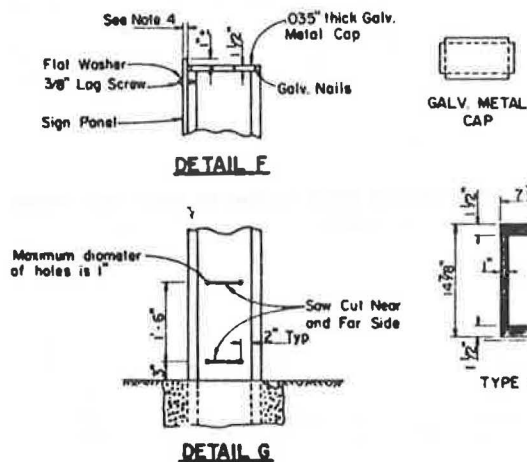
Figure 2. Caltrans standard plan for laminated wood box post for roadside signs.

The box section, which weighs 12 lb/ft, was selected over the H-section. It should be less susceptible to handling damage, more resistant to wind loads without increased impact resistance, and higher in torsional and lateral load resistance.

The box-section posts used for the tests cost approximately \$6.00/linear ft. A verbal quote in August 1981 for small quantities, free on board (FOB) in Oregon, was \$6.90/linear ft for type M and \$8.80/linear ft for type L (see Figure 2).

After the unsuccessful timber-pole tests, Caltrans substituted a standard design by using steel posts and a slip base in February 1980. In mid-1981, box-section posts were added as an alternative (see Figure 2). The standard plan for roadside signs by using 6x8-in or smaller wood posts was unchanged. Although the steel post and slip base designs have functioned well, Caltrans has preferred wood support designs for the following reasons: (a) The wood supports have generally been less expensive in California, (b) their service life has proved to be sufficient, (c) they are easier for maintenance

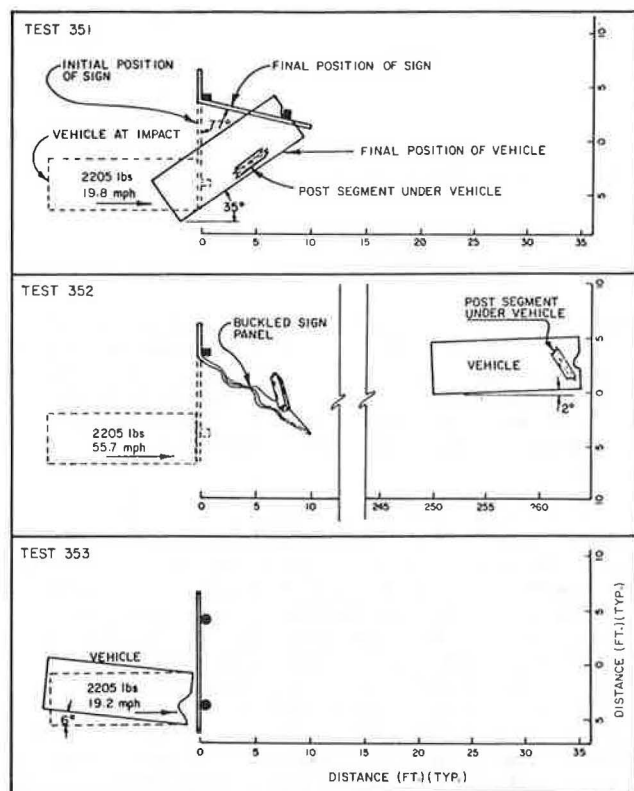
Figure 20. Final position of test vehicle and sign: tests 351-353.

In tests 353 and 354, the timber poles stopped the test vehicles too abruptly; thus, they did not meet the structural adequacy requirements. In test 355, the fallen sign projected 11 ft laterally beyond the original post location, thereby posing a possible traffic hazard. The switch from through bolts to lag screws for the sign-panel-to-post connection in test 356 prevented pull down of the nonimpacted post. The post pieces in test 356 projected out laterally 15 ft. The 1.5-in-thick pieces were flat on the ground. They would pose a psychological hazard more than a physical hazard.

Figures 20 and 21 show the final positions of the test vehicles, test signs, and sign debris. The criteria in TRC 191 (4) and NCHRP Report 230 (16) for vehicle trajectory were satisfied in all six crash tests.

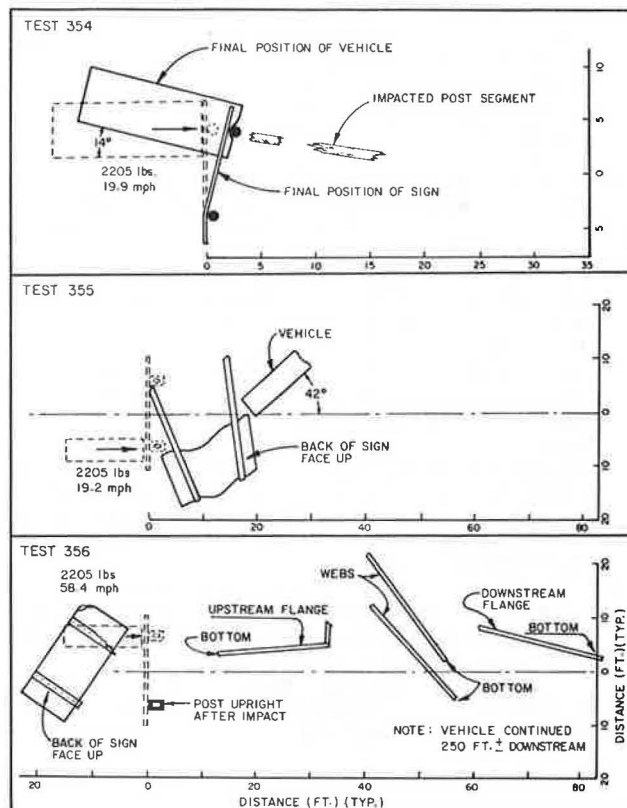
Figure 21. Final position of test vehicle and sign: tests 354-356.

After impact in test 355, the post split between the upper and lower 1-in holes on the upstream side and split to the ground from the lower downstream 1-in hole (see Figures 12-15). Then most of the post sheared off through the lower holes and sawcut. The vehicle moved in a circular path, pushing the box-section post in front of it. When this post was 15° off vertical, cracks appeared in the nonimpacted post. Eventually this post was twisted off at its base through the lower sawcuts. The sign panel remained attached to the posts but buckled in the middle. The vehicle went under the impacted post and stopped beyond the fallen sign.
