# Evaluation of Two Geotextile Installations in Excess of a Decade Old

BARRY R. CHRISTOPHER

Many erosion-protection installations for roadway embankments were designed and constructed by using geotextiles during the 1960s. Two such installations constructed in 1969 were studied to evaluate the long-term field performance of the facilities and the geotextile material. These projects were the 79th Street Causeway in Miami Beach, Florida, and the Bahia Honda Bridge in Bahia Honda Key, Florida. The 79th Street Causeway was constructed with a woven geotextile as a filter in a rip-rap revetment-type seawall to protect one of the bridge abutments and a segment of the causeway. The geotextile design was used in place of a conventional granular filter design to prevent erosion of the subgrade soils through the rip-rap. The protected section was designed for 3-ft waves and a 3-ft tidal variation. The Bahia Honda Bridge project was constructed with a woven geotextile as a subgrade-protection filter beneath sand-cement rip-rap-constructed bridge abutments, drains, and seawalls at both ends of the bridge. In this system, a geotextile was used to act as a filter between the rip-rap and underly

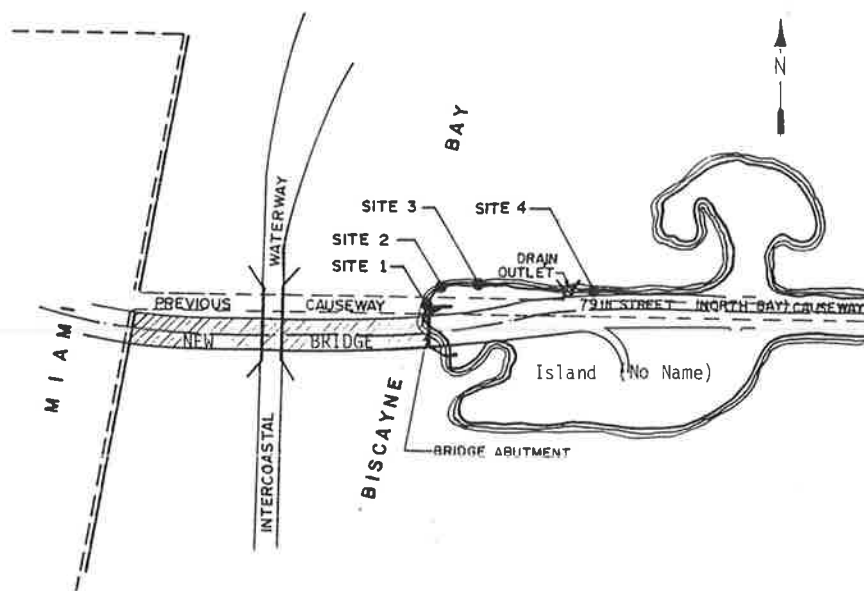
Figure 1. Location diagram for 79th Street Causeway.

Four sites were selected for further examination of the soil-geotextile system, as indicated in Figure 1. Site 1 was located approximately 3 ft north of the north corner of the causeway bridge abutment. The north corner of the concrete abutment and the location of site 1 are shown in Figures 3 and 4. This area was selected due to the relatively smaller size of rip-rap covering the area and the location in reference to protection of the bridge abutment. Also, due to a relatively flat slope in this section, the majority of the excavation could be performed above the water level at low tide.

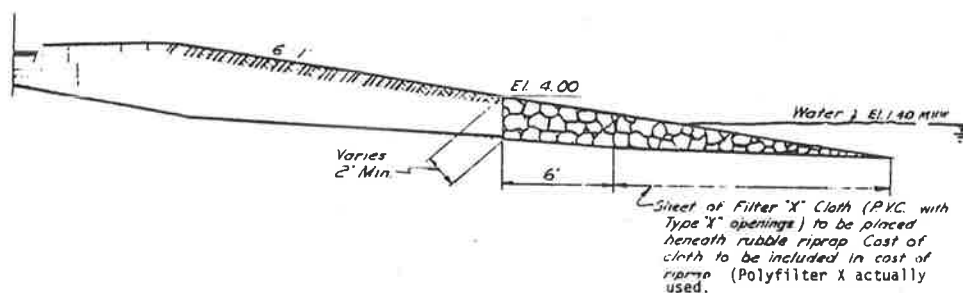
Figure 2. Proposed design of seawall.

Beneath the large surface rip-rap a 1-ft layer of 6- to 12-in.-diameter rip-rap was encountered. Beneath the total depth of rip-rap a 3-in. layer of coarse sand and gravel was underlain by approximately 0.25 to 0.50 in. of fine to medium sand. Note that the 3-in. cushion layer of sand and gravel was not shown in the proposed design (Figure 2). The sand was located directly on the surface of the geotextile and was probably the result of sand being washed down from the upper slope above the protec-

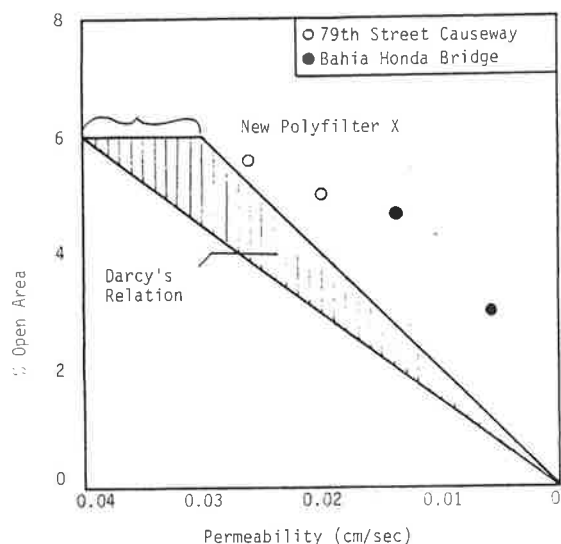
Figure 7. Relation between permeability and percent open area.

The data in Figure 7 indicate the theoretical decrease in permeability of the fabric with a decrease in the percent open area for a gradient of 1. Percent open area is defined as the area of the openings (times 100) divided by the total surface area of the unit of fabric; it is equivalent to the porosity of the soil. Note that the data in the figure are only applicable to the particular material tested; other fabrics may react in a different manner. Permeability values obtained from the field study are included on the graph. (Also included in this graph are the test values obtained from a similar fabric-exhuming project at Bahia Honda Key, which will be subsequently discussed.) Note that the decrease in permeability due to particle retention in the fabric generally follows the relation of

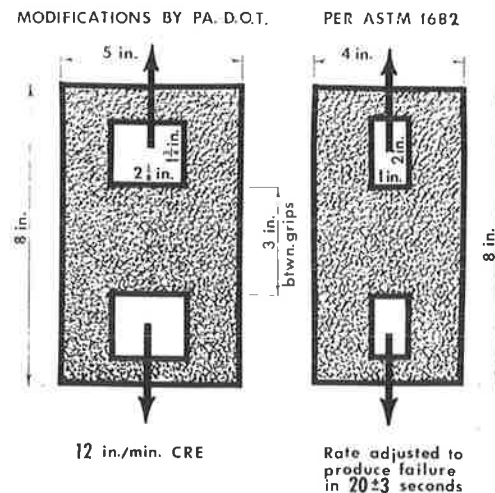
Figure 6. Modifications to grab tensile test as compared with specified procedure.

in order to exactly duplicate the procedures used to test the initial and the 1- and 2-year-old samples. The modifications along with the specified items are shown in Figure 6. Essentially, the differences were
