# Durability of Asphalt Coating and Paving on Corrugated Steel Culverts in New York

WALLACE W. RENFREW

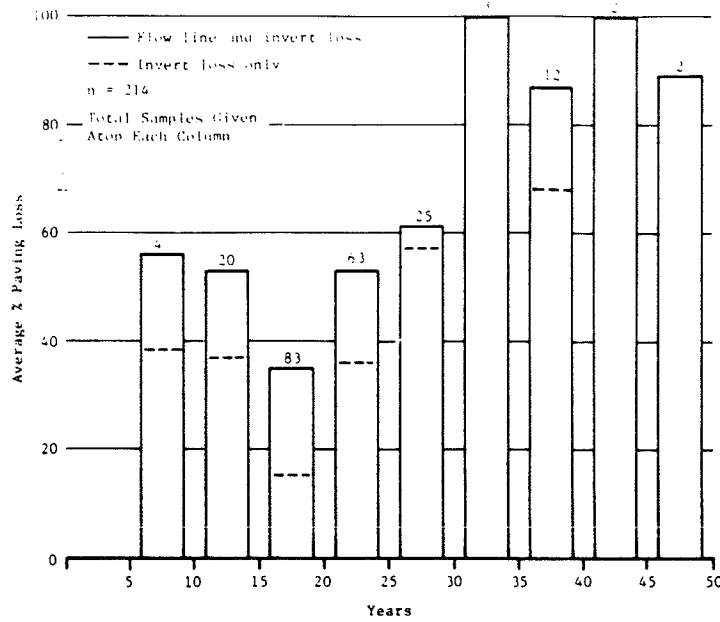
FIGURE 8 Average paving loss in 5-year increments (n = 214).

Referring to Figure 8, it can be seen that the 6 to 10 and 11 to 15 age groups have average losses greater than 50 percent. The 16 to 20 age group has losses less than 50 percent, whereas the next two groups have increasing losses. At 31 years and older the losses are almost all 100 percent. To summarize, the following observations can be made from this figure:

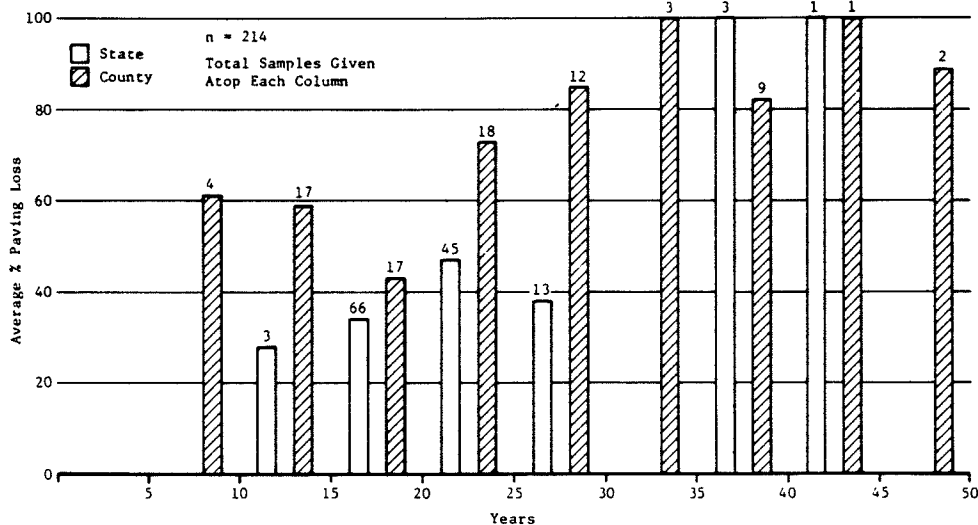
FIGURE 9 Average paving loss (system).

The culverts used for this study were from both state and county systems, and the method of selecting candidate culverts has already been explained. Figure 9 shows the average percent paving loss versus age in 5-year increments for each system, plotting only to 30 years when paving is essentially 100

percent lost for both the state and county systems. This graph shows a difference for the two systems. In four of the five age groups (there are no state pipes in the 6- to 10-year-old group), average percent loss is greater for county than state pipes.

Combining the first five age groups (6 to 30 years), the average loss is 39 percent for 127 state pipes and 64 percent for 68 county pipes. Several possible explanations were found for this:

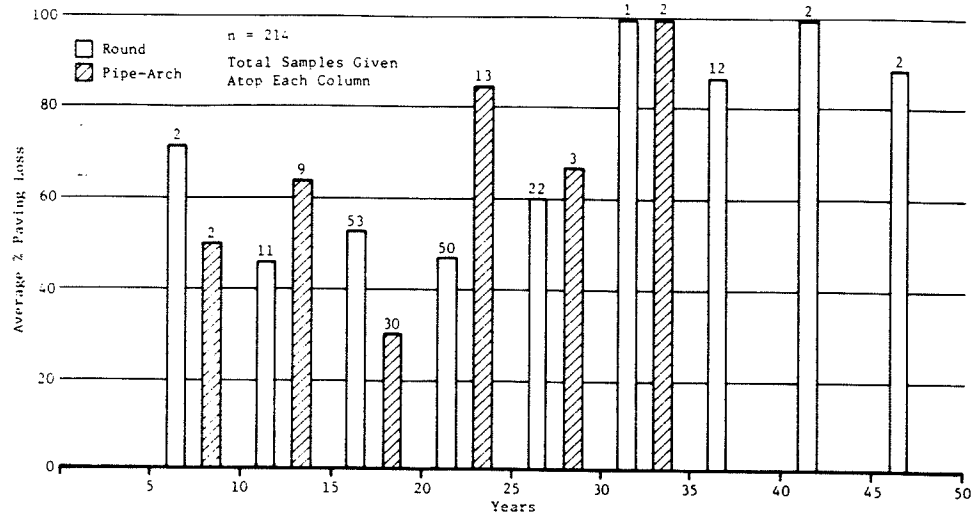
FIGURE 10 Average paving loss (shape).

Figure 10 shows the average percent paving loss versus age to 30 years (in 5-year increments) for shape. In three of these five critical age groups, pipe-arches have higher losses than round pipes. For

the combined 6 to 30 age group, the round average loss is 42 percent for 138 pipes and the pipe-arch is 59 percent for 57 pipes. These differences are similar to system differences because state pipes are generally round and about half the county pipes are pipe-arch.

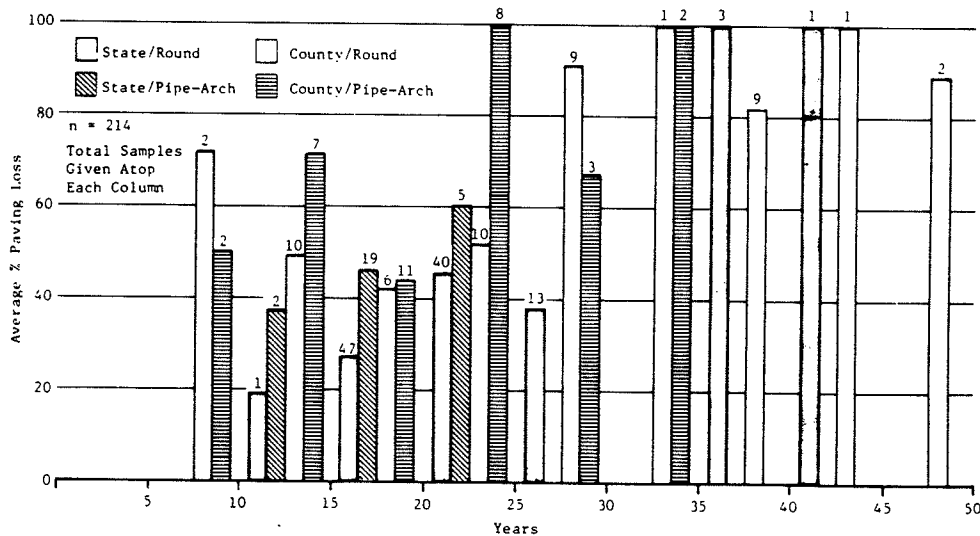
FIGURE 11 Average paving loss (system and shape).

To determine if the differences are caused by system or shape, further analysis was completed. Figure 11 shows the pipe for each age group to 30 years in four categories: state round, state pipe-arch, county round, and county pipe-arch. The numbers of pipes and average percentage losses for the four categories are given in Table 3. As can be noted, state pipes tend to have lower losses than county pipes and round pipes have lower losses than pipe-arches.

Because considerable differences appear in paving losses between state and county and round and pipe-arch pipes, it would appear imprudent to designate a single time to failure for all paved pipe in New York. Figure 11 shows the differences in losses for the different groups of pipes. None should be assumed to retain paving beyond 30 years. For design purposes, round state pipes can be assumed to reach failure at about 30 years. A life of about 20 years appears justified for state pipe-arches.
