# Renovation of the Third Avenue Bridge in Minneapolis

DAVID O. MILLER and RICHARD D. BECKMAN

## ABSTRACT

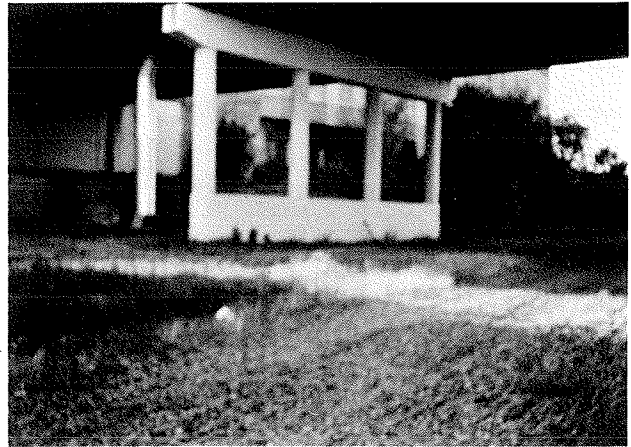
FIGURE 2 South approach bent.

The new design called for completely rebuilding both abutments and approach spans. Because of new design standards, the plans called for replacing the three bents at each approach with single bents of similar design (Figure 2). This was more economical

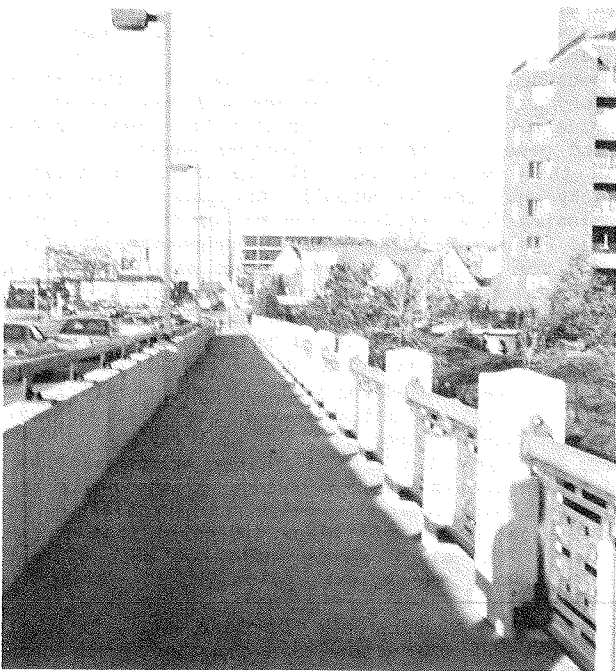
FIGURE 4 Lighting system.

Another concern was the bridge lighting system. The original reconstruction plan called for 19 swan-neck, standard freeway design, lighting fixtures. The argument was made that this lighting system would not be in character with the design and historic nature of the bridge. The parties concerned finally decided upon 53 architectural-style units, only 20 ft high (Figure 4). This lighting system satisfies functional standards and looks attractive

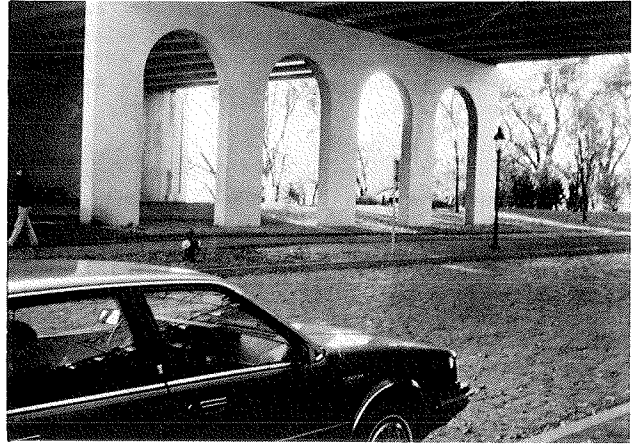
FIGURE 5 North approach to bent.

The northeast approach bent was also changed. It was argued that the redesign was less aesthetically pleasing than the original arched bents and that the railroad crash barrier was not needed because the track was used rarely and at slow speeds. A vaulted bent without a crash barrier was finally decided upon (Figure 5). In addition the historic agencies objected to the proposed replacement of the art-deco

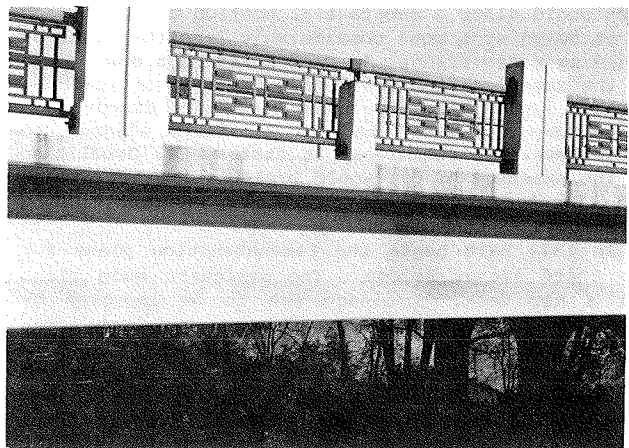
FIGURE 6 Art-deco railing.

railing. Mn/DOT agreed that the railing should be salvaged and reinstalled (Figure 6).

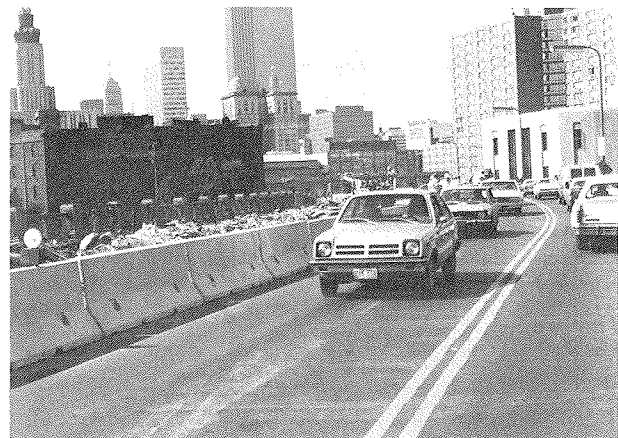
FIGURE 7 Traffic barrier on upstream half of bridge.

Bids were opened at a special letting on July 6, 1979, and Johnson Brothers Corporation of Litchfield, Minnesota, was the low bidder at \$9.1 million. They elected to maintain traffic on the upstream half of the bridge, and bolted portable traffic barriers to the in-place deck (Figure 7). Demolition began with removal of the bituminous surface and the sand layer that was over the structural slab (Figure 8). At that point it became apparent that the structure was in worse shape than anticipated (Figure 9). It was questionable how much construction equipment the slab could support. On the

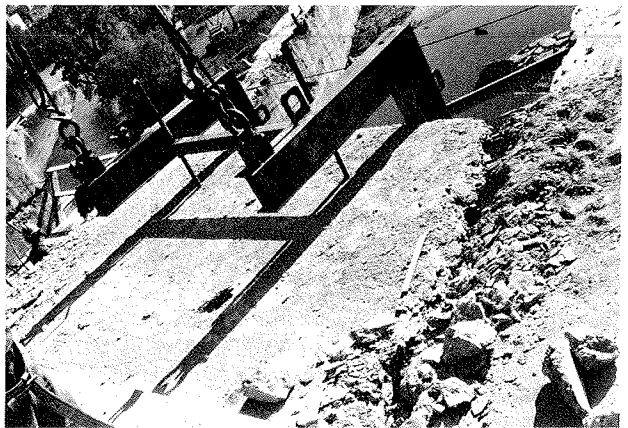
FIGURE 13 Deck removal.

When the sand layer had been removed the contractor began concrete removal. The method chosen to remove the old deck was to first saw it into large panels (Figure 13). The contractor devised a sling-type device that, when used with a mobile crane, held the slab while the reinforcing steel was cut. When the steel was cut the crane merely lifted the slab and set it on waiting trucks or on a spot from which it could be hauled away later. The deteriorated spandrel columns and walls were removed in a

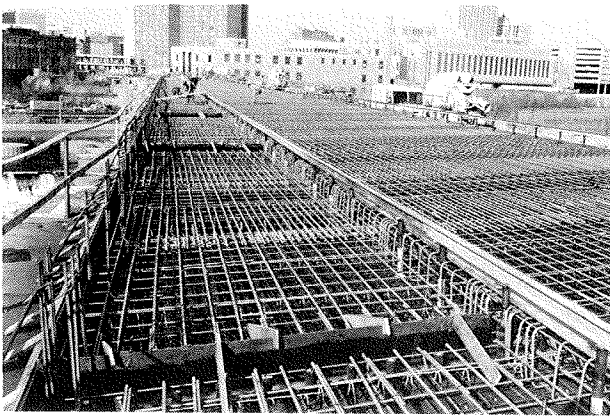
FIGURE 17 Structural deck ready for pouring of concrete.

The bridge was closed to traffic after the first of the year and the contractor continued work. The approach spans over land at the northeast end of the bridge were completely torn down. The approach spans over land at the southwest end were left in place until nearly the end of the job and were used by the contractor for access. The temporary Northwestern Bell trestle at the northeast end was also used for foot access by workmen. The upstream half of the bridge was used as an access road and not demolished until enough of the downstream half was rebuilt to allow it to be used for access. Except for a short time when the weather was too bitterly cold to work, rebuilding of the spandrel columns and the northeast pier continued all winter (Figure 16). Forms were insulated and the temperature of the concrete was continually checked to be sure that it did not freeze. The first section of structural deck was ready for concrete pouring by April (Figure 17).
