Rehabilitation of Steel Deck Girder Bridges

STANLEY W. WOODS

Two 12-span bridges composed of two steel plate girders with a floor system were constructed in 1960. These were the first all-welded girder bridges built in Wisconsin. Plans were prepared to widen these bridges to carry a third lane and replace the existing deck. Several flaws that required repair were discovered in the welded girders. Before construction a transverse crack in the flange was found under the gusset plate used to attach the lower lateral bracing. The gusset plate was welded longitudinally and transversely to the bottom flange. During construction several other flaws were found: cracks under tack welds on the flanges, fatigue cracks in floor-beam webs, web butt welds with incomplete fusion, poor flange-to-web fillet welds, and improper termination of welded covered plates. These flaws were repaired to extend the life expectancy of the bridge by (a) removing the welded gusset plates, grinding the flange smooth, and bolting on new gusset plates; (b) removing the tack-welded piece and grinding out the cracks in the flanges; (c) removing the stringer-to-floor beam welded web connections, reattaching with bolt

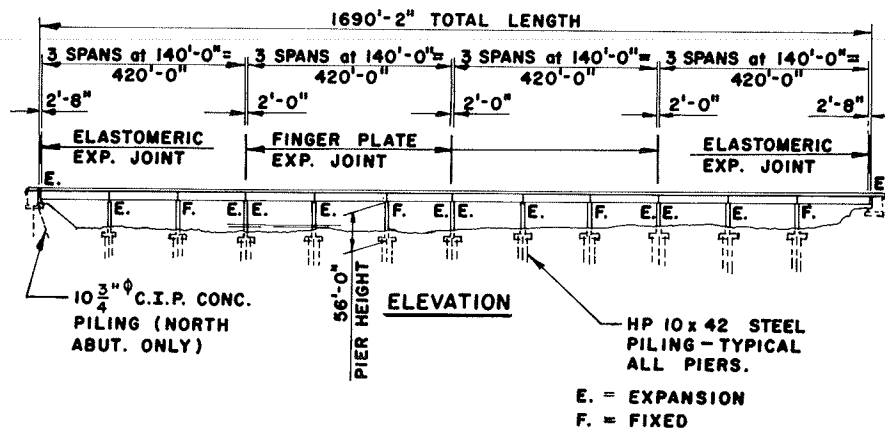
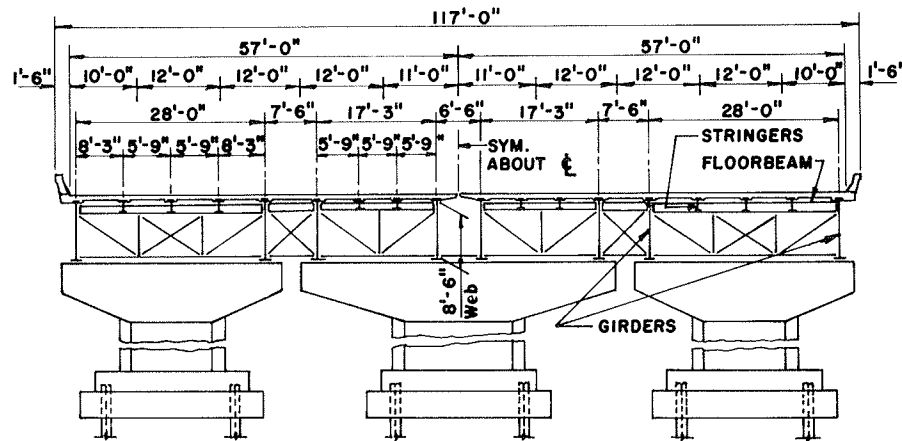
FIGURE 1 Design data.

Two bridges carry Interstate 94 across the Wisconsin River. These 12-span bridges are composed of two steel girders with a floor system and were designed in four segments of 3 continuous span units (Figure 1). The bridges were constructed in 1960 and were the first all-welded girder bridges built in Wisconsin.

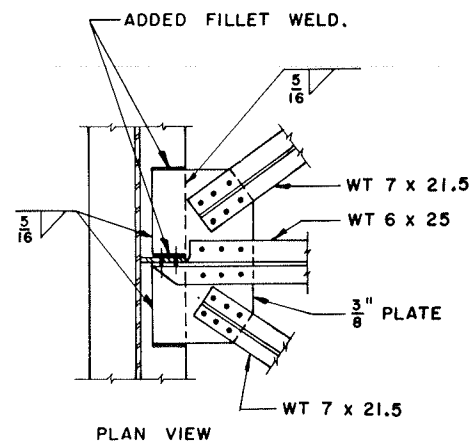
The bridges were fabricated entirely from A242 steel. The lower lateral system was attached to the main girders by gusset plates welded to the top side and inside of the bottom flange (Figure 3). The shop details showed the gusset plates to be attached with longitudinal welds only, but the fabricator had welded these plates on all sides. Flange butt welds also occurred under some of these gusset plates. Before the bidding on this bridge was opened, maintenance personnel discovered a crack in the bottom flange in the butt weld under a gusset plate. Ultrasonic testing indicated that the crack reduced the net section by 75 percent (Figure 4). A bolted splice detail (Figure 5) was developed using A588 steel to attach the lower lateral system as well as splice the flanges together. In addition, a hole

was drilled at the web-flange intersection to prevent crack growth into the web. The fillet welds connecting the cover plate to the flange were removed for 1 in. on both sides of the crack centerline to prevent crack growth into the cover plate.
