Effect of Water Infiltration of Penetrating Cracks on Deterioration of Bridge Deck Slabs

TAKEAKI KATO and YUJI GOTO

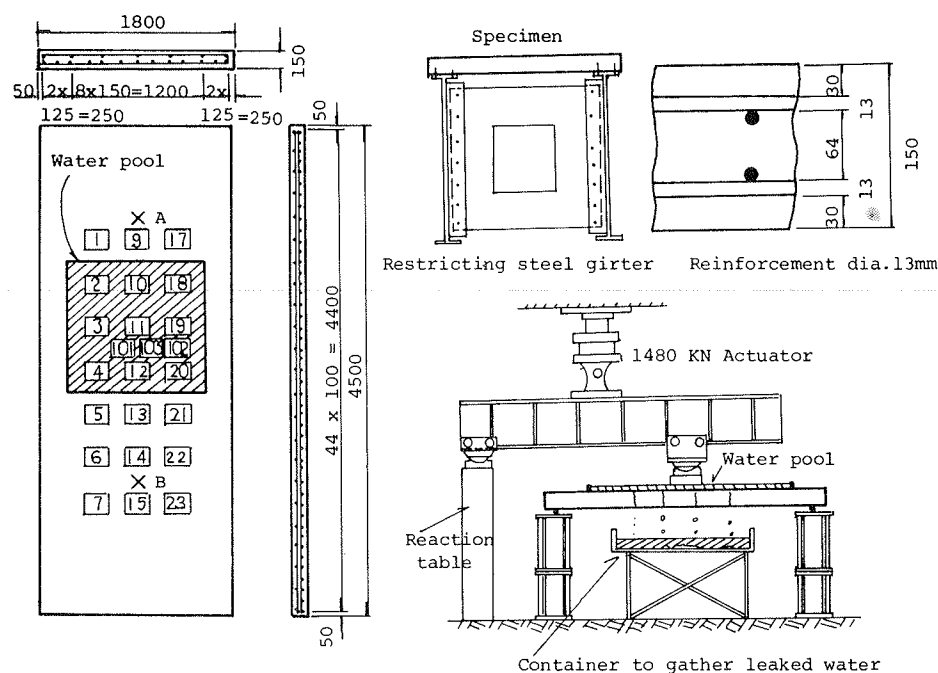
FIGURE 1 Shape of specimen, loading points, and loading apparatus.

Details of this specimen are shown in Figure 1. The result was that many cracks, mainly above the positions of reinforcements, were generated in about 30 minutes after the concrete was cast. By the beginning of the fatigue test, about 3 months after

Figure 1 shows the loading apparatus, the positions of the moving load, and the water that was ponded on top of the slab during fatigue loading of the top surface of the slab. As a preliminary loading, approximately 2,000 78.4-kN repeated loadings were applied to points 1 to 23 to produce a gridlike pattern of cracks over the entire bottom surface. Consequently, cracks occurred and finally crack density reached 10 m/m^2 (total crack length per unit area) as shown in Figure 2(c).

After fatigue tests were completed, static loading tests were carried out on points A and B shown in Figure 1. Static strength was 282 kN at point A and 273 kN at point B. If the average of these values is taken as the static strength of this slab, the ratio of fatigue upper loads of 88.3 kN and 103 kN
