Fatigue Strength of Weathered and Deteriorated Riveted Members

A study has been performed on the fatigue resistance of corroded and deteriorated riveted members. The need for this study arose from the concern with the large number of riveted structures functioning today that have various degrees of corrosion and potential fatigue damage. The validity of AASHTO and American Railway Engineering Association category D that is generally used for riveted connections is uncertain, particularly near the fatigue limit. A series of fatigue tests was carried out on 80-year-old steel bridge stringers with a riveted built-up

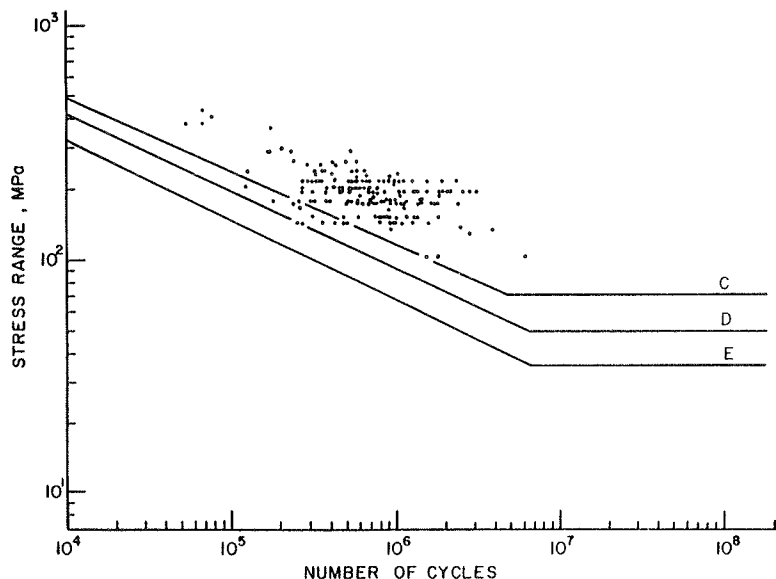
A recent literature survey by the authors confirmed the validity of category D as a lower-bound estimate for fatigue strength. Figure 1 shows the collected test results for normal clamping force and bearing ratios as permitted by the specifications. The test results for bearing conditions that exceed the specification limits are shown in Figure 2, which shows that some results fall below category D.

FIGURE 1 Fatigue resistance of riveted steel connections with normal clamping force and low bearing ratio (≤ 1.5).

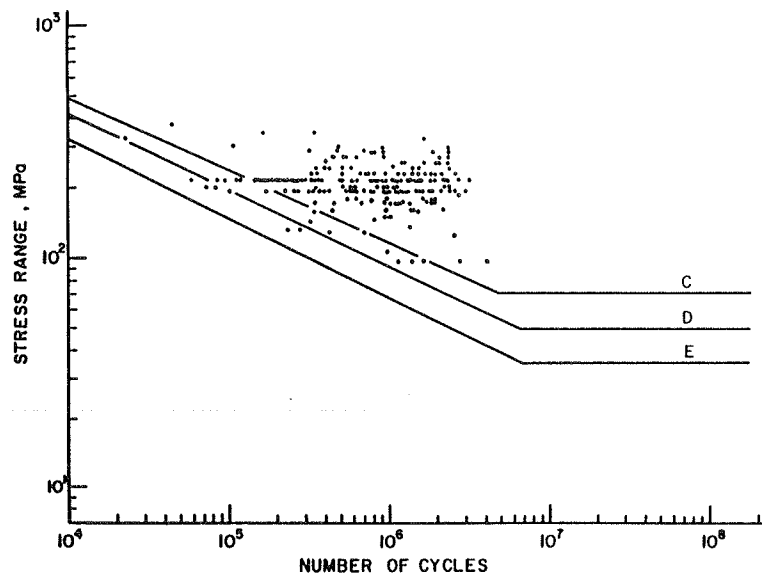
FIGURE 2 Fatigue resistance of riveted steel connections with normal clamping force and high bearing ratio (≥ 1.5).

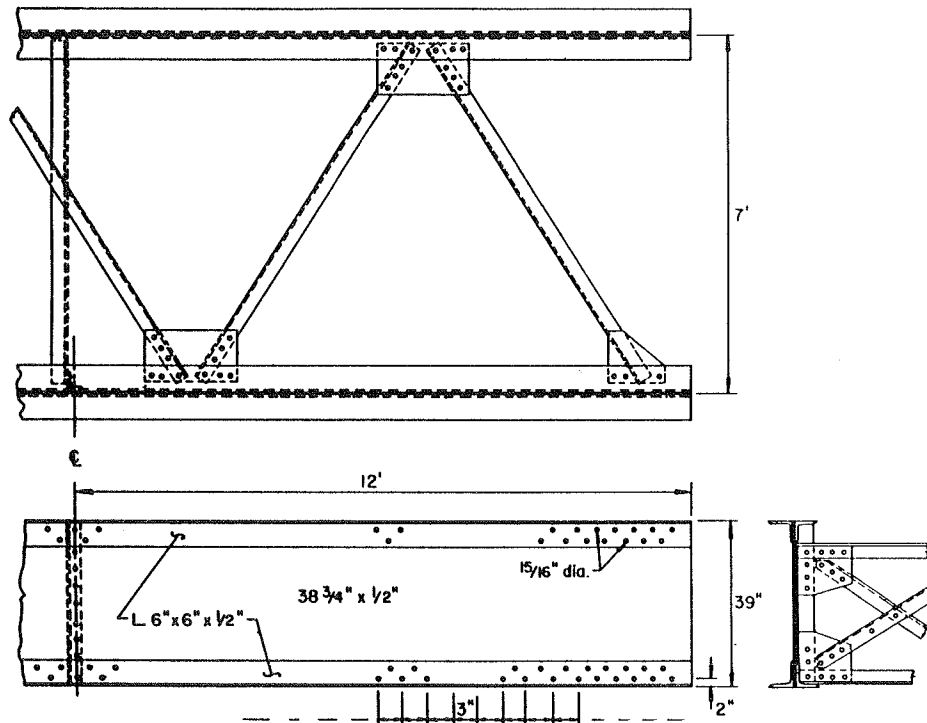
FIGURE 3 Stringers of the French Broad Ivy River Bridge.

Fritz Engineering Laboratory acquired six of the stringers. They were built-up I-shapes that were 1 m deep and 0.32 m wide, and consisted of a web plate and four angles that were connected to the web by two rows of rivets (Figure 3). Their original length was 7.32 m. As cut from the bridge, they were about 6.10 m long.

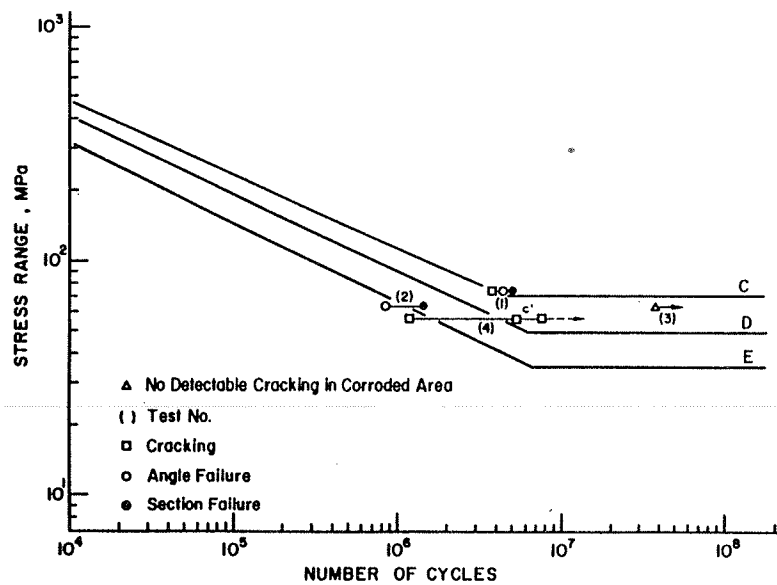
The fatigue test data of the corroded region detail of the flange angle are shown in Figure 15. The stress range is defined on the net section.

FIGURE 15 Fatigue resistance of corroded area details.

was not severe enough to have a crack initiate. The severity of the corroded regions of stringers 1, 2, and 4 were greater than that predicted by considering the loss of cross-sectional area only, as they all plot well below category A. Apparently, the roughness of the surface and the associated stress concentrations are the major factors in making this detail more severe than anticipated.

A final note should be made on the crack length at discovery in the various cases. For beam 4, the crack was small when detected--7.6 mm. This condition is identified in Figure 15 as cracking. The condition where the crack length has increased to approximately the length at discovery for beam 1 is represented by point C'. Hence the fatigue strength of the corroded sections of beams 1 and 4 are comparable.

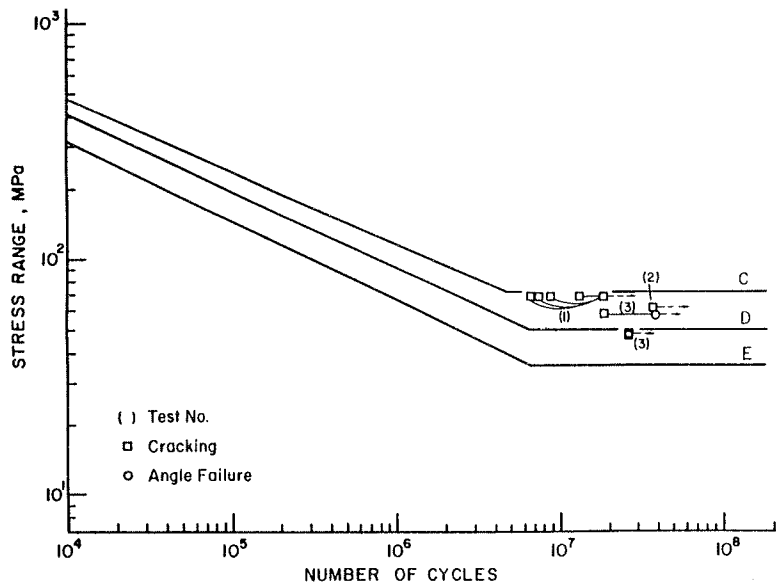
Fatigue cracks formed at rivet holes, as illustrated in Figure 16. The crack surface of one of these details is shown in Figure 17. The fatigue strengths of the rivet details that cracked independently of each other are summarized in Table 2 and plotted in Figure 18 as a function of the net section stress range. In Figure 18 cracking denotes first observed cracking. Failure of the flange angle developed for stringer 3 only. The cracked angles of the remaining stringers were retrofitted before failure could

FIGURE 18 Fatigue resistance of rivet details.

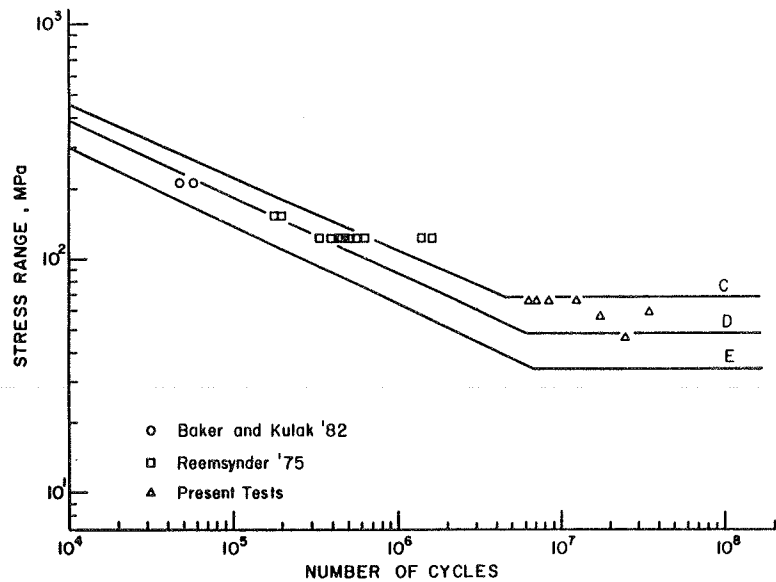
The fatigue resistance of the riveted stringers is compared with the category C and D resistance lines, which are shown to represent riveted members (2) in Figure 19. Also plotted are the results of other tests on riveted members. Fatigue life is defined as first observed cracking in all cases. The truss joints tested by Reemsnyder (6) and the hanger members tested by Baker and Kulak (7) were subjected to much higher stress range levels than the stringers and therefore yielded much shorter fatigue lives. All three sets of test data confirm that category D is a lower bound for the fatigue life, as defined by the development of a small crack.

FIGURE 19 Fatigue resistance of riveted members.

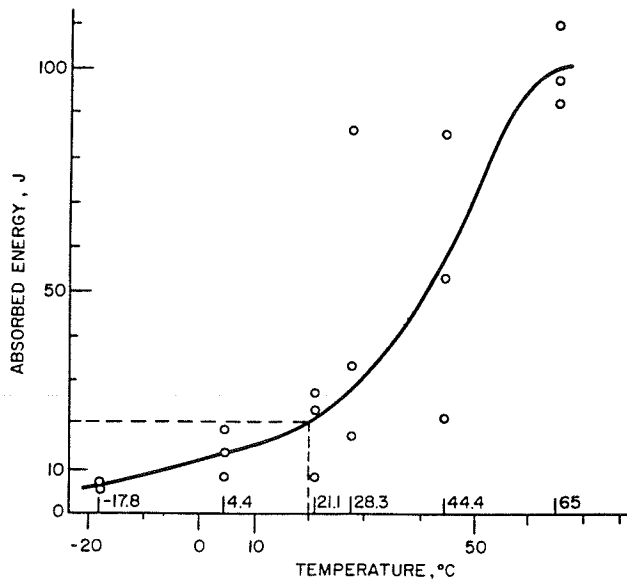
An indication of the fracture characteristics of the material was obtained by performing a series of Charpy V-notch impact tests on 18 specimens taken from a tension flange angle of one of the stringers. Temperatures varied from -18° to 66°C . The results are shown in Figure 22.

A large variation in absorbed impact energy can be seen at test temperatures between 21° and 44°C .

FIGURE 22 Charpy V-notch characteristics of flange angle.

The estimated 20.3 J transition temperature was about 20°C. Hence the material would satisfy the impact energy requirement for zone 2 of the AASHTO and AREA specifications.
