## Fatigue Behavior of Welded Wrought-Iron Bridge Hangers

PETER B. KEATING, JOHN W. FISHER, BEN T. YEN, and WILLIAM J. FRANK

The behavior of fatigue crack growth and fatigue strength of welded lap splice wrought-iron hangers in a railroad bridge was studied. The original wrought-iron hangers were lap spliced with steel plates for the purpose of tightening the members. Field inspection revealed cracks in the welded lap splices. Examination of simulated test joints and cracked hanger splices in the laboratory indicated that fatigue cracks would develop from weld deposits at the cut of the wrought-iron bar, propagate into the steel splice plate, and cause failure. Fatigue cracks could also propagate into the wrought-iron bars but would be arrested by the slag (iron silicate) stringers. Breaking of the wrought-iron bar only occurred when the applied stress was quite high in comparison with the yield point. Measured live-load stresses in the actual bridge member were relatively low. Evaluation of traffic and load records indicates that the effective live-load stresses would be well below the fatigue strengths of these spliced joints. No imminent problem of fatigue failure is expected

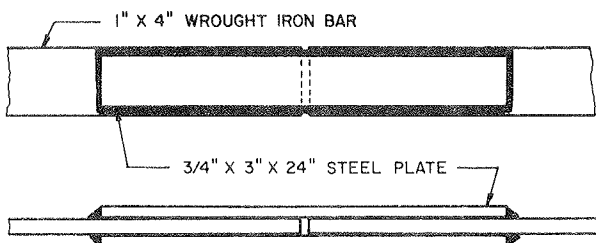
FIGURE 3 Plan of lap splice repair.

Throughout its history, the bridge has undergone an extensive number of repairs and revisions (note that these data are from the records and summarizations of repairs to Bridge 651 of the Norfolk and Western Railroad). This includes span shortening and relocation, stringer replacement, and eyebar tightening. Beginning in 1937, a period during the early development of the welding process, many of the repairs incorporated welding, some to an extreme. Common to old, pin-ended truss bridges, many of the eyebar members loosened with time and required tightening. The corrective repair procedure used on this bridge was to cut the eyebar body and then to weld steel lap shear splices over the cut. A small length was cut out of the eyebar body and the two cut ends were drawn together so as to retension the member. Splice plates were welded on either side, thus overlapping the cut (Figure 3). The steel lap plates were of A7 material.

A continuous fillet weld was placed around the entire perimeter of each lap plate, which resulted

in both transverse and longitudinal welds, the latter bridging the exposed gap between the two wrought-iron plate ends. This was done on many of the diagonals, bottom chord members, and on six of the eight eyebar hangers in span F, as well as eyebar members in the other seven spans. For the hangers in span F, the original cross-sectional area of the wrought-iron bar is 4.0 in.<sup>2</sup>. The addition of the splice plates increases the total area by 12 percent to 4.5 in.<sup>2</sup>. This type of tightening procedure was a common method of repair before the fatigue strength of weldments became known. The American Railway Engineering Association (AREA) specifications now provide procedures for eyebar tightening by heating and upsetting of the eyebar body.

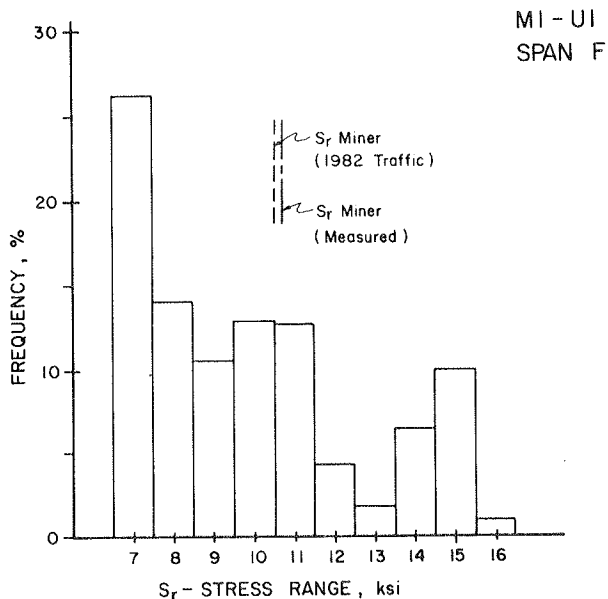
FIGURE 6 Histogram for hanger, span F.

Figure 6 shows the frequency of maximum stress for 10 trains during the recording period, excluding stress ranges less than 7 ksi. The maximum recorded stress range was 16 ksi, which accounted for only 3.5 percent of the total number of cycles. The effective stress range ( $S_r$  Miner) was calculated to be 10.6 ksi. Examination of the stress histories indicated that there occurred one load cycle per car or locomotive for the hanger members. Each wheel group (the two trucks from adjoining cars) gave one complete cycle.

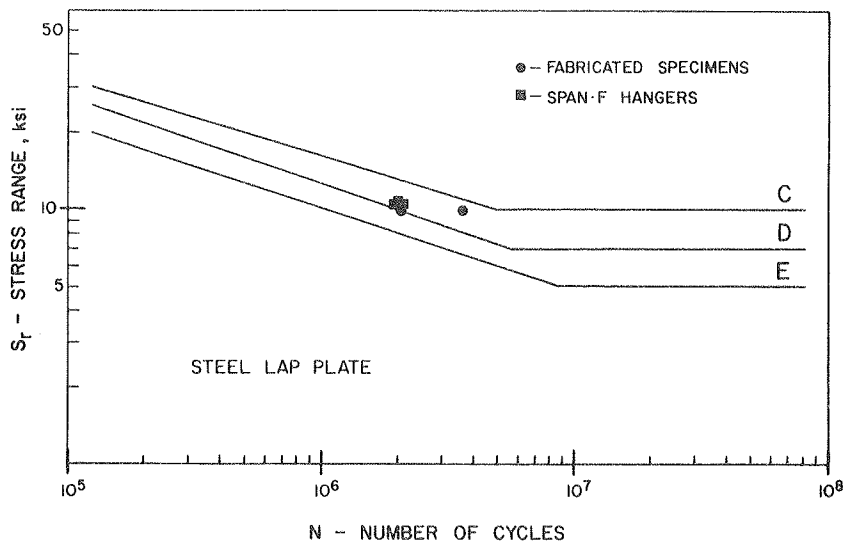
FIGURE 8 Plot of steel lap plate data on S-N curve.

range of 12 ksi in the eyebar. As expected, failure occurred, with a fatigue crack originating at the center gap, where the stress range was 10.7 ksi, and propagated into the steel plates. Final failure occurred at 1.9 million cycles; the results are plotted in Figure 8. This obviously is a lower-bound estimate of the life, as it did not consider the stress cycles experienced by the detail in the bridge. Each of the two resulting halves of the original joint were then tested separately to evaluate the fatigue resistance of the visible transverse weld toe cracks. Although each piece experienced toe cracks in the wrought iron and root cracking of the welds, the tests were carried to 10.0 million cycles without any evidence of failure or inability to continue to resist the cyclic loads. These tests are also plotted in Figure 9; the arrows indicate that they had not failed. Two additional joints were tested to determine the fatigue strength of the steel splices. These tests are plotted in Figure 8 as solid squares. All three joints provided slightly less fatigue resistance than the fabricated specimens as a result of their prior cyclic loading in the structure.

The test results from the welded wrought-iron specimens and the actual hangers are summarized in Figures 8 and 9. These tests demonstrate that the fatigue resistance is much greater than that provided by category E--the expected fatigue category for such welded steel details. None of the details

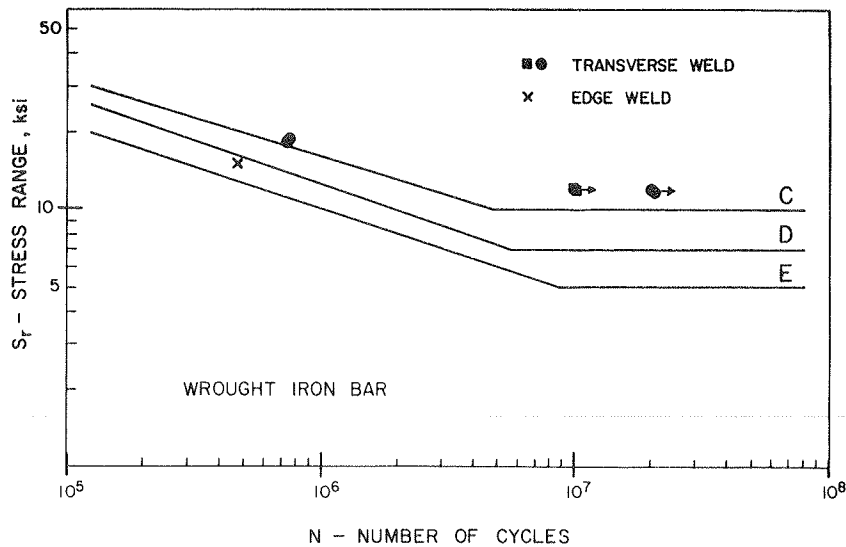
FIGURE 9 Plot of wrought-iron data on S-N curve.

Because failure at the toe weld of the wrought-iron plate did not result in failure at 12 ksi, the stress range was increased to 18 ksi for the next three specimens. At the higher stress level failure occurred at the toe of the transverse weld beginning at approximately 0.74 million cycles. This was still well above the fatigue strength expected at a category E detail. All fatigue test results applicable to the wrought-iron members are plotted in Figure 9. Those tests that were stopped before failure are indicated with an arrow.

tested at a stress range of 12 ksi failed as a result of the crack that formed at the weld terminations. These cracks were arrested and did not impair the load-carrying capability of the joint. Failure, should it occur, was shown to develop at the gap region.

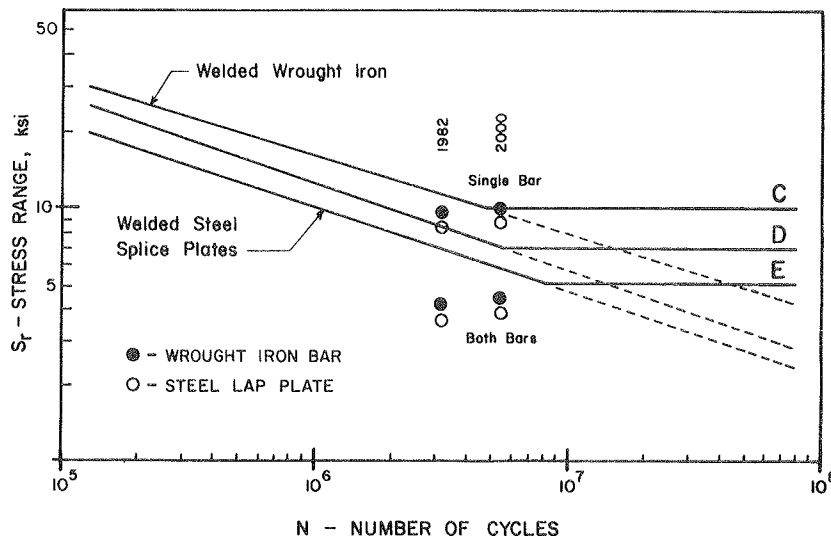
FIGURE 14 Plot of estimated fatigue life for hangers, span F.

Because the lap plate splices are more critical at the cross section at the center of the joint where the eyebar was cut, those values are plotted in Figure 14. The increased cross-sectional area decreases the effective stress range to 3.8 ksi in 1982 if both bars are effective and to 8.7 ksi if only a single bar is carrying the load. The small degree of cracking observed in the field and in the eyebars removed from the structure suggests that both hangers were carrying the load throughout much of their life. Had both hangers shared the load, no appreciable damage would have developed for the traffic projected to the year 2000.
