Evaluation and Field Testing of the Dan Ryan Rapid Transit Structure

ANDREW E. N. OSBORN and MICHAEL J. KOOB

A post-construction investigation of the Dan Ryan elevated rapid transit structure between 17th and 23rd streets in Chicago was conducted for the Chicago Transit Authority (CTA). The purpose of the investigation was to evaluate the sensitivity of welded details in the structure to fatigue.

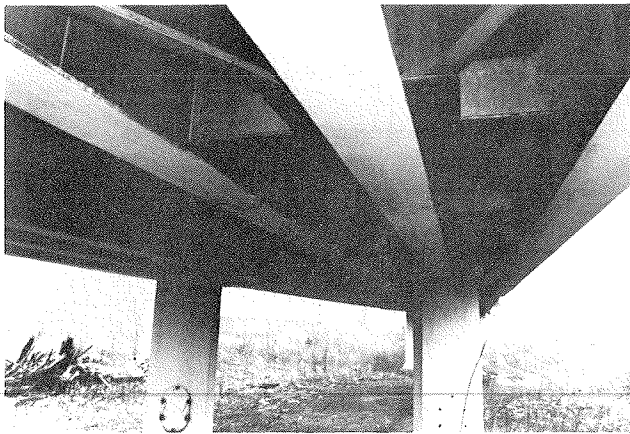
The plate girders are provided with vertical stiffeners spaced approximately 4 ft apart and horizontal gusset plates spaced at approximately 8 or 16 ft, depending on location. The gusset plates are located about 4 in. above the bottom flange of the stringers. Deep, channel-shaped diaphragms are bolted to stiffeners along the web of the channel and gusset plates at the channel flange. Lateral bracing members are also bolted to the gusset plates. Lateral bracing consists of angle K bracing to bent 34 and structural tee X bracing beyond bent 34. A plan view of three spans that shows the variation in framing systems is presented in Figure 3. The underside of span 15 is shown in Figure 4; it shows the lateral bracing system typical of spans 2-16.

FIGURE 4 View of framing on the underside of span 15.

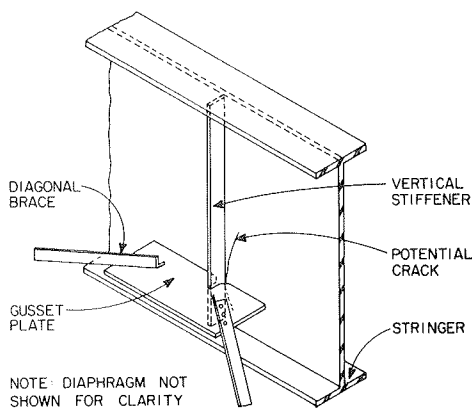
Lateral gusset plates are welded to the webs of stringers, with the vertical stiffener fitting into a cutout in the gusset plate, as shown in Figures 5 and 6. In spans 1-27 the cutouts are close fitting, and fillet welds were used for the gusset plate to stringer web connection. In spans 28 and above there is an approximate 0.5-in. gap between the cutout edge and the stiffener, and the gusset plates were single-bevel groove welded to the web. Back-up bars were used to make the groove weld connections in spans 35-40. The back-up bars or gusset plates were attached with short intermittent fillet welds for fit-up before completing the groove welds. The termination of all these welds represents conditions that are sensitive to fatigue (2).

FIGURE 5 Gusset-plate connection: schematic view.

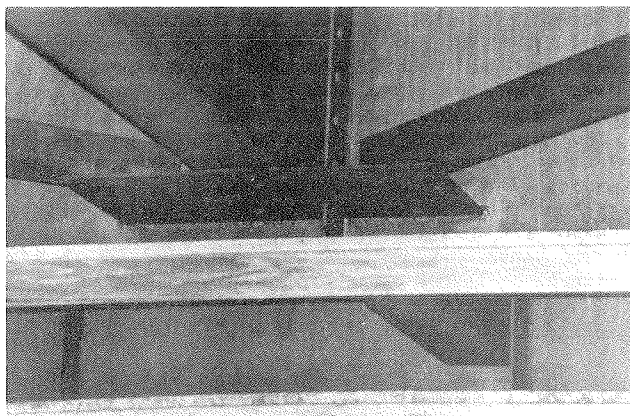
FIGURE 6 Gusset-plate connection: typical detail.

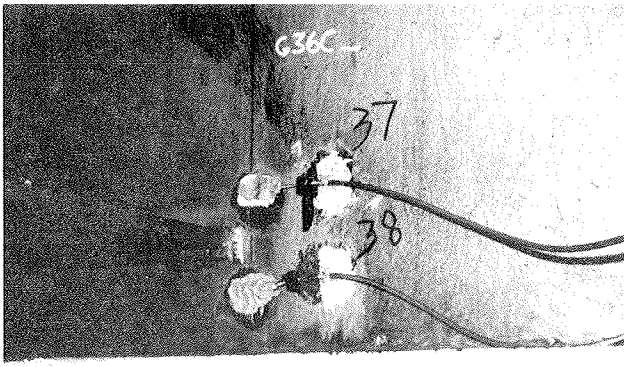
Strain gauges were installed primarily on webs of stringers adjacent to gusset plates, on stringer flanges, and on cross-bracing members. Figure 9 shows an installation adjacent to a gusset plate. Gauges were also installed on the webs and flanges of box bents and on a hinge link. Details of the strain-gauge layout are shown in Figure 10.

FIGURE 9 Type A gauge installation on web of stringer adjacent to gusset plate.

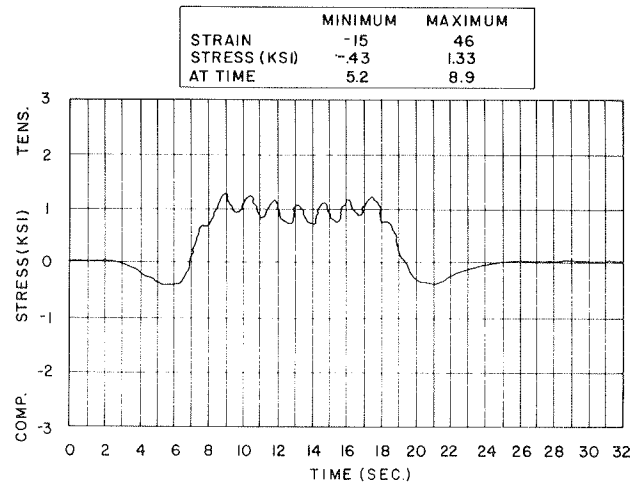
FIGURE 11 Dynamic strain response during the passage of an eight-car train.

1. In all the measured strain responses it was observed that a single train, regardless of length, induces a single large cycle of stress. A typical plot of dynamic strain response during the passage of an eight-car train is shown in Figure 11. In many cases the groupings of four axles at the ends of adjacent cars caused individual cycles to have magnitudes of up to one-third the maximum stress ranges measured. In the most extreme cases the magnitudes of the individual cycles were found to be less than about 400 psi, which is not considered to be significant.

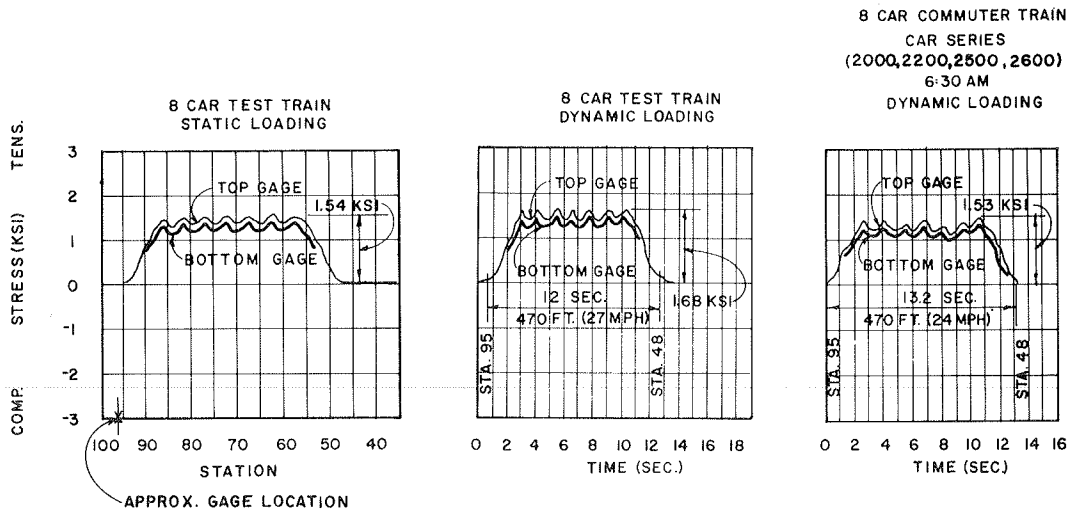
2. Dynamic stresses are a maximum of 10 percent greater than static stresses in simply supported spans, as shown in Figures 12 and 13. In continuous spans the dynamic results are generally equal to the static results (Table 2). These effects are difficult to quantify because the differences are small.

FIGURE 12 Comparison of upper and lower type A gauges in span 22 under different loading conditions.

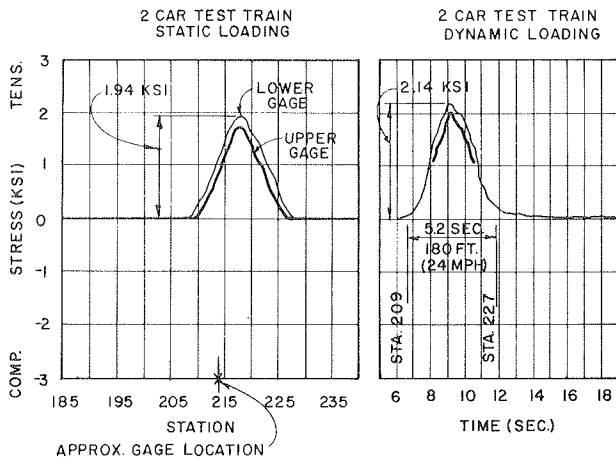
FIGURE 13 Comparison of upper and lower type A gauges in span 36 under different loading conditions.

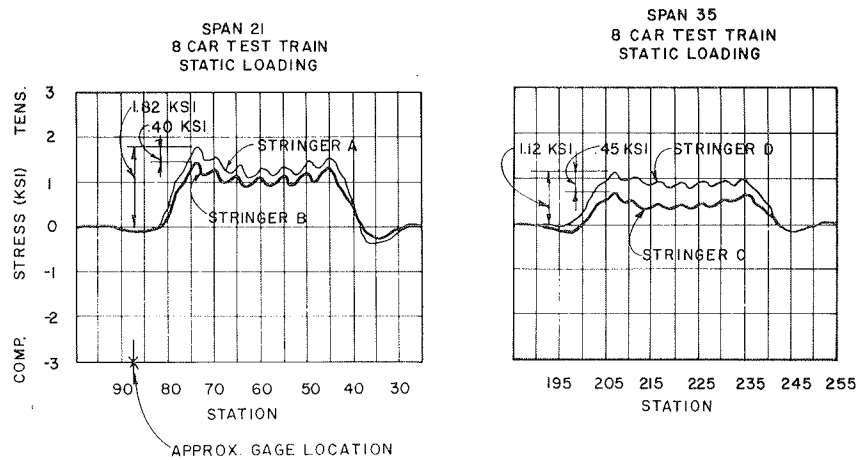
3. As expected, the outside stringer on horizontal curves carries greater loads than the inside stringer. Figure 14 shows comparisons in stress range for geometrically similar gauge locations in adjacent stringers in three different spans. Note that there appears to be a somewhat more equal distribution of load in spans 36NB and 36SB, which are simple spans of only two stringers. The relationship

FIGURE 14 Comparison of stresses measured in type A gauges for adjacent stringers.

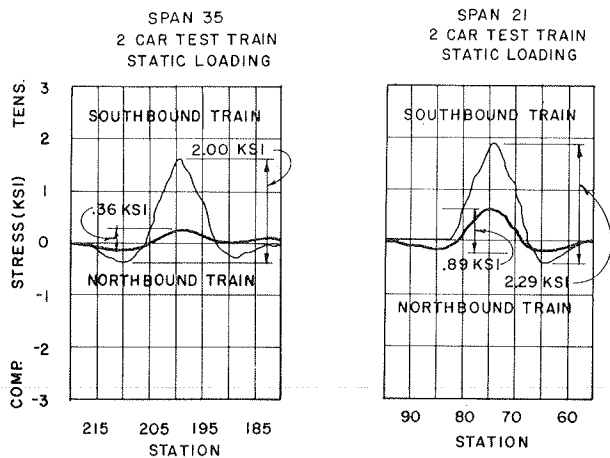
One of the reasons for the difference between theoretical and measured stress levels is shown in Figure 15, which compares stresses from northbound and southbound trains. These gauges are on the exterior stringer under the southbound track in spans 35 and 21. Note that the stresses from northbound trains are 18 and 39 percent of the values from southbound trains, which show the substantial lateral distribution of loads by the concrete deck and steel diaphragms. Smaller lateral stiffnesses for span 35 relative to span 21 are also indicated. Span 35 has a limited lateral bracing system between the northbound and southbound sides of the structure.

FIGURE 15 Comparison of influence of northbound and southbound trains showing lateral load distribution.
