Characteristics of Sinkhole Development and Implications for Potential Cavity Collapse

BYRON E. RUTH and JANET D. DEGNER

ABSTRACT

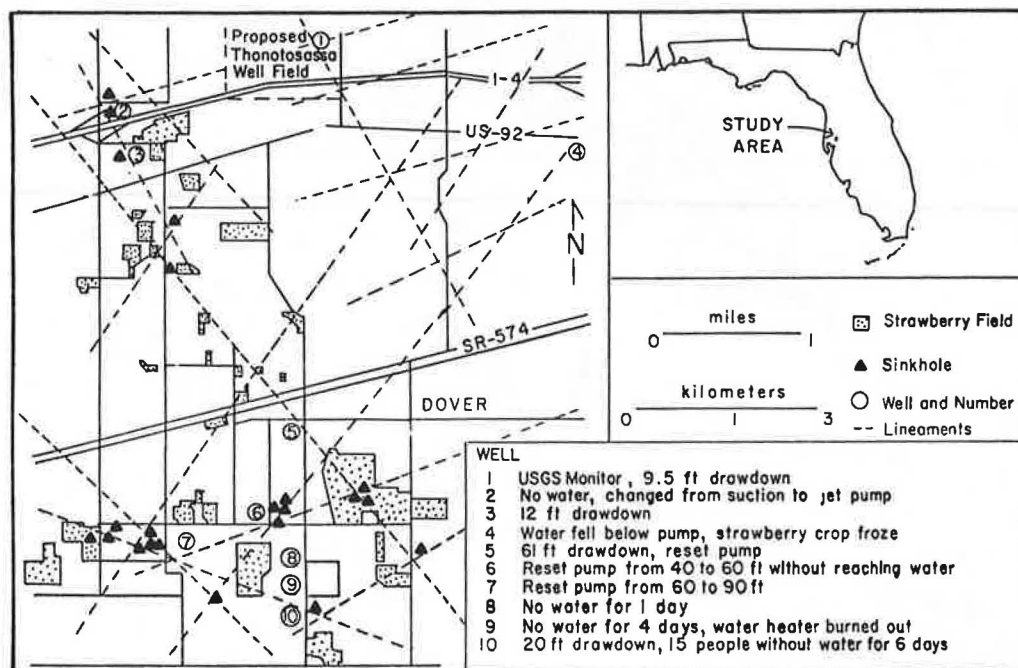
The lineaments were mapped primarily from soil and vegetation tonal alignments, and the linears formed by a few old sinkholes. The lineaments were transferred to a base map that identified the location of the 22 sinkholes. Figure 6 shows this map that illustrates the location of wells, strawberry fields, and new sinkholes in relation to lineaments.

These lineaments are similar to the northeast and northwest trends mapped by Vernon (13) in 1951. The majority of the sinkholes occurs at or near the intersection of lineaments and in slightly lower or depressed areas of the terrain (14). The area south of FL-574 had the greatest activity (17 sinkholes), which is probably attributable to greater drawdown and intensity of overhead irrigation for freeze protection of crops.

FIGURE 6 Lineament and sinkhole map for study area west of Plant City, Florida [modified from Hall and Metcalfe (12)].

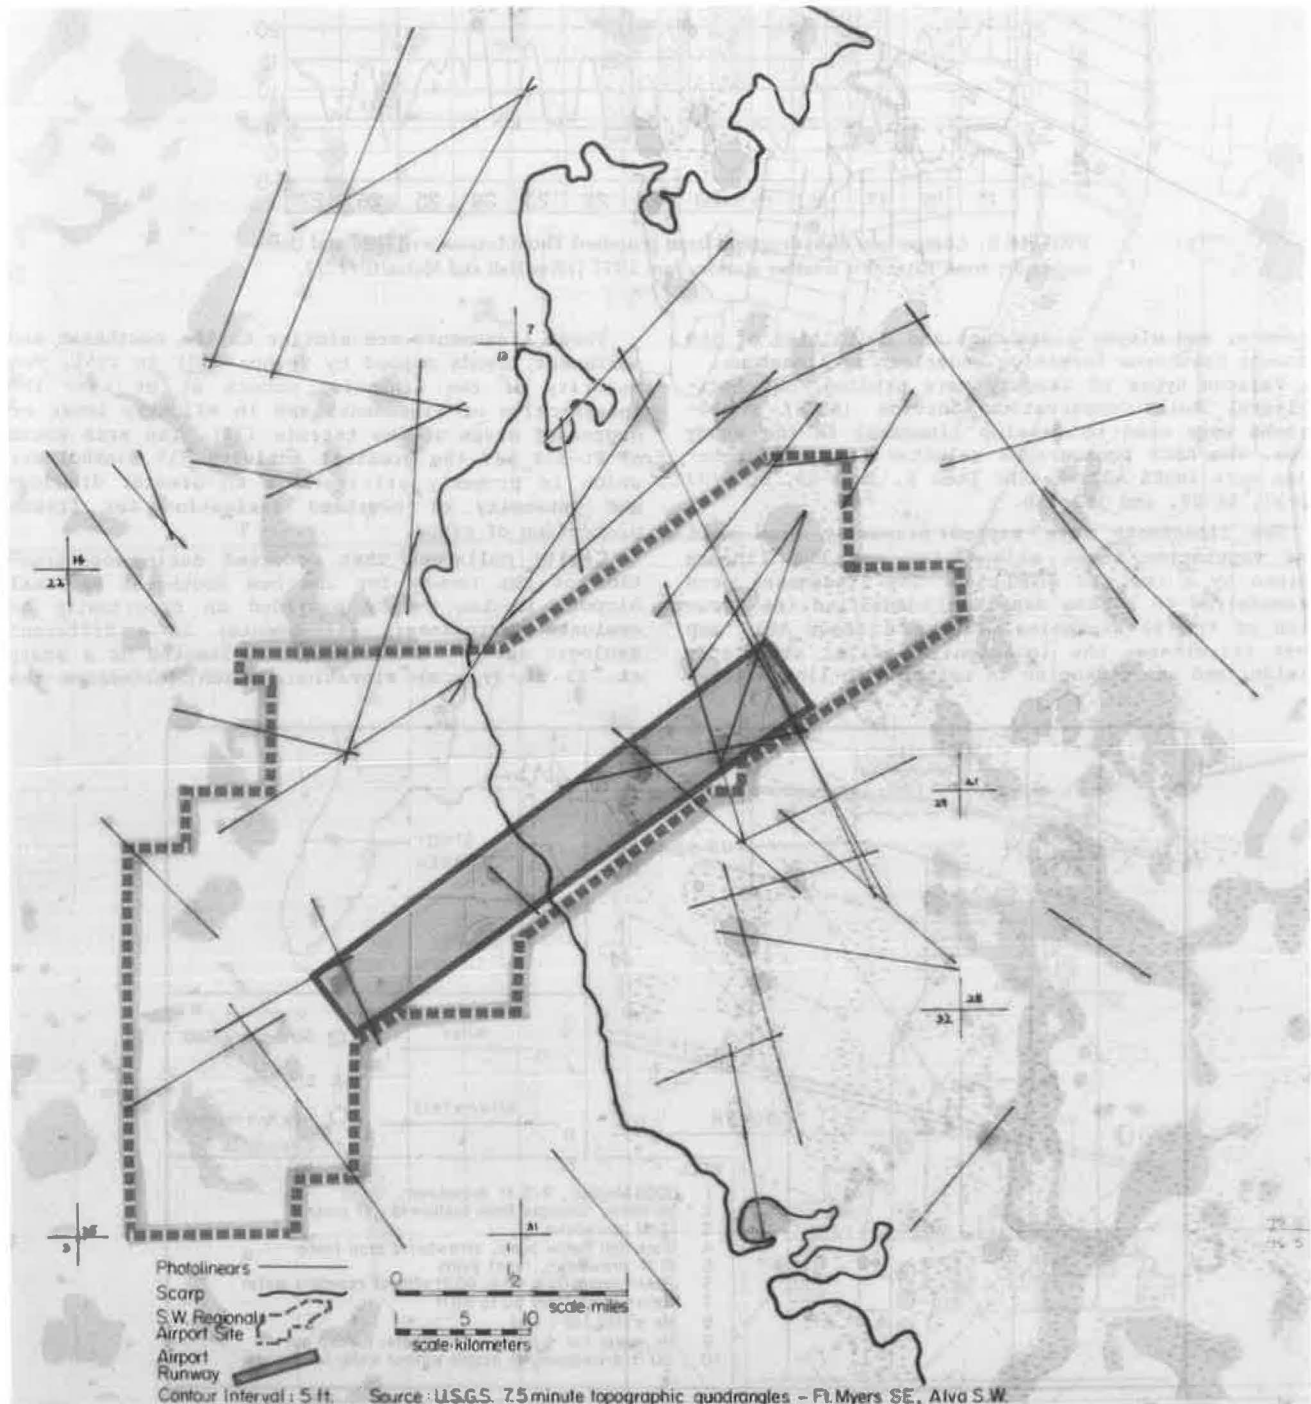
FIGURE 7 Photolinear map of the Southwest Regional Airport site and vicinity, Lee County, Florida.

transferred to a U.S. Geological Survey 7.5-min topographic quadrangle map. Figure 7 shows that the northeastern portion of the airport runway is located in a zone of the Immokalee Rise that has a predominance of photolinears and intersections of these linears. It was also obvious that numerous depressions and wet, swampy areas are located within this zone.
