Field Performance of a Low-Modulus Silicone Highway Joint Sealant

THOMAS R. ZIMMER, SAMUEL H. CARPENTER, and MICHAEL I. DARTER

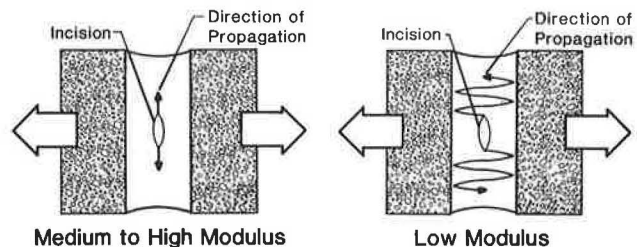
Another property of Dow Corning 888 silicone sealant is its resistance to tear propagation. Usually sealant tears propagate perpendicular to the direction of stress (1). In contrast, the low-modulus silicone has a very ragged tear that propagates slowly back and forth almost parallel to the direction of stress (Figure 1).

FIGURE 1 Difference in tear propagation between low-modulus and higher-modulus silicone sealants.
