Emergency Opening System for Authorized Vehicle Lanes

JAMES R. MORGAN, JOHN W. STRYBOS, HAYES E. ROSS, Jr., and JAMES G. DARDEN III

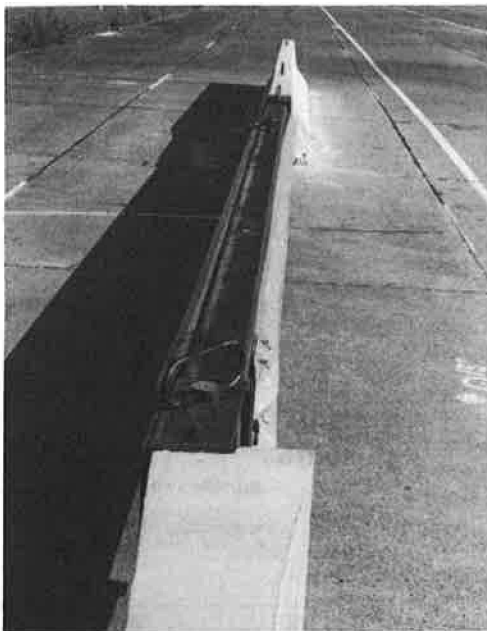
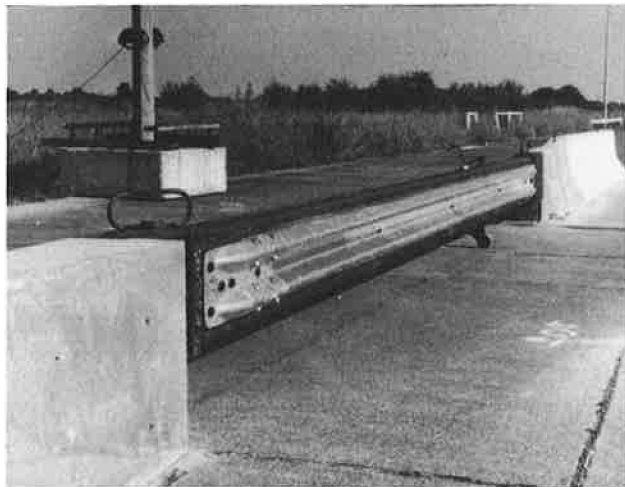
FIGURE 1 Emergency opening system.

The strength of the EOS was achieved by using two square steel tubes mounted on top of each other and separated vertically by 1.38 in. (3.5 cm). The tubes were mounted between two modified CMB sections 30 ft (8.9 m) long that were separated 30 ft. The details of the EOS design and operation are given in Figures 1 and 2. The size and orientation of the steel members were selected on the basis of information from a computer analysis. The EOS was analyzed with a computer program developed to study the behavior of an automobile striking a deformable barrier of general configuration (1). In the computer program, a dynamic, inelastic large displacement structural analysis problem is solved in two dimensions by using a step-by-step method. The automobile is modeled as a plane body of arbitrary shape surrounded by inelastic springs. During impact, the automobile slides along the barrier. Forces between the automobile tires and the pavement as well as the interaction forces between the automobile and the barrier are taken into account. The barrier is modeled as an assemblage of beams, posts, springs, and damping devices with loads applied to the barrier only at the nodes. For the purposes of this study the barrier was modeled as a system of 20 beam elements. Impact with a large, 4,500-lb (2040-kg) vehicle traveling at 60 mph (96.6 km/hr) and 25 degrees was investigated. The joint loads, 250 kips (34.6 kN) axial and 50 kips (6.9 kN) lateral shear, and deflections from this simulation were used to design all the appurtenances of the EOS.

The connections and supports of the EOS were designed by using the applicable standards (2,3) to transmit and contain the peak loads obtained in the computer simulation. The details of the EOS design have been presented elsewhere (4). The system consists of a 30-ft-long steel beam section, which is pinned at each end to a 30-ft-long modified CMB. A 3.25-in. (8.3-cm) diameter steel pin in quadruple shear transfers the load at each end of the EOS through tongue plates to a base plate bolted to the CMB. Further details of the system, in both as-tested and modified configurations, are available elsewhere (4).

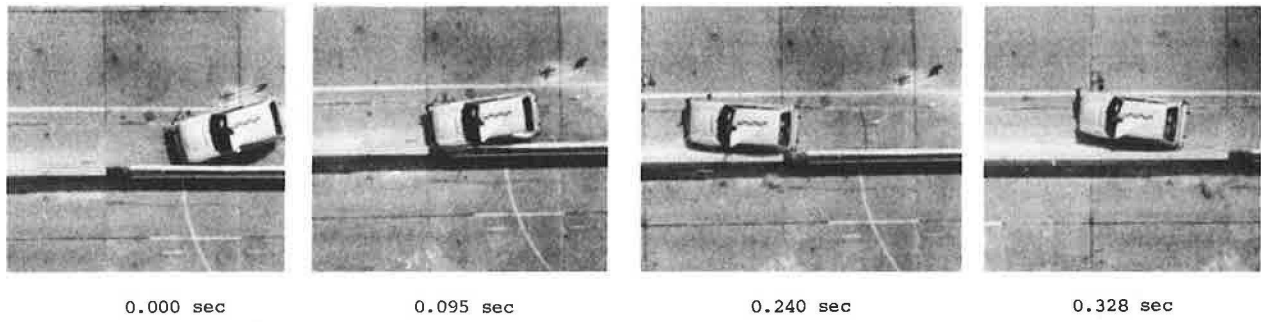
FIGURE 3 Sequential photographs, Test 1.

In the first test, an 1,800-lb (815-kg) Honda Civic 1200 (1977) impacted the EOS 6 ft upstream from the downstream end of the steel gate system at 55.2 mph (88.8 km/hr) and 15 degrees. Figure 3 shows sequential photographs of this test. The test vehicle was smoothly redirected. The vehicle exit angle and speed were 5.5 degrees and 48.0 mph (77.3 km/hr), respectively. The occupant impact velocities were 14.15 ft/sec (4.31 m/sec) longitudinal and 16.42 ft/sec (5.00 m/sec) lateral. The peak 50-msec average acceleration was 4.27 g longitudinal (Figure 4) and 7.52 g lateral (Figure 5). All the occupant risk values as well as the vehicle trajectory hazard are below recommended values (5) for this type of test.

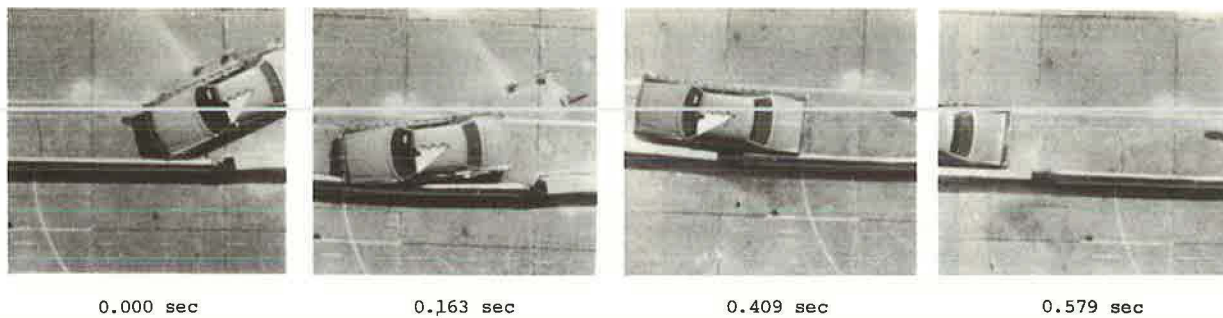
FIGURE 8 Sequential photographs, Test 2.

In Test 2 the strength of the gate system was examined. A 4,500-lb (2040-kg) Plymouth Grand Fury (1977) impacted the EOS 6 ft upstream from the midpoint of the steel gate at 60.7 mph (97.7 km/hr) and 25.25 degrees. Figure 8 shows sequential photographs of this test. The test vehicle was smoothly redirected. The occupant impact velocities were 18.89 ft/sec (5.76 m/sec) longitudinal and 22.77 ft/sec (6.94 m/sec) lateral. The vehicle exit angle was 4 degrees and the vehicle exit velocity was 47.96 mph (77.2 km/hr). The peak 50-msec average acceleration was 5.77 g longitudinal and 9.32 g lateral. The

vehicle accelerations were within acceptable limits (5) for this type of test. The longitudinal occupant impact velocity was also within acceptable limits, but the lateral occupant impact velocity exceeded the recommended value, although it was less than the limiting value. In addition, this type of test was not required to meet the NCHRP (5) criteria.

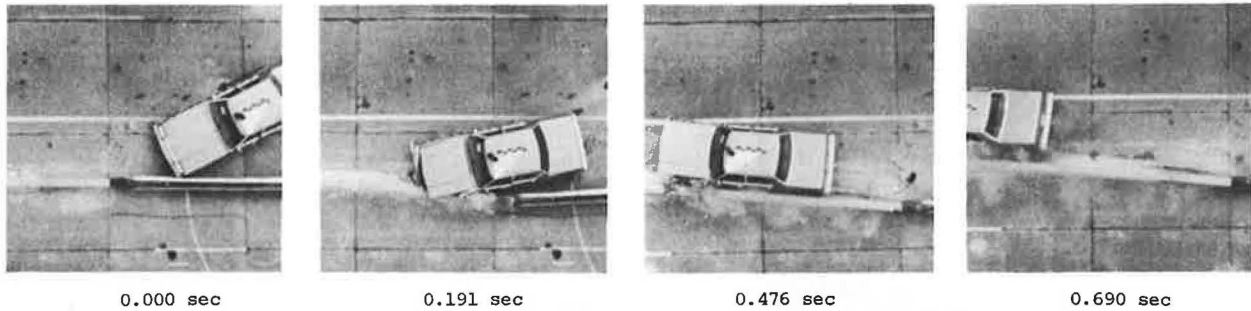
FIGURE 11 Sequential photographs, Test 3.

In Test 3 the strength of the beam-to-CMB connection was examined. A 4,500-lb Plymouth Grand Fury (1977) impacted the EOS 6 ft upstream from the downstream end of the steel gate system at 60.04 mph (96.6 km/hr) and 25.5 degrees. Figure 11 contains sequential photographs of this test. The test vehicle was smoothly redirected. The vehicle exit angle was 1.75

degrees and the vehicle exit speed was 39.01 mph (62.8 km/hr). The occupant impact velocities were 25.62 ft/sec (7.81 m/sec) longitudinal and 20.54 ft/sec (6.26 m/sec) lateral. The peak 50-msec average acceleration was 8.59 g longitudinal and 8.32 g lateral. The vehicle accelerations were within acceptable limits (5) for this type of test. The lateral occupant impact velocity was also within recommended limits, but the longitudinal occupant impact velocity exceeded the recommended value, although it was less than the limiting value. In addition, this type of test was not required to meet the NCHRP criteria (5).

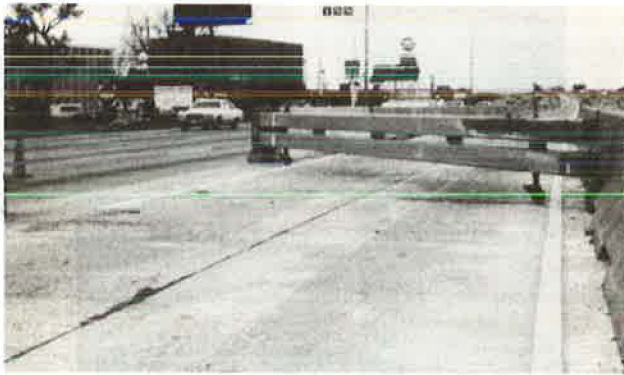
FIGURE 14 EOS as implemented.

At the writing of this paper the concepts and modified designs presented here are being implemented on the I-45 AVL project in Houston, Texas (Figure 14).
