Repair of Timber Bridge Piling by Posting and Epoxy Grouting

R. RICHARD AVENT

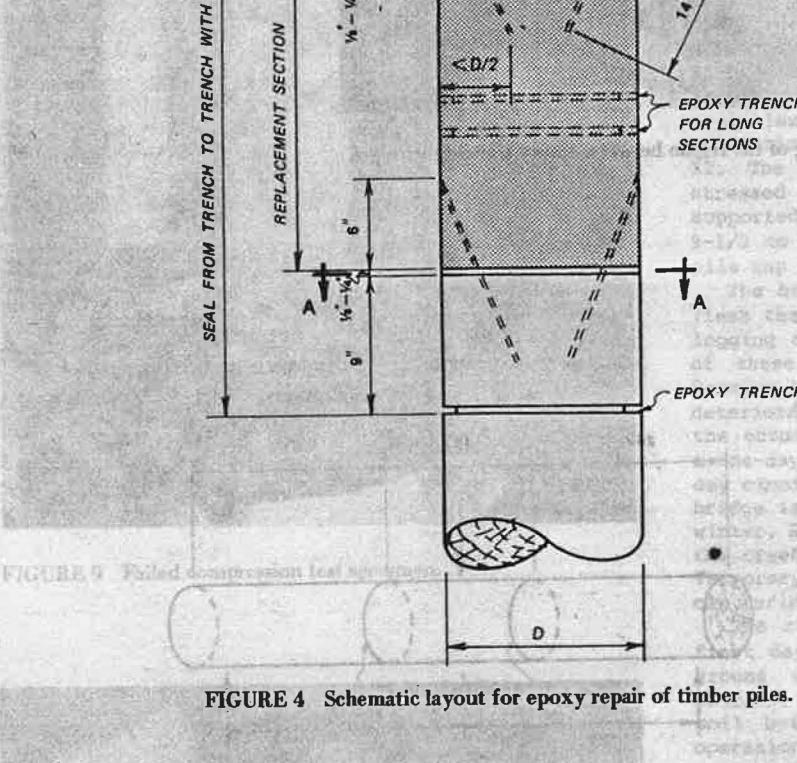
FIGURE 6 Spiral steel rod being placed at joint.

6. The pins are placed at each cut location. Four holes are drilled at approximately 6 in. above each joint with a 14-in. long, 9/16-in. drill bit. The holes are spaced at 90 degrees around the pile and drilled at a 60-degree or larger angle with the horizontal as shown in Figure 4. The steel pins are 3/8-in. square bars twisted to form a spiral of one revolution for each 6 in. of length. The pins are lightly driven until flush with the surface (Figure 6).

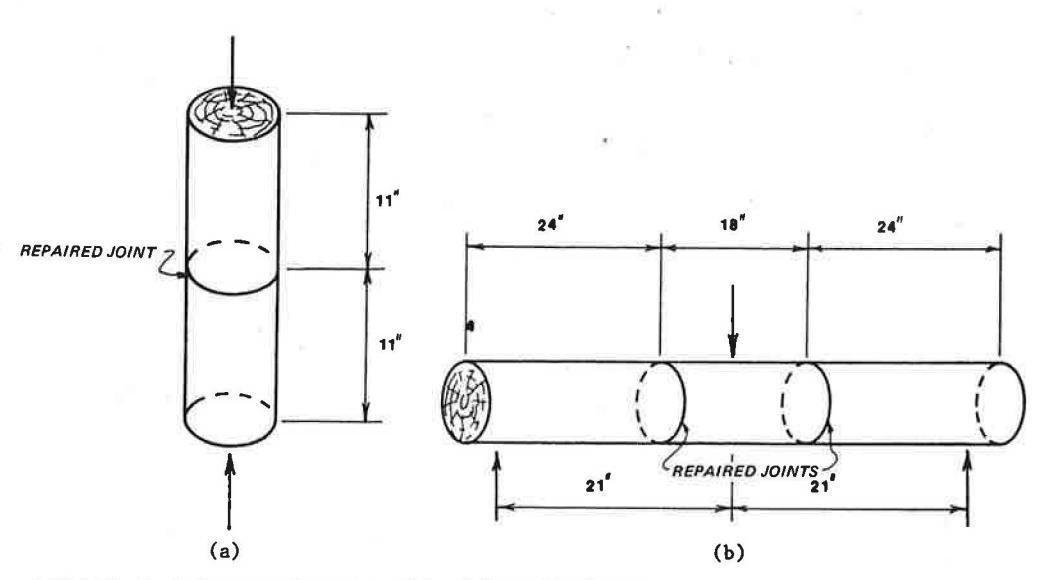
FIGURE 8 Typical test specimens for axial and flexural load tests.

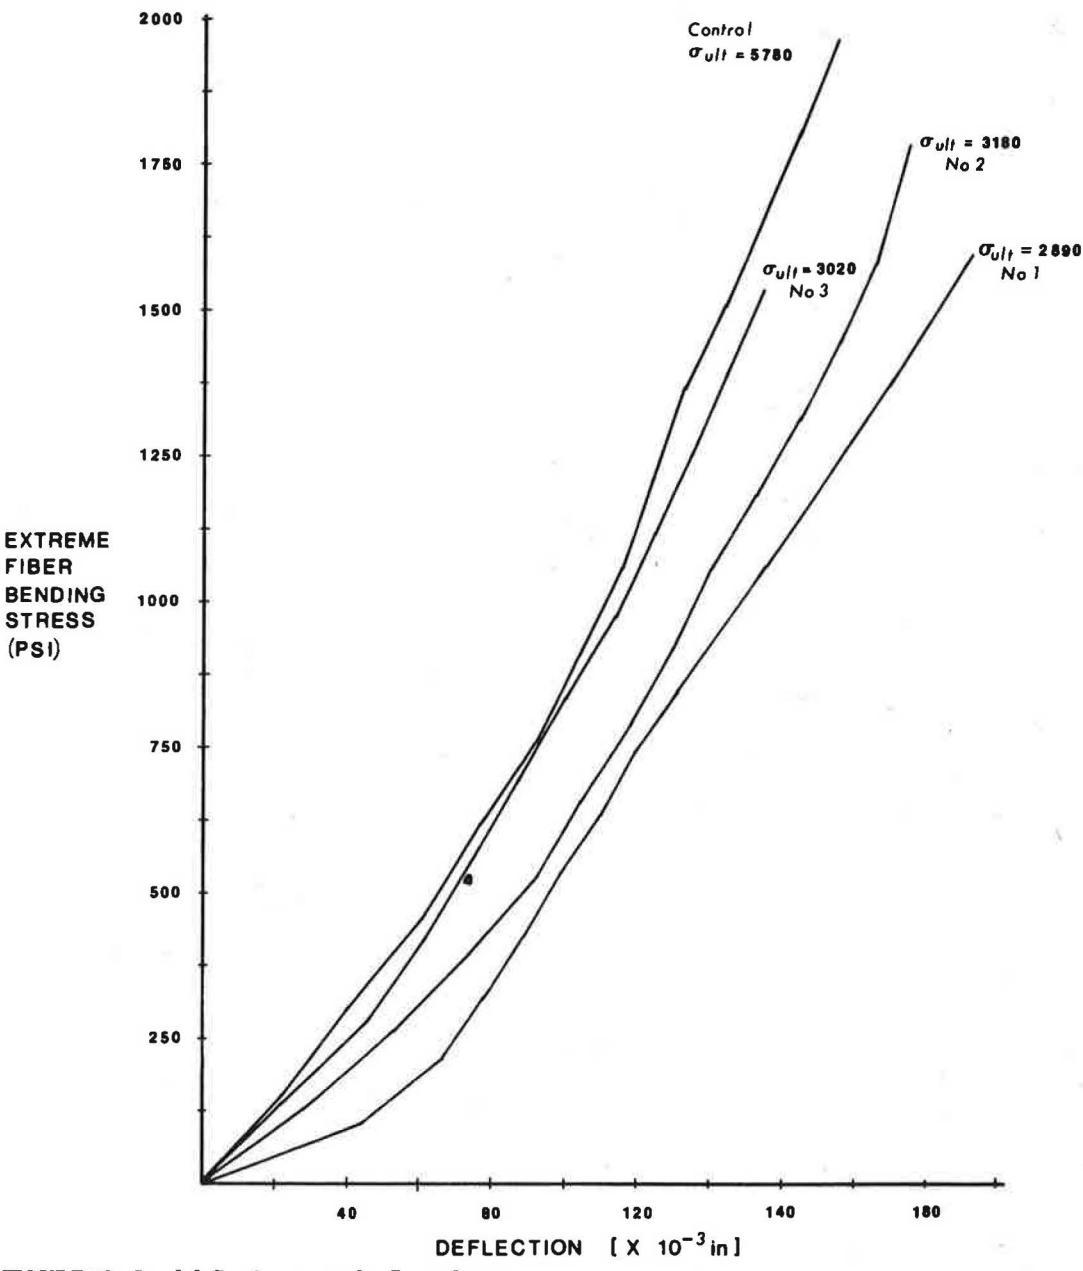
failure did not occur at the epoxy-to-wood bond, but rather in the epoxy itself. This failure type indicates the effectiveness of the pressure-injected epoxy at the bond line because the epoxy failed before the bond. A load-deformation curve was plotted for each specimen. These plots are shown in Figure 11. It can be seen that the stiffnesses of the epoxy-repaired sections are similar to that of the control specimen, which was a solid section of the same stock. Although not measured, it should be noted that the failures represented ductile behavior. After ultimate load was obtained, the spiral bars provided a significant level of reserve ductile strength.

FIGURE 11 Load-deflection curves for flexural tests.

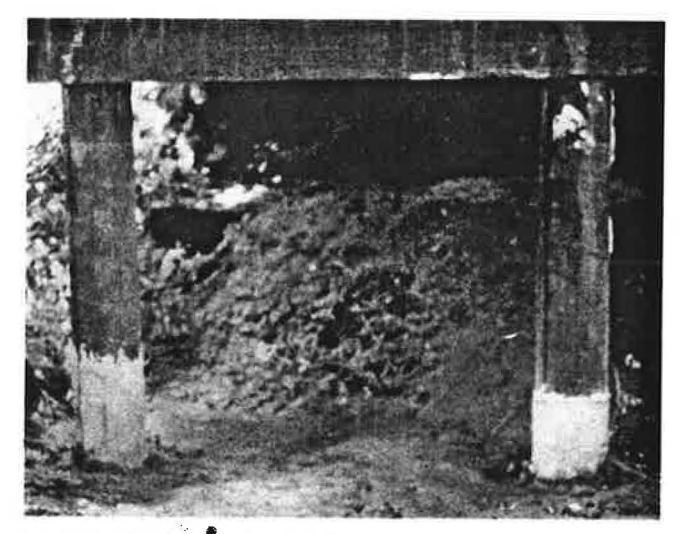
The damaged piles are shown in Figures 13 and 14. Piles 1 and 2 were damaged from the pile cap to a depth of 5 ft and were 10 1/2 and 11 1/2 in. in diameter, respectively. These 5-ft sections were replaced with new treated sections obtained from a local lumber yard. Pile Number 1 with the damaged section removed is shown in Figure 3, and the new section in place at Pile Number 1 is shown in Figure 6. Pile Number 3 was repaired by replacing a 3 ft section beginning at 2 ft below the pile cap and having a 9 1/2-in. diameter. The new section in place is shown in Figure 5. All piles were repaired using the procedure described previously. After the replacement sections were placed and wedged, the jacking forces were released. Figure 7 illustrates the sealing phase of the repair on Piles 1 and 2. The repaired Piles 1 and 2 are shown 1 year after repair in Figure 15 and 2 years after repair in Figure 16.

FIGURE 16 Piles Number 1 (left) and Number 2 (right) 2 years after repair.
