# Fish Passage Through Poplar Grove Creek Culvert, Alaska

MICHAEL D. TRAVIS and TIMOTHY TILSWORTH

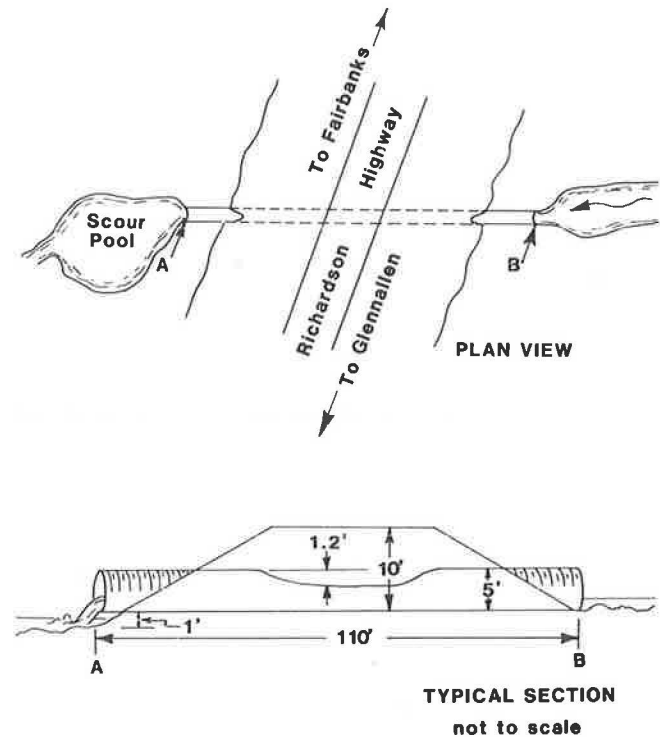
The Poplar Grove Creek culvert is 110 ft long (skewed to the road crossing at about 45 degrees), 5 ft in diameter, and is constructed of corrugated metal. It has been in place since 1953. The outlet is perched approximately 1 ft above the streambed. In the middle of the culvert, subsiding road material and traffic load have depressed the top of the pipe (Figure 2). The culvert is positioned on about a 0.5 percent slope, and no streambed material is present along the culvert's bottom. A 60- by 120-ft scour pool exists at the culvert outlet. The pool depth ranges from about 2 to 5 ft and is a popular fishing spot for local residents. The ADF&G fish passage criteria requires a maximum average outlet velocity of 1.8 ft/sec (fps) during a  $Q_{2.33}$  for this culvert (Figure 1). According to ADF&G, this maximum outlet velocity will ensure that at 2.8°C, 75 percent of 9.5-in. fish will successfully negotiate the culvert.

FIGURE 2 Plan view and typical section Poplar Grove Creek.
