Field Performance of Corrugated Polyethylene Pipe Culverts in Ohio

JOHN O. HURD

A total of 172 corrugated polyethylene pipe culverts 12 through 24 in. in diameter and ranging in age from 0 to 4 years were inspected in Ohio in the summer of 1985. Data pertinent to structural performance and durability of the culverts were collected at each site. These data were pipe diameter, cover over the pipe, type of backfill, culvert age, average daily traffic, pipe deflection, flow depth and velocity, bed load depth and size, water pH, and pipe slope. No culvert showed any signs of wear even at sites with abrasive flow. One 4-year-old site had constant low pH dry weather flow with a bed load of large cobbles. The incidence of large maximum deflections or wall flattening and buckling, or both, was significantly greater for 12- and 15-in. pipes than for 18- and 24-in. pipes. The only instances of wall flattening or buckling were limited to the 12- and 15-in. culverts. Large deflections, flattening, and buckling were generally due to bending of the pipe wall in both the circumferential and longitudinal directions. The greater flexibility and thinner walls of the 12- and 15-in. culverts were the

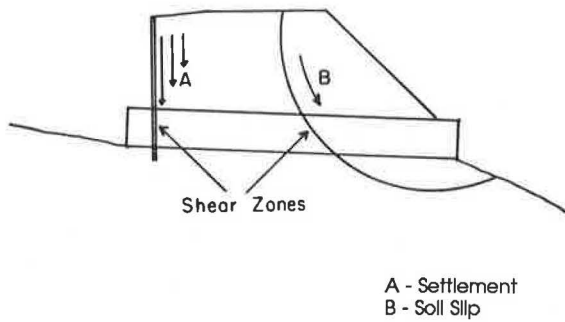
Changes in vertical or horizontal alignment, or both, of the culverts were noted. Because of the longitudinal flexibility of corrugated polyethylene pipe, minor changes in culvert grade or direction can be accomplished by "bending the pipe." An increase in pipe deflection was not noticed with a gradual transition accomplished by a long bend. However, a slight increase in deflection was observed at quick changes in grade. Shear loading points such as soil settlement behind retaining walls or soil slip planes were also noted (Figure 3). Considerable increases in deflection were observed at these points. Buckling of the ring section was observed at a soil slip plane on one culvert, but the remainder of the pipe had no deflection. Alignment changes were observed much more often in 12- and 15-in. pipe than in 18- and 24-in. pipe. District and county personnel noted difficulties in maintaining alignment of the 12- and 15-in. pipes during backfill procedures.

FIGURE 3 Schematic representation of shear loading.

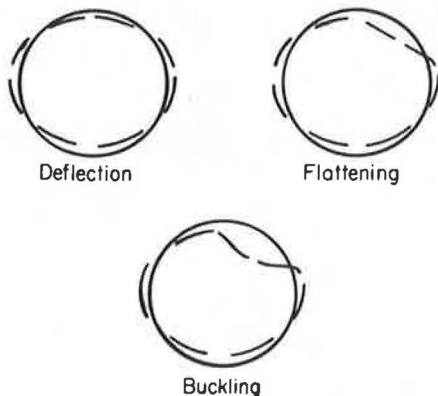
Three primary indices were used in the evaluation of the structural performance of corrugated polyethylene pipe culverts: average deflection, maximum deflection, and the presence of wall flattening or buckling. Average deflection is the average observed or measured deflection throughout the length of the culvert, excluding the ends. Average deflection is representative of culvert performance under "uniform" loadings and backfill conditions that are in general conformance with ring compression-deflection theory. Maximum deflection is the deflection at the point within the culvert where deflection is greatest, excluding the ends. Maximum deflection is more representative of culvert reaction to variable spot loadings and backfill conditions often encountered in actual installations. Flattening is the loss of curvature in the pipe wall, and buckling is the reversal of curvature in the pipe wall. Deflection, flattening, and buckling are shown schematically in Figure 4.

FIGURE 4 Schematic representation of flexible pipe deflection, flattening, and buckling.

Significant deflection to the point of wall flattening or buckling through a significant portion of the culvert length was observed in four culverts. Flattening occurred at deflections exceeding approximately 15 percent. Buckling occurred at deflections exceeding 25 percent. Where significant deflection occurred throughout the pipe length, it was not constant but occurred in waves as shown in Figure 6. Large deflections, flattening, and buckling appeared in general to be caused by bending of the pipe wall inward in both the circumferential and longitudinal directions. In three cases flattening of the wall was more prevalent in the invert than on the crown

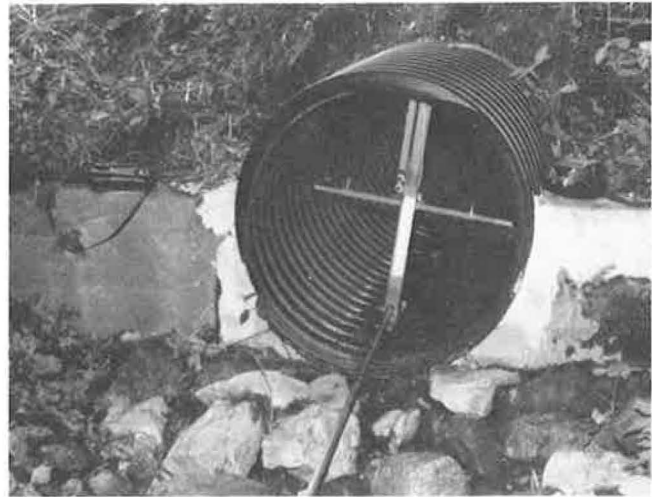
so recorded. Where significant vertical deflection was observed and the interior of the pipe was accessible for measurement, the rise of the pipe was measured with a deflectometer developed by a local corrugated polyethylene pipe manufacturer. Where the pipe interior was not accessible vertical deflections were estimated. In general there was concurrent increase in the horizontal dimension with decrease in the vertical dimension. Deflectometers were available for 15-, 18-, and 24-in. culverts. The 24-in. deflectometer is shown in Figure 5. All seven culverts previously measured were remeasured even if no significant deflection was observed. There was no increase in pipe deflection in any of these seven culverts.

FIGURE 5 Direct-reading deflectometer for measuring deflection in 24-in. culverts.
