Evaluation of Metal Drainage Pipe Durability After Ten Years

WILLIAM H. TEMPLE AND STEVEN L. CUMBAA

This study represents an investigation of the comparative performance of coated and uncoated, corrugated, galvanized steel and aluminum drainage pipe in Louisiana. The highly corrosive environments in some areas of the state make durability requirements of metal pipe as critical as strength requirements. Department personnel installed 10 types of metal drainage pipes at each of 10 locations in 1973. The test sites were selected on the basis of the pH and the electrical resistivity of the soil and the effluent. One pair of each type of culvert was installed at each site. Every 2 years one designated culvert of each of the pairs was removed and subjectively rated by a panel. The final (10-year) panel ratings reflect the condition of the undisturbed culverts in each pair. It was found that, in general, the 16-gauge asphalt-coated aluminum; the 14-gauge asbestos-bonded, asphalt-coated galvanized steel; and the 16-gauge galvanized steel with a 12-mil interior and a 5-mil exterior polyethylene coating were the test pipes with the most resistance to corrosion at the majority of the test s

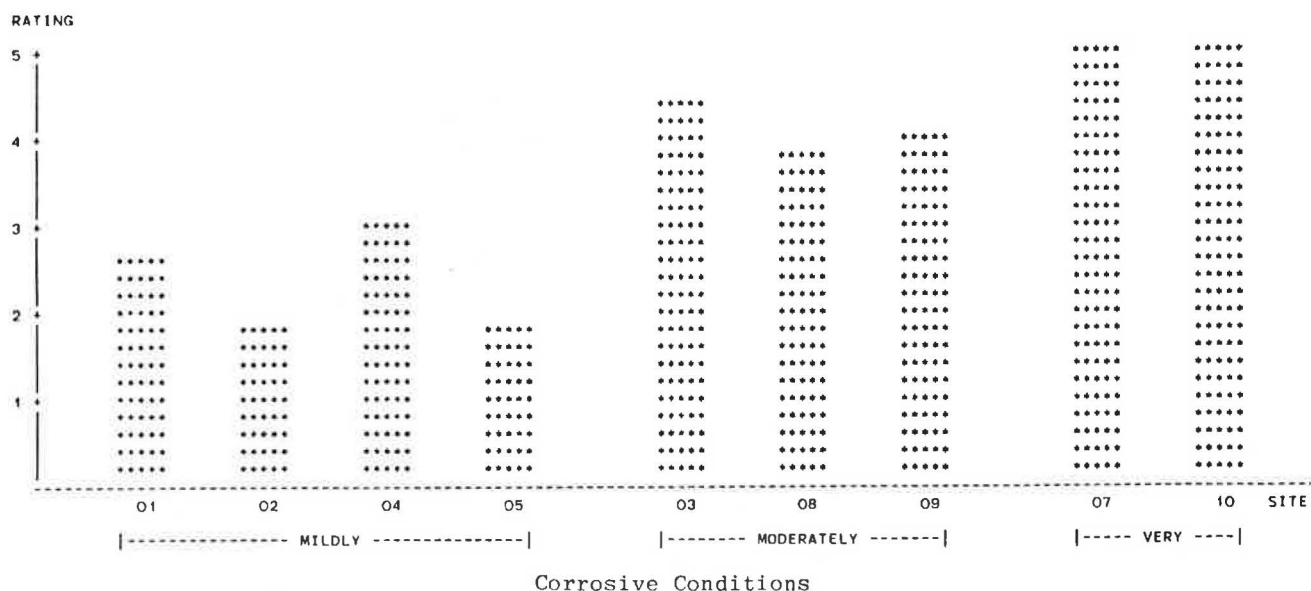
Figure 2 indicates that the ratings assigned to the uncoated galvanized steel pipe (Pipe 1) are not consistent with the expected performance when based on minimum resistivities only [i.e., some galvanized steel pipes located at an assumed moderately corrosive site have a rating lower (better) than the same pipe at what was thought to be a mildly corrosive site]. Because of these inconsistencies, a different criterion for categorization or grouping of the 11 separate sites was established. This different grouping is based on the combined effect of all environmental influences on corrosion of uncoated galvanized steel as indicated by the assigned rating. In other words, the relative condition of 10-year-old uncoated galvanized steel pipe was used to place the sites in categories of increasing corrosion potential. Figure 3 shows the ratings of the uncoated galvanized steel when the sites are placed in the new categories. The limits of each category were established as follows:

Corrosive Condition	Uncoated Galvanized Steel Rating (10 years)
Mild	1.0-3.4
Moderate	3.5-4.5
Very	4.6-5.0

FIGURE 3 Ratings for 16-gauge galvanized steel pipe, new grouping (based on 10-year performance).
