Analysis of Slope Failure in Overconsolidated Fissured Residual Soils: A Case Study

STEVEN F. PUTRICH, ROY H. BORDEN, AND PHILIP C. LAMBE

In this paper an analysis is presented of a slope failure that occurred in 1978 at the intersection of the Norfolk-Southern Railroad Underpass and US-64 located in the Durham Triassic Basin, the northern portion of the Deep River Triassic Basin deposit of North Carolina. Figure 1 shows the Deep River Basin deposit in relation to the series of Triassic deposits located along the Atlantic Seaboard and the general location of the site investigated in this study.

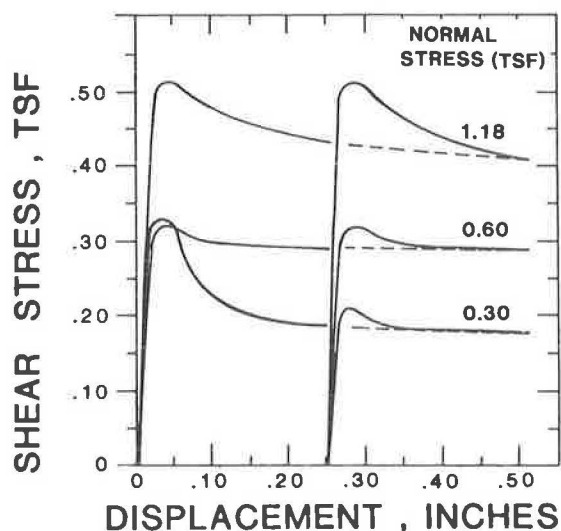
FIGURE 8 Drained direct shear test results: shear stress versus displacement.

In the summer of 1983, a program of drained direct shear tests was undertaken, and the gray and tan fissured clay seam from the upper portion of the maroon soil unit was tested. The results of these direct shear tests for the Railroad Underpass/US-64 site are presented in Figures 8 and 9. The stress-versus-displacement results demonstrate that this material loses strength with continued horizontal displacement beyond the peak strength and are in general agreement with the idealized response of stiff, fissured clay during a drained direct shear test as shown in Figure 10 [after Skempton (2)].

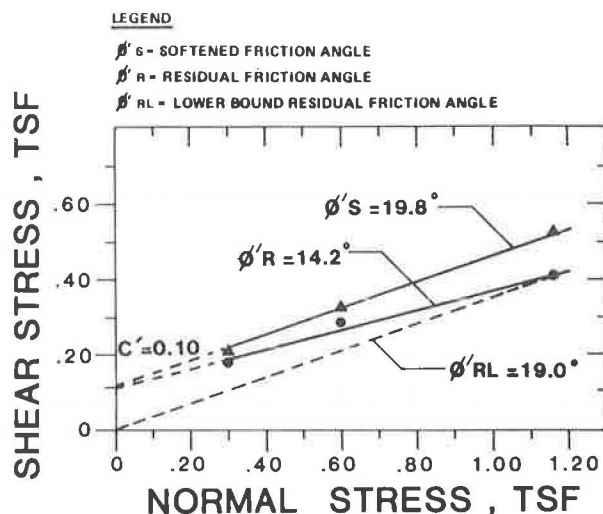
FIGURE 9 Drained direct shear test results: shear stress versus normal stress (2).

Shear strength envelopes corresponding to the softened, residual, and lower-bound residual conditions for the fissured clay tested are shown in Figure 9. A dashed line has been used to indicate that the shear strength below the lowest stress increment in the strength envelopes is not known. The dashed portion of these lines is a continuation of the slope of the strength envelopes for the stress range tested to the vertical intercept. An apparent effective cohesion (c') is given for the purpose of defining the linear equation of the envelope.

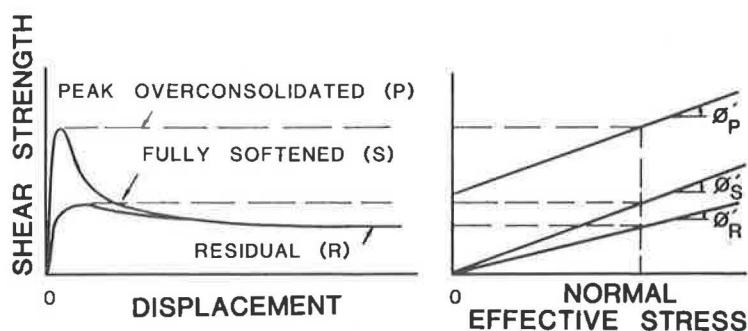
FIGURE 10 Idealized stress-displacement response of stiff fissured clay (2).

The softened strength and zero cohesion residual strength indicated in Figure 10 are generally recognized as the upper and lower boundaries for the range of in situ strength mobilized for slope failures in overconsolidated fissured clays. The softened strength is defined as the peak stress response for a "remolded" normally consolidated clay (i.e., critical state condition) and the residual strength is defined as that value of stress at which further accumulated displacement will not result in a lowering of strength (i.e., steady-state condition) and is generally recognized as an indication of the in situ strength mobilized in a second-time slope failure.

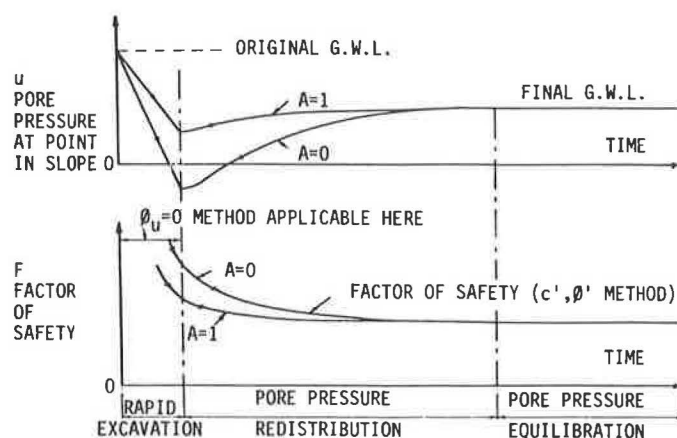
FIGURE 11 Pore pressure and factor of safety as function of time for cut slope in clay (5).

and indicates that the drained condition is more critical than the undrained condition. As shown in the plot of factor of safety versus time, the factor of safety continues to decrease until the pore pressure reaches a steady-state condition ($\Delta u = 0$). Skempton (6) refers to this condition as the long-term stability, where the pore pressure is determined directly from the flow net. The effective stress analysis has been employed in numerous slope stability studies, including ones by Lambe et al. (7), Wu (8), Vaughan and Walbanke (9), and Peck (10).

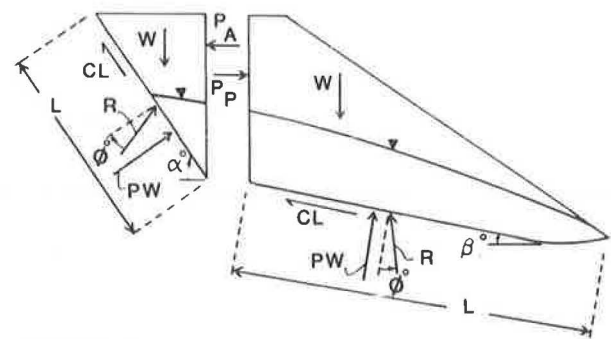
FIGURE 13 Wedge analysis model (12).

The failed mass may be thought of as two wedges moving downward and outward. If one imagines a wall between the two wedges, the wedge to the left of the wall corresponds to the active wedge and the wedge to the right of the wall is the passive wedge. Figure 13 shows a free-body diagram of both the active and passive wedges and a description of the forces involved. The equations used to determine the active and passive wedge forces, P_a and P_p , shown in Figure 13, are as follows:

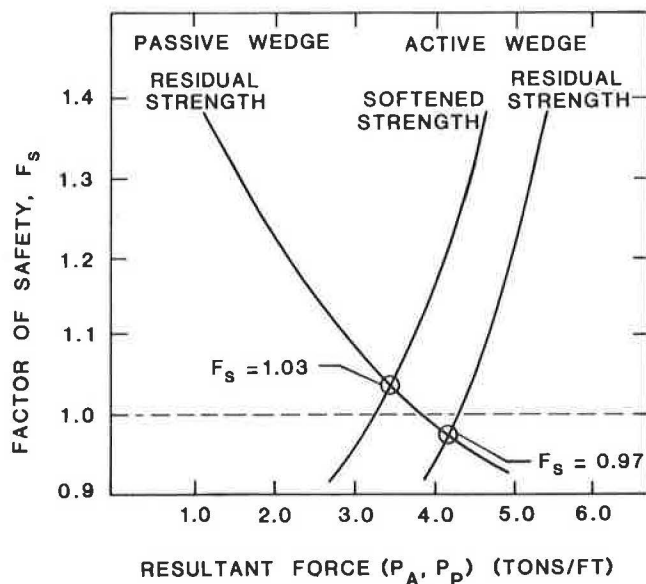
FIGURE 14 Equilibrium factor of safety.

The final step in the procedure of this slide analysis was to plot curves for the factor of safety versus values of P_a and P_p as a function of shear strength acting along both the active and passive failure surfaces. A sample of this simple procedure is shown in Figure 14. The intersection of any two curves (P_a and P_p , respectively) indicates that equilibrium between the active and passive wedges has been satisfied and corresponds to a factor of safety for that set of strength parameters.
