# Performance Evaluation of Jointed Concrete Pavement Rehabilitation Without Resurfacing

DAVID L. LIPPERT

The results of a research project that was conducted to evaluate the effectiveness of concrete pavement restoration (CPR) on jointed portland cement concrete pavement are described. The CPR methods evaluated were pavement grinding, grout undersealing, installing underdrains, retrofitting double-vee load transfer devices, and pavement patching. Five construction sections, located on Interstates in Illinois, were selected for evaluation. The original pavement sections were constructed between 1960 and 1963, then rehabilitated in 1983 and 1984. All pavements were of the same design: a 10-in. slab over a 6-in. granular base and a joint spacing of 100 ft. The evaluation began just before rehabilitation of each section and continued until May 1986. Evaluation was done using crack surveys, destructive testing, and nondestructive testing. Performance factors monitored were faulting, pavement cracking, pavement roughness, skid resistance, deflection, load transfer, void development, and drainage. A great deal of emphasis was placed on grout undersealing and doweled patching in laborat

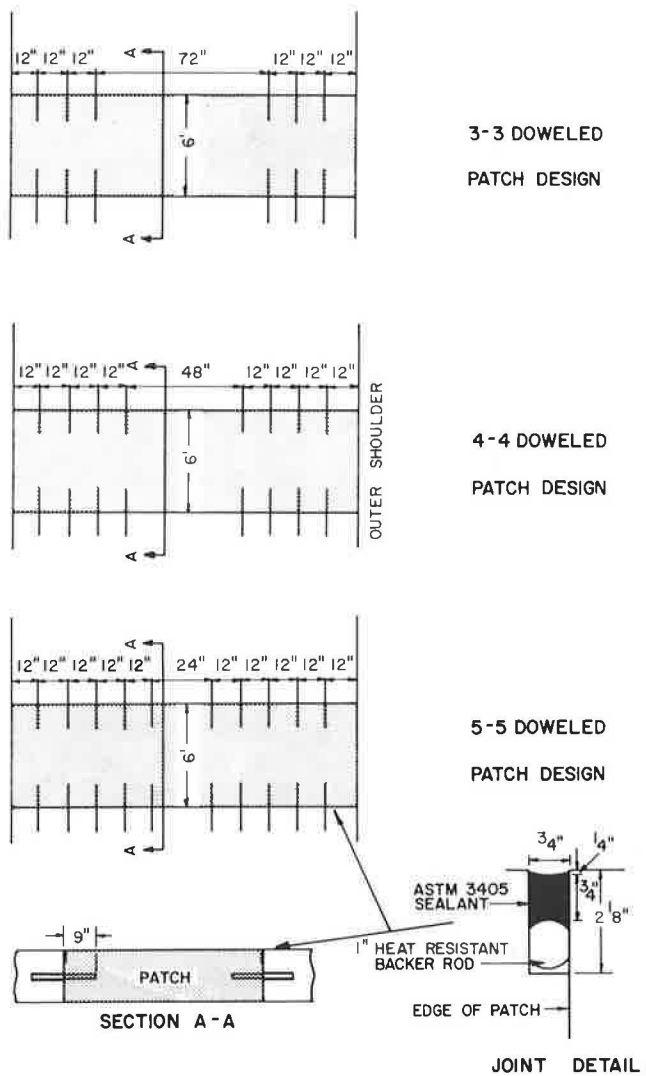
FIGURE 7 Experimental patch details.

Variables in the experiment were selected such that some patch designs would be underdesigned and some overdesigned. The patching experiment investigated two dowel bar sizes, three dowel bar arrangements, tied joints, nonshrink grout, and an epoxy grout. The experimental features are given in Table 6 by number of patches constructed in each design variable. Another feature of the experiment was transverse joint seals that were included on all patches, as well as undersealing the old pavement near the patch joint. Design details of experimental patching are shown in Figure 7.

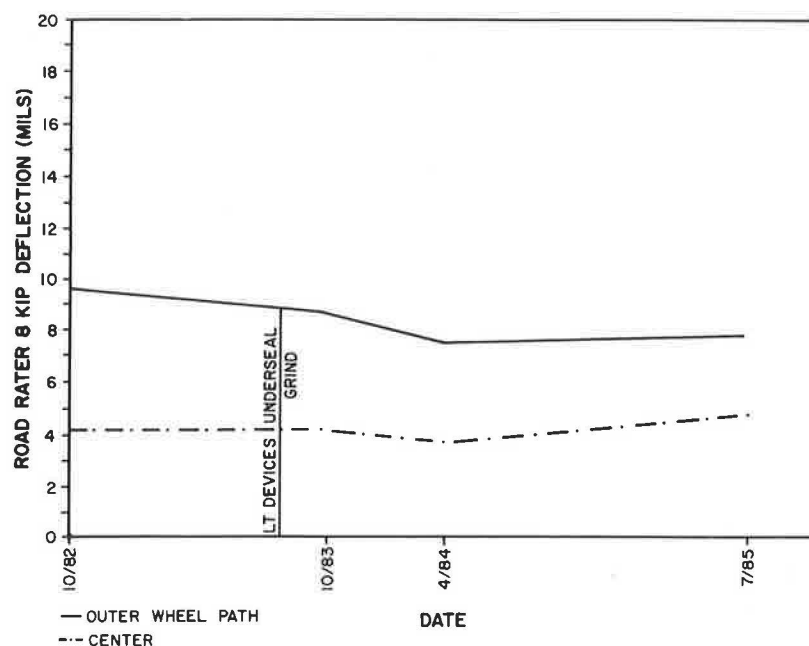
FIGURE 12 Deflection history of undersealing on Project 4.

deflection testing before undersealing, after undersealing, and then periodically. On Project 4, the department's Road Rater 2008 was used to apply an oscillating 8-kip peak-to-peak load at a frequency of 15 Hz to the pavement. The deflection histories of outer wheelpath deflection and center of slab deflection of Project 4 are shown in Figure 12. The figure shows a reduction in deflection after undersealing, but the reduction is so small that it is doubtful whether the undersealing produced any benefits. The effects of subgrade support, which are reflected in the center deflection, appear to have more influence on deflections than does undersealing in this case.

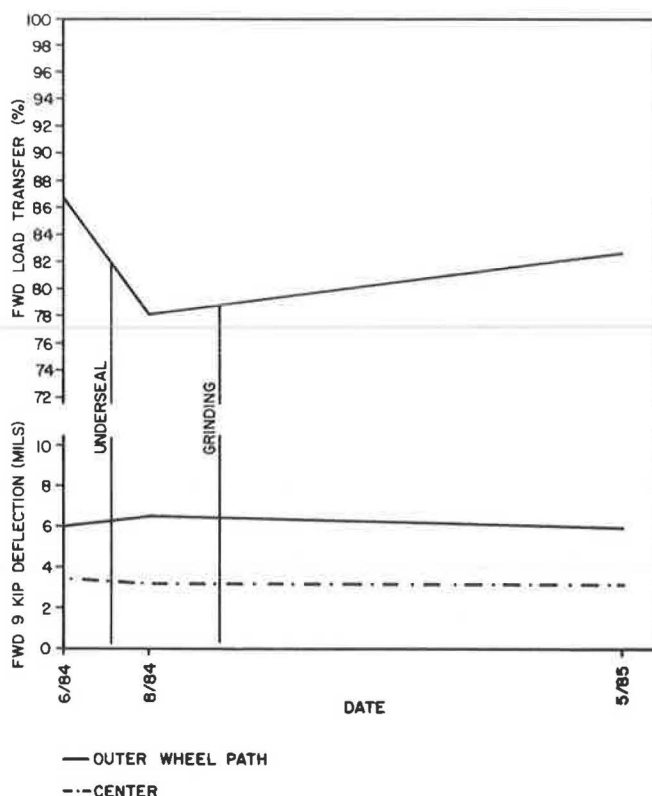
FIGURE 13 Deflection and load transfer history of undersealing on Project 5.

following year showed that the voids were filled and remained stable. The deflection and load transfer histories are shown in Figure 13.

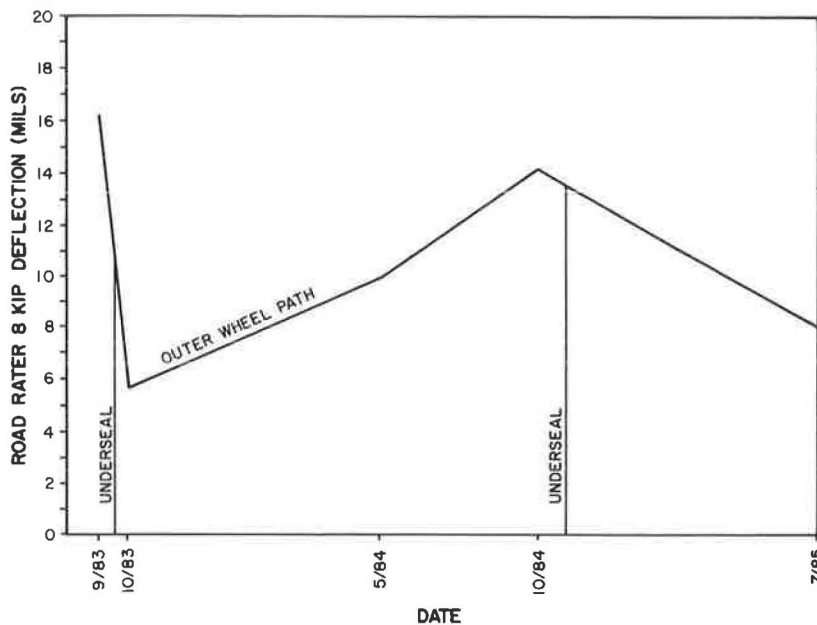
FIGURE 14 Deflection history of patch undersealing on Project 1.

In Project 1, nine patches, which were pumping and rocking under traffic, were selected for undersealing in conjunction with rehabilitation on Project 2 in 1983. Deflection testing, using the Road Rater, was conducted before and after undersealing. Deflections were greatly reduced, but continued testing showed that within 1 year deflections had nearly reached preundersealing levels. These patches, along with all other patches in Project 1, were undersealed again in the fall of 1984. The Road Rater deflection history is shown in Figure 14.
