Construction of a Thin-Bonded Portland Cement Concrete Overlay in South Dakota

DANIEL JOHNSTON

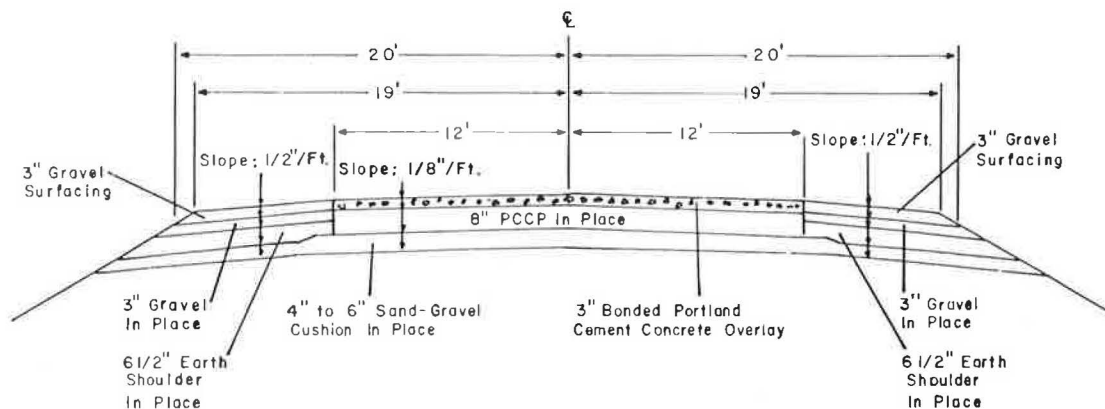
FIGURE 1 Typical slab section.

The thickness chosen for the thin-bonded overlay was 3 in. for most of the project, with an additional experimental section 4 in. thick to be placed on a $1/3$ -mi section in the middle of the project to be used to monitor long-term performance. Plans called for the scarification of the old concrete pavement at the west end of the project to allow for a 1.5-in. minimum thickness of the overlay through an approximate 25-ft transition. The actual thickness of the overlay could vary from $1\frac{1}{2}$ to 4 in. depending on location and gradeline. Figure 1 shows a typical pavement section.

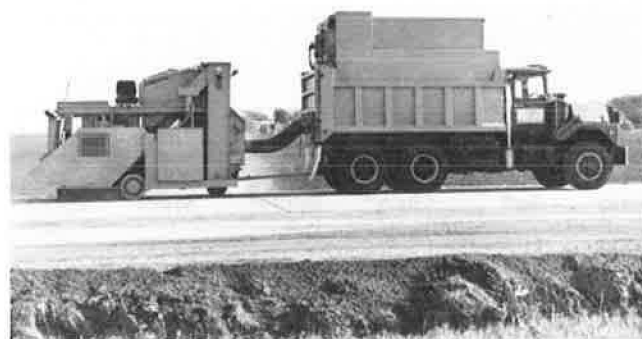
FIGURE 4 Shotblaster in operation.

The shotblaster did an excellent job of cleaning sound concrete and even lightly scaled concrete surfaces presented no problem (see Figures 3 and 4). The sections of the project that

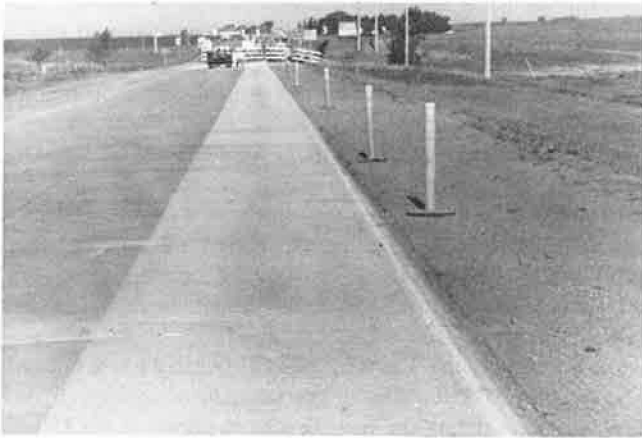
FIGURE 5 Clean concrete after one shotblaster pass.

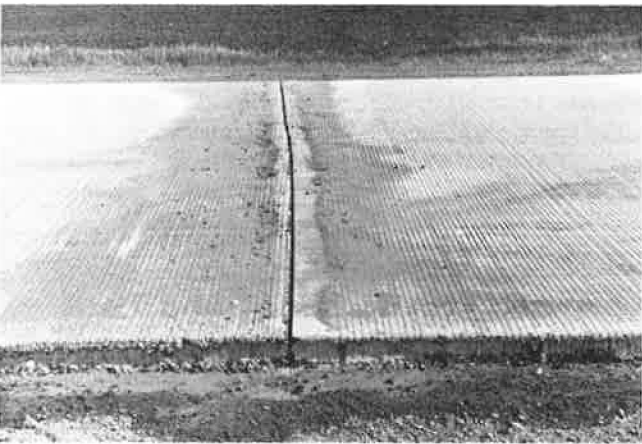
As soon as the concrete had hardened sufficiently to support the sawcutting machinery transverse sawcutting began. An initial sawcut was made using steel pins as references to locate the original transverse joints. Two sets of steel pins were color coded to identify each lane. Sawcuts were made separately in each lane along a line representing the least deviation of the new sawcut from the old, generally crooked, transverse joint. As a result, the transverse sawcuts were seldom straight across (see Figures 5 and 6). A total of 20 random cracks on transverse joints appeared soon after sawing was complete. The average length of the cracks was $3\frac{1}{2}$ ft and ranged from 6 in. to 12 ft in length. All random transverse cracks were routed with a $\frac{3}{8}$ -in. router and filled with epoxy.

FIGURE 6 Transverse joint sawed half-lane.
