Review of Field Measurements for Distortion-Induced Fatigue Cracking in Steel Bridges

JOHN W. FISHER, BEN T. YEN, AND DAVID C. WAGNER

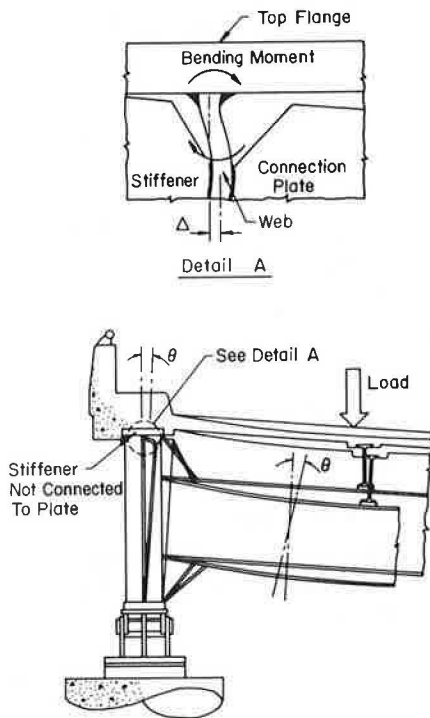
FIGURE 6 Representation of floor beam end rotation and web behavior.

schematic in Figure 6 for the negative moment region of the girders. The connecting plates are tightly fit to, or cut short of, the top (tension) flange. Floor beam end rotations introduce out-of-plane displacement in the web of girders and cause cracking of the web plate. A listing of crack length and the maximum out-of-plane displacement measured under normal traffic loads is presented in Table 2. There appears to be a direct relationship between the displacement and the length of the crack. The displacements at the 1/2-in. (12.7-mm) gaps with cracks were 10 to 20 times larger than those at the bearing stiffeners.

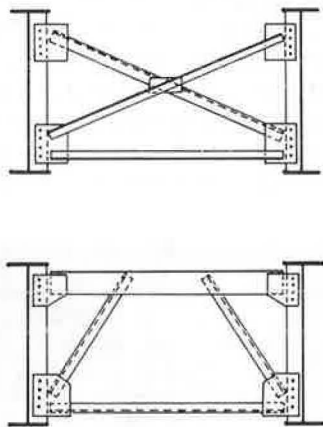
FIGURE 9 Diaphragm connection details for Bridge 2680.

This type of fatigue cracking in welded multigirder bridges was detected in the I-79 Bridge 2680 over Big Sandy Creek (4). The bridge has two 108-ft (32.9-m) side spans and two 130-ft (39.6-m) interior spans, with six continuous girders of 5 ft (1.5 m) depth. The diaphragms are equally spaced and the configurations are shown in Figure 9. Small cracks were found in the web along both the flange-to-web weld and the connection plate weld in many diaphragm connection plate gaps. The gap lengths ranged from 1/2 to 5/8 in. (12.8 to 15.9 mm). The cracks were parallel to the primary stresses in the web plate. The maximum measured vertical stress on the web surface was 20 ksi (138 MPa). At all locations, measured strains revealed

that the diaphragm was distorting the web and inducing cyclic, out-of-plane bending stresses with the passage of live load, leading to the development of cracks.

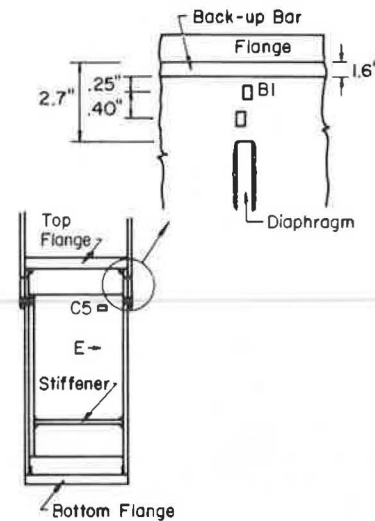
FIGURE 10 Typical box section and expanded detail, I-79 box girder.

This type of distortion-induced cracking has developed in the 750-ft (228.6-m) box girder of the tie arch structure at Neville Island (5). Cracks were found to exist in the welded connections between diaphragm plates and the outside web of the 42- x 150-in. (1,067- x 3,810-mm) box. A typical box

section and expanded detail are shown in Figure 10. The strain-time data from the strain gauges show that major stress cycles occur when trucks pass over the 8-ft (2.44-m) floor beam. The diaphragm and web plate in all four gaps are subjected to high-magnitude stress cycles that include stress reversal.

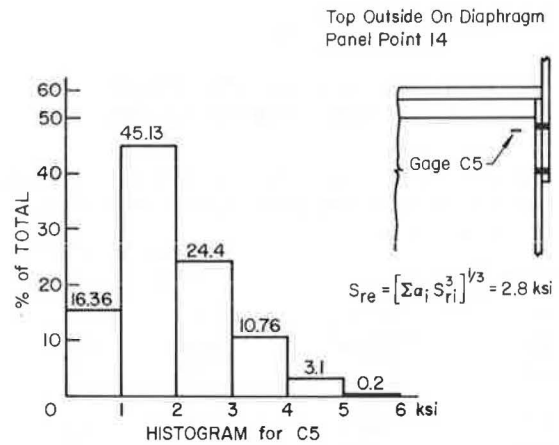
FIGURE 11 Stress range histogram of box diaphragm.

A stress range histogram from a gauge on the diaphragm is shown in Figure 11. The maximum range of stress is 5.6 ksi (38.6 MPa) and the equivalent constant-amplitude stress range is 2.8 ksi (19.3 MPa). The stress range histogram from a gauge on the web is given in Figure 12. The maximum stress range within such gaps varies between 8 and 11 ksi (55.2 to 75.8 MPa), with effective stress ranges of 3 to 4 ksi (20.7 to 27.6 MPa). These stresses cause cracking in the web on both inner and outer surfaces of the web plates, similar to the condition at floor beam connection plates with out-of-plane displacements.

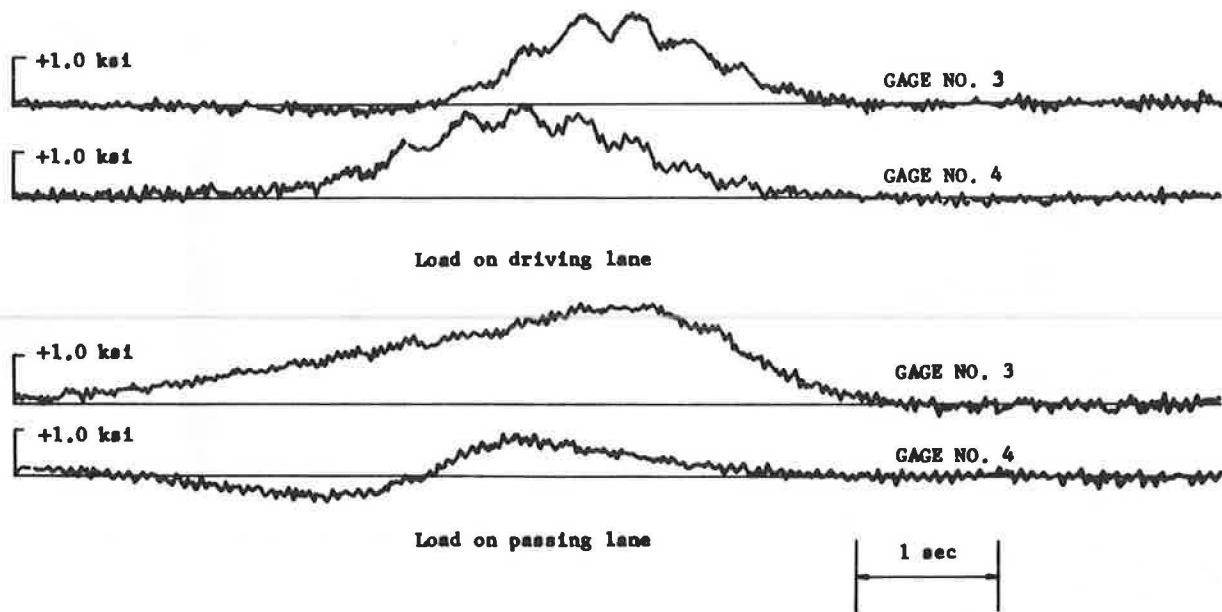
FIGURE 16 Time-dependent strain response of the lateral bracing.

Strain measurements indicated a maximum flexural bending stress range of 3 to 5 ksi (20.7 to 34.5 MPa) in girder flanges and a maximum stress range of 2 to 3 ksi (13.8 to 20.7 MPa) in the lateral bracing members framing into a gusset plate. Figure 16 shows the time response of the two laterals as a truck crossed the bridge. The time lag in the development of tensile stresses and the difference in magnitudes imply rotation of the lateral connection plate in addition to transverse displacement.

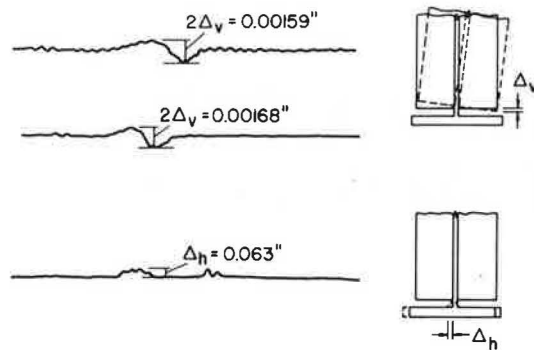
FIGURE 18 Displacement-time response of gaps at stiffener adjacent to a field splice.

Two cracked locations were monitored during normal random truck traffic. Figure 18 shows the displacement-time responses. At one location, the presence of a long horizontal crack allowed a relative horizontal displacement to occur between the flange and stiffener. The rotation of the stiffener with respect to the flange below the gap is minimal. The other location had only a short crack. Truck loads induced relative rotation between the stiffener and the flange with little relative horizontal movement. The distortions were compatible with the small out-of-plane bending stresses measured on the web at the gap. At the ends of these cracks, the in-service, out-of-plane cyclic stresses were always less than 1 ksi (6.9 MPa). Such stress levels should not produce a threat to the life of the structure.
