# Field Study of a Pedestrian Bridge of Reinforced Plastic

FRED C. MCCORMICK

A discussion of the behavior of the superstructure of a pedestrian bridge fabricated with glass-reinforced plastic under a field load test is presented. Experimental measurements of elastic vertical deflections were 1.8 times greater than those predicted by means of a finite element solution. A live load of 3.5 times the dead load of the superstructure and polymer concrete deck was used for the elastic load test. Elastic strains were uniform among the different elements of the superstructure and computed stresses did not exceed 10,000 lbf/in.<sup>2</sup> at full live load. A residual deflection in the superstructure of 0.10 in. on removal of the live load was concentrated in the supports. Creep deflection and strain measurements recorded over 61 days indicated that negligible creep occurred under a load of 2.6 times the dead load. Air temperature variations produced pronounced changes in deflection and strain readings, but were reversible. The overall structural behavior of the bridge and resistance to handling abuse exceeded expectations.

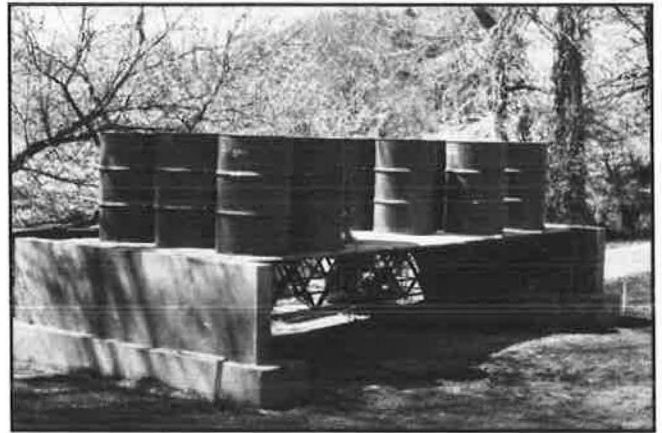
FIGURE 1 Pedestrian bridge in place over the discharge channel of an irrigation pond at Pen Park.

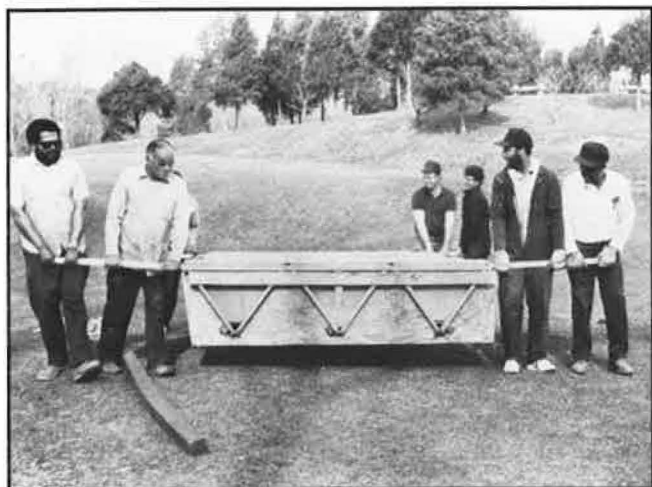
FIGURE 2 Movement of superstructure from staging area to abutments.

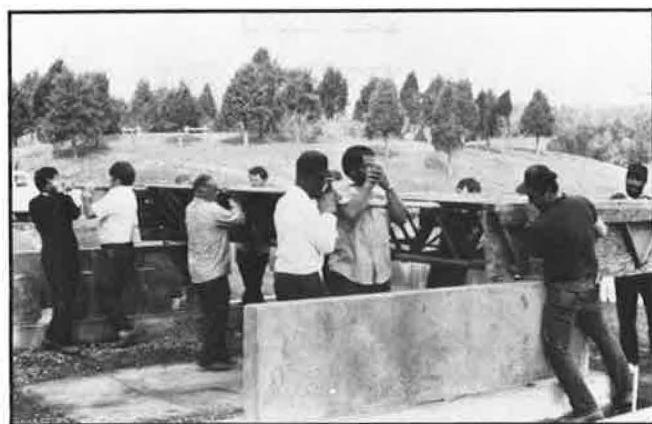
FIGURE 3 Lifting superstructure onto the precast concrete seats.

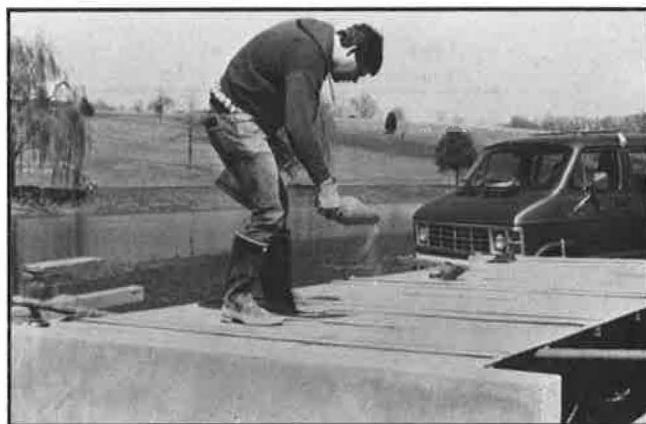
Successive PC layers were applied at intervals of approximately 2 hr to allow sufficient time for the resin binder to cure. Figure 4 shows the hand application of sand at a rate of 2.5 lb/yd<sup>2</sup> to the liquid resin to provide an individual layer thickness of approximately 1/8 in. Excessive amounts of sand were applied to ensure maximum aggregate content in the layer of concrete. The small deck area to be covered did not warrant the use of mechanical equipment for placing the materials. Excess sand was removed after each layer was cured in preparation for the next resin coating. To facilitate water drainage to the sides of the otherwise flat surface, eight layers of sand and resin were applied over various areas of the deck to provide a crown along the center of the deck. Application of the PC in successive

FIGURE 4 Sand aggregate applied to polyester resin to form polymer concrete wearing course.

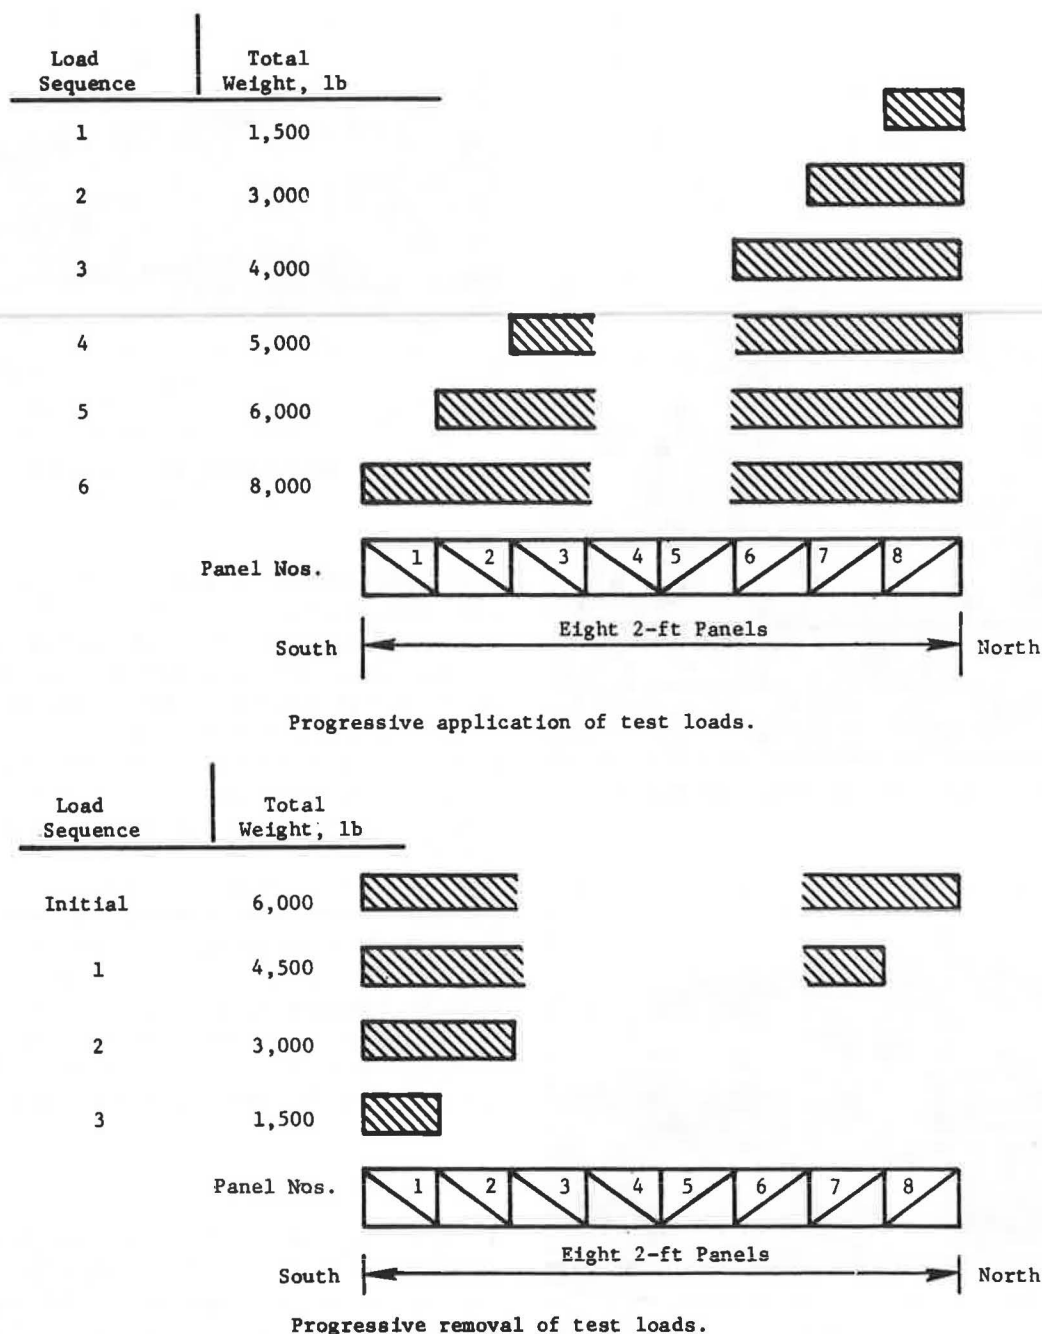
Loads were applied by filling 55-gal steel drums with water ( $\approx 500$  lb total per drum) in the sequence shown in Figure 5. Note that the two center panels of the bridge were not loaded. The progressive manner of loading simulated a load moving from one end of the bridge to the other, which reversed the direction of the shear force in panels 6 and 7 as the load was added to the bridge. The original design with the heavy concrete deck slab precluded a shear reversal in the panels with the application of the design live load, so the diagonal elements in the panels were expected to resist only tensile forces resulting from transverse shears. Consequently, the deck elements (1/2-in.-thick flange, 1/4-in.-thick coverplates, and 1/2-in.-thick PC) were required to transmit the total live shear force from the loaded portion to the centerline of the bridge. Minor buckling of the plates was observed in several of the panels and considerable buckling occurred in the diagonal elements in panels 5 and 6 as the live load was applied successively to the end panels. The diagonals in panel 5 of one of the outside girders remained slightly buckled throughout the load test period. It is probable that the nonuniform application of the live load or

FIGURE 5 Sequence of load application and removal.

After 61 days under live load, all drums were removed, and rebound deflections of the bridge were measured over a period of 46.5 hr. The unloading sequence for live load removal was depicted in Figure 5. In general, the same progressive load removal sequence was used as was followed for the application of the load to observe the effect of a simulated load passing off of the structure. Some buckling of the diagonals in panels 3 and

4 was observed as the load was removed, but not as much buckling was noticed as occurred in the opposite end of the girders when the load was applied.

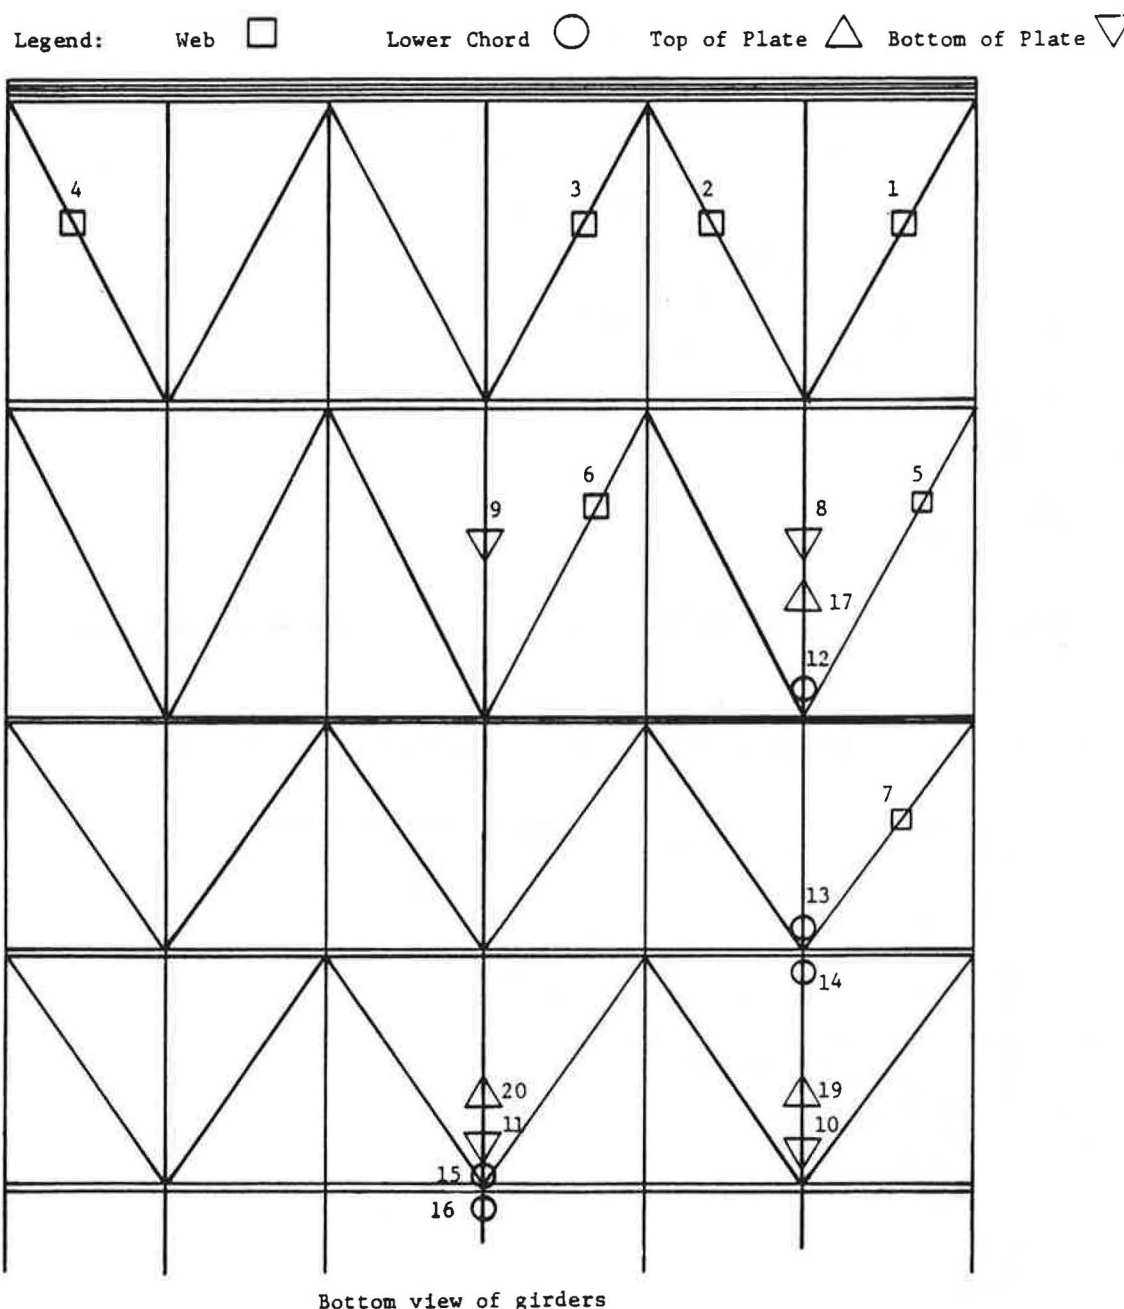
When the structure was built, 20 electrical resistance strain gauges (EA-06-250-BF-350 by Micromeritics Co.) were bonded to various elements of the deck, web, and lower chord as shown in Figure 9. After 8 years in storage, 18 gauges remained functional and were attached to two portable switching units and one indicator (Bud Co., Model P350).

FIGURE 9 Location of electrical strain gauges bonded to elements of the bridge superstructure.
