W-Beam Approach Treatment at Bridge Rail Ends Near Intersecting Roadways

M. E. BRONSTAD, M. H. RAY, J. B. MAYER, JR., AND C. F. McDEVITT

This paper is concerned with guardrail approach treatment at bridge ends near the intersection of two roadways. A state design was evaluated by full-scale crash tests. Based on the findings of this test, design modifications were made and subsequent crash tests were conducted. Success in the later crash tests was realized although the current testing criteria do not give a clear definition of recommended tests for evaluating this unique construction detail.

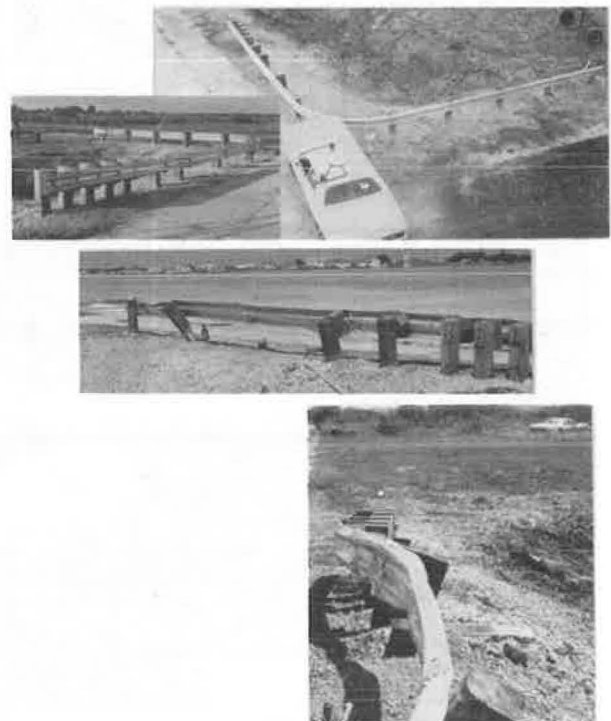
FIGURE 12 Test WA-5M.

This test repeated the conditions of the first test on the Washington design (WA-1). The installation was identical to that of the previous test, as shown in Figure 12.
