# Hydraway Edgedrain Experience in Ohio

KEITH T. HINSHAW

The purpose of this paper is to compare the effectiveness of the Hydraway™ edgedrain, which is manufactured by the Monsanto Company, with the Ohio Department of Transportation's standard 4-in. pipe underdrain without fabric wrap. The 650-ft-long test sections are contiguous, constructed at the same grade, and have separate outlets. The U.S. Geological Survey, Water Resources Division, installed equipment to measure the discharge from each test section. Preliminary results from the monitoring devices are not conclusive. There have been too many gaps in the data. For various reasons, such as damage from lightning, an automobile accident, and at times water backing up in the ditch, complete data for the most significant rainfall events are not available. Neither system has shown consistently superior performance over the other. The costs for the Hydraway on the two projects in 1985 were \$4.10 and \$5.50/ft. The costs for three projects in 1986 and 1987 were \$2.42, \$2.80, and \$2.85/ft. This compares to an average cost of \$2.50 to \$3.00/ft for the standard pipe underdrain. Collection of data will be continued until matchin

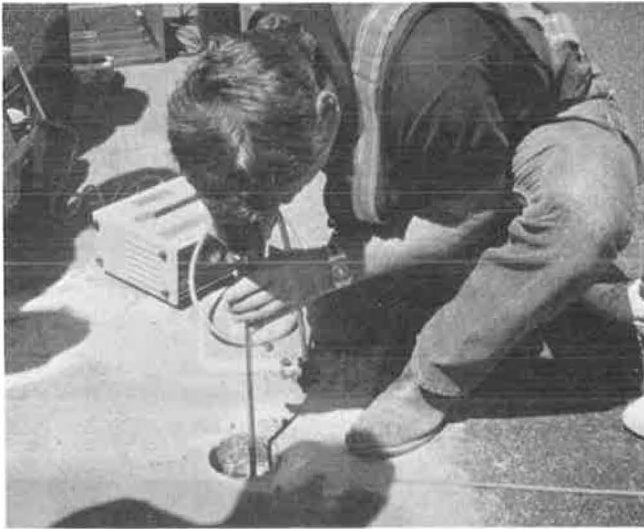
FIGURE 13 Borescope.

In June, 1987, Monsanto Company representatives installed 1/2-in. plastic inspection pipes at three locations along the 650-ft test section of their edgedrain on I-70 (Figures 11 and 12). The pipes were placed at each end and at the center of the 650-ft test section. Viewing of the inside of the edgedrain by use of a borescope is possible (Figure 13). In the upstream location there was no flow, but in the center and downstream locations there was approximately 6 in. of standing water, which was a concern because if there was an obstruction the flow data would be affected. A decision was made to dig up the outlet pipe in an attempt to determine the cause of the problem.
