Tie Girder Fracture in Siouxland Veterans Memorial Bridge

JOHN M. HANSON, MICHAEL J. KOOB, AND GILBERT T. BLAKE

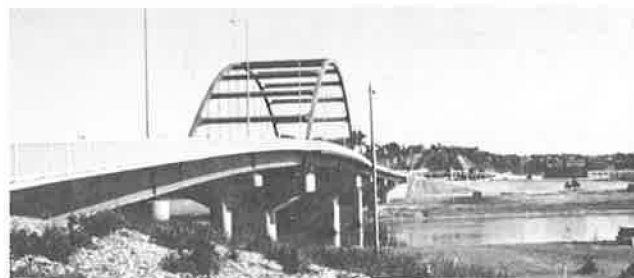
FIGURE 1 Siouxland Bridge at Sioux City, Iowa.

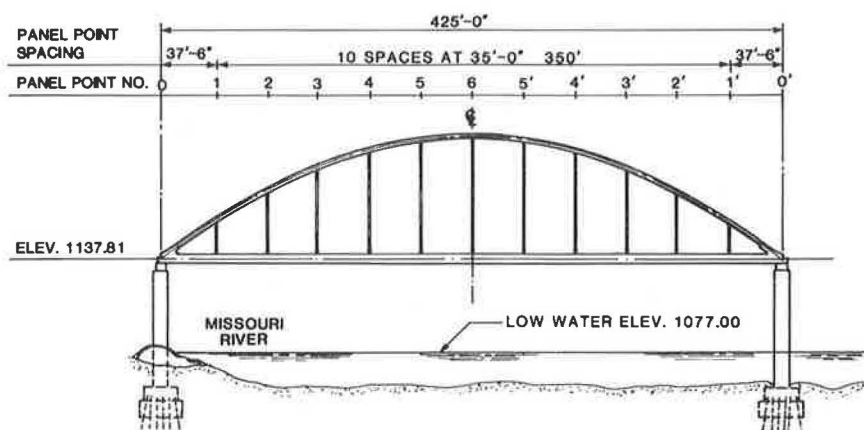
The Siouxland Bridge is a steel tied arch structure with continuous-welded plate-girder approach spans. A view of the 425-ft tied arch span, looking south, is shown in Figure 1. As shown in the elevation in Figure 2, the interior panels are 35 ft 0 in. long, and the end panels are 37 ft 6 in. long. The tie girders act in tension to counteract the compressive thrust of the arch, as well as in flexure to resist the live-load bending moment. Panel points are numbered from 0 to 6 to 0'.

FIGURE 2 Elevation looking west.

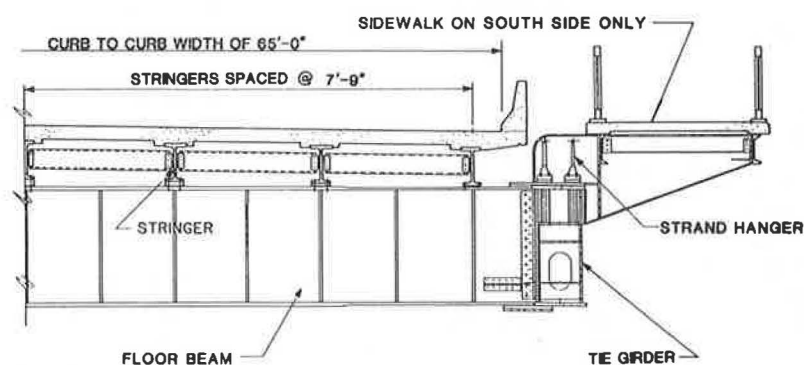
A partial cross section of the bridge is shown in Figure 3. The reinforced-concrete deck slab, which carries four lanes of traffic, is supported on nine longitudinal stringers, which bear

FIGURE 3 Partial cross section.

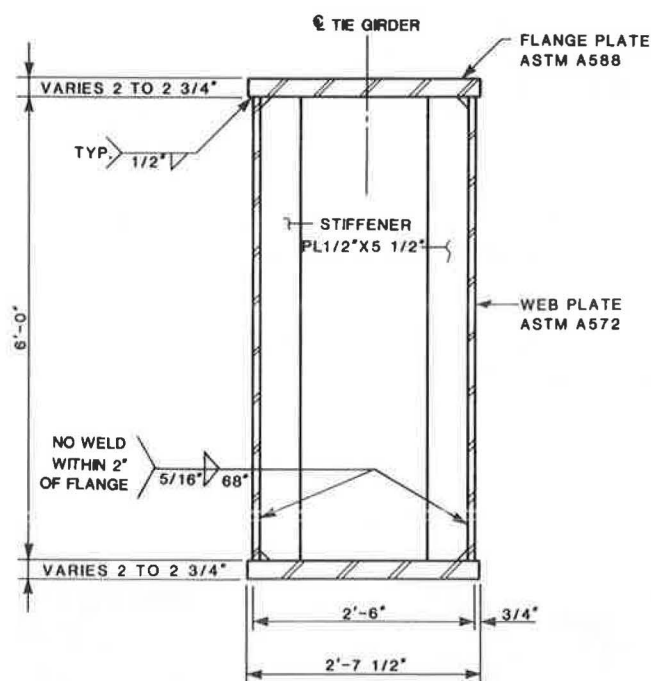
The tie girders, shown in Figure 4, are box members that are 2 ft 7 $\frac{1}{2}$ in. wide by 6 ft 4 in. to 6 ft 5 $\frac{1}{2}$ in. deep, fabricated from ASTM Grade A588 and A572 steel. The A588 flange plates vary in thickness between 2 and 2 $\frac{3}{4}$ in. The A572 web plates are 6 ft deep by $\frac{3}{4}$ in. thick and are inset $\frac{3}{4}$ in. from the edge of the flanges. The flange and web plate lengths vary from 8 ft 9 in. to 70 ft, depending on field splice locations. It is believed that the plates were flame cut without preheat. Welded construction was used throughout the tie girders, except for the high-strength bolted field splices. All welded details utilized in the bridge were Category C or better.

FIGURE 4 Cross section of tie girder at typical intermediate stiffeners.
