# Restoration of Joint Load Transfer

MICHAEL J. REITER, MICHAEL I. DARTER, AND SAMUEL H. CARPENTER

Load transfer at joints and cracks in concrete pavements greatly affects faulting, cracking, and spalling. The restoration of load transfer has been attempted recently by several highway agencies. The results of field performance studies of 369 restored joints and cracks located in 9 states are presented. Four retrofit load transfer devices were evaluated: round steel dowels, double-vee shear devices (without precompression or grooving), figure-eight devices, and miniature I-beam devices. Extensive field and office data were collected and analyzed. Models were developed to predict the relative performance of the devices. Results indicate that the round steel dowel bar did the best job of reducing faulting, and it showed no device or matrix failure. Additional research is under way to provide improved performance data. A recommended retrofit dowel design for joints and cracks is provided.

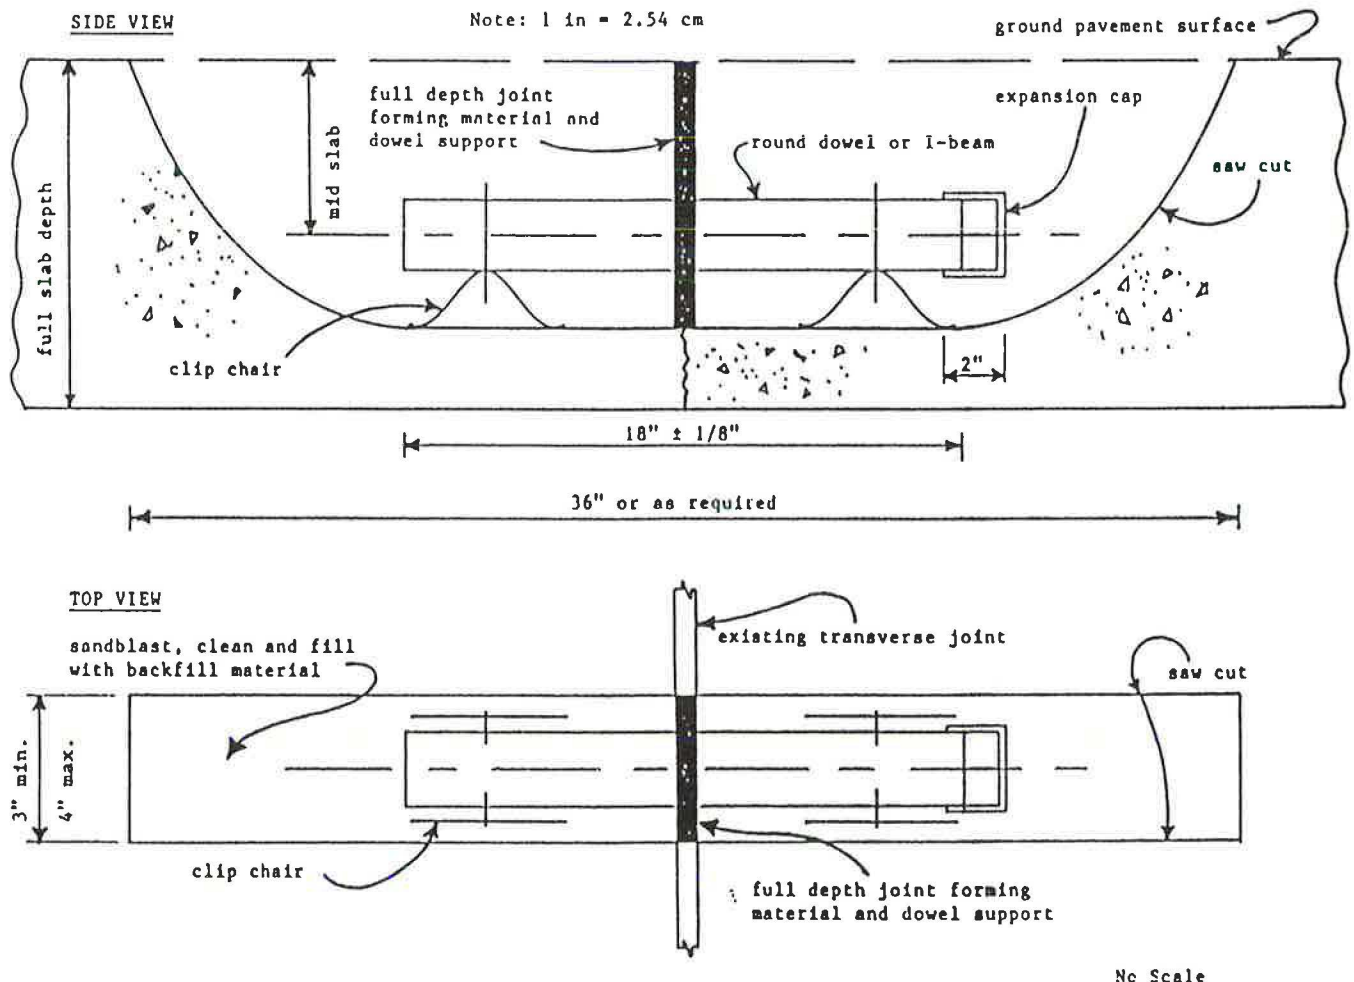
FIGURE 4 Diagram of retrofit dowel or I-beam device and installation.

The performance of the retrofit round steel dowel bars, as shown in Figure 4, was measured in terms of two criteria:

The mean faulting reading of the 72 joints restored with retrofit dowel bars was 0.04 in. (0.10 cm). This faulting occurred after an average of 2.62 million ESALs had loaded the pavements during an average 3.8 years of service. This mean faulting lies well below the failure criteria for faulting of 0.13 in. (0.33 cm), the point at which faulting affects rideability significantly (8).

Of the 515 retrofit dowel bar load transfer devices inspected, 507, or better than 98 percent, were in good condition (Figure 5). The most prominent mode of failure identified was material failure (1 percent or five devices) wherein the backfill matrix had been cracked or become loose and dislodged by traffic. Less than 1 percent of the joints were debonded on the approach, leave or approach, or leave side. None of the joints restored with retrofit dowel bars exhibited device failure or multiple modes of failure. Multiple modes of failure refers to the existence of two or more of the failure mechanisms given in Table 1 at any one device. The one

Dowels must be provided with filler board or styrofoam material at midlength to prevent the intrusion of patch material into the existing joint or crack and to form the joint in the kerf. To fill varying joint or crack widths over the project, multiple thin sheets of filler can be used. To keep joints or cracks free of material it is important to have a tight-fitting filler that matches the existing contraction joint width. Details of dowel placement are shown in Figure 4.

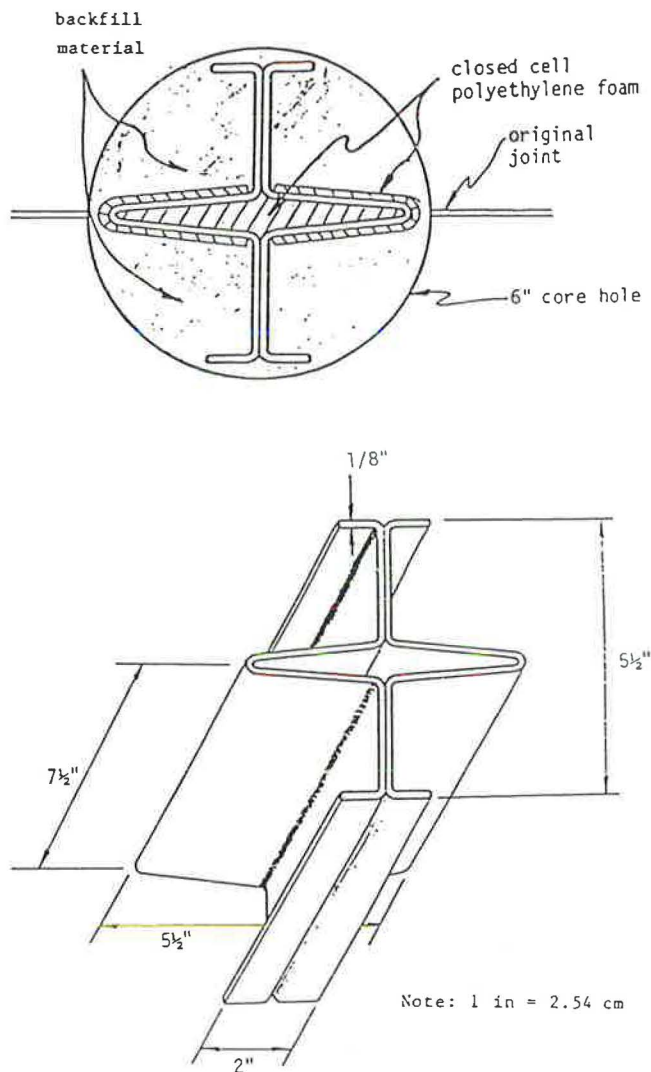
**FIGURE 6** Diagram of double-vee shear device and installation.

The performance of the double-vee shear devices (Figure 6) was measured in terms of two criteria:

The mean faulting reading of the 260 joints restored with shear devices was 0.07 in. (0.18 cm). This faulting occurred after an average of 2.55 million ESALs had loaded the pavement during 2.5 years of service, on average. This mean faulting is approximately one-half of the failure criteria for faulting of 0.13 in. (0.33 cm), the point at which faulting affects rideability significantly (8).

Of the 810 uncompressed, ungrooved shear load transfer devices inspected, 583, or 72 percent, were in good condition (Figure 7). The most prominent mode of failure identified was debonding on both the approach and leave sides of the same device, which was found on 108, or 13 percent, of the devices. As was stated previously, this failure mode was recorded separately from the individual modes of debonding failure. Again, the Florida study is evaluating the use of device precompression and core wall grooving as remedies to this debonding mode of failure. None of the joints restored with

shear devices exhibited device failure. Multiple modes of failure were identified at 4 percent of the devices.

It is important to note that the projects in which double-vee devices were used did not include grooving of the core walls or precompression of the devices. These two modifications may or may not have a significant effect on performance of these devices and are currently under study at a Florida experimental section on I-10 near Tallahassee.

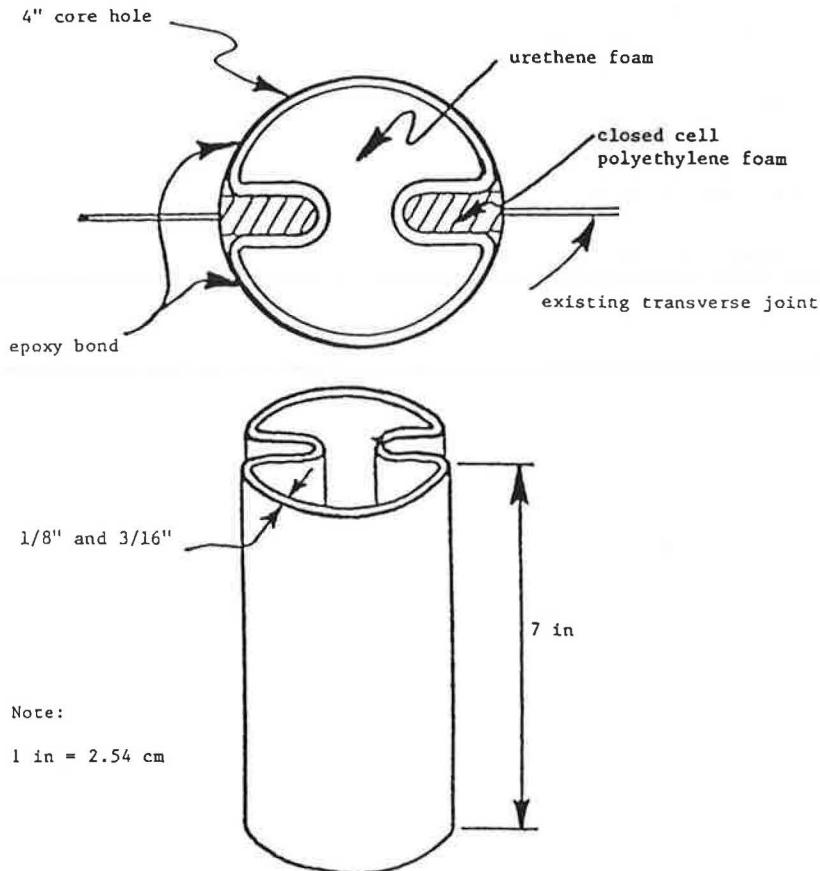
FIGURE 9 Diagram of figure-eight device and installation.

The performance of the figure-eight devices (Figure 9) was measured in terms of two criteria:

The mean faulting reading of the 8 joints restored with figure-eight devices was 0.08 in. (0.20 cm). This faulting occurred after an average of 5.45 million ESALs had loaded the pavement during 9.0 years of service, on average. This mean faulting is approximately two-thirds of the failure criteria for

Of the 36 figure-eight load transfer devices inspected, 27, or 75 percent, were in good condition (Figure 10). The most prominent failure modes identified were debonding on the approach side and material failure. Both of these failure modes occurred at 8 percent of the devices. None of the joints restored with figure-eight devices exhibited device failure. Multiple modes of failure were identified at approximately 3 percent of the devices.

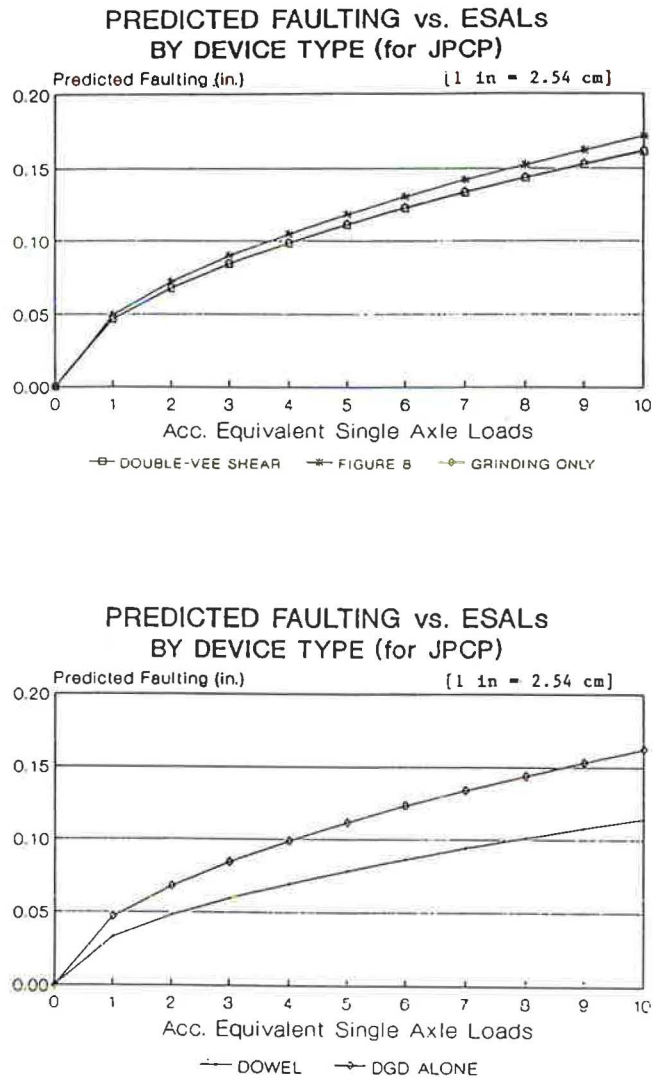
**FIGURE 12** Sensitivity plot depicting model-predicted faulting vs. accumulated 18-kip (80-kN) ESALs for JPCP.

The plot shows that the retrofit dowel bars reduce faulting significantly from that obtained with grinding alone. The double-vee shear devices and figure-eight devices have practically no effect, and the I-beam devices appear to increase faulting. This increase, however, must not be taken literally because there is no physical reason for this result. It should only be concluded that the device has no effect on faulting according to the available data. These results are in response to the coefficients that were derived from the regression analysis. Similar results are shown in Figure 12 for JPCP, but without the I-beams because these devices were used only on JRCP. If 0.13 in. (0.33 cm) and 0.26 in. (0.66 cm) are used as faulting criteria for JPCP and JRCP, respectively, the following allowable loadings result from this model:

The extension of life obtained with retrofit dowels is significant (almost double). Diamond grinding addresses only the symptoms of pavement deterioration (excessive faulting) without addressing the source of the deterioration, which may require load transfer restoration, subdrainage, and the like. If diamond grinding is used as a temporary repair strategy, it has been shown that faulting will develop at a rate greater than that of initial new pavement faulting (7). Load transfer restoration appears to be an effective means of extending the life of a restoration project.

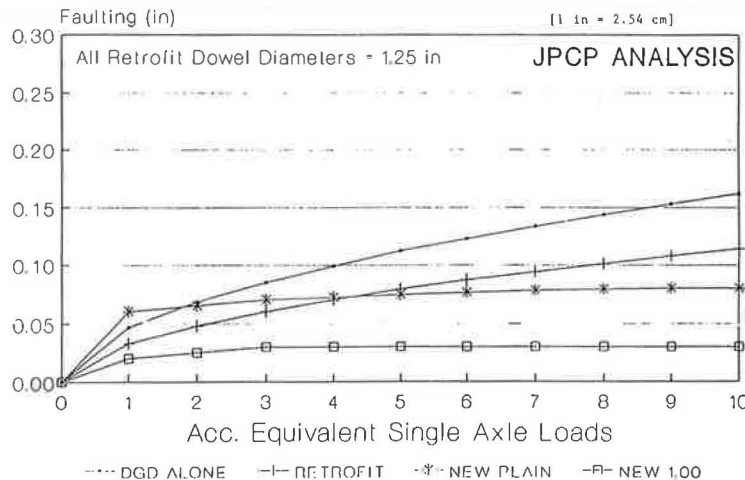
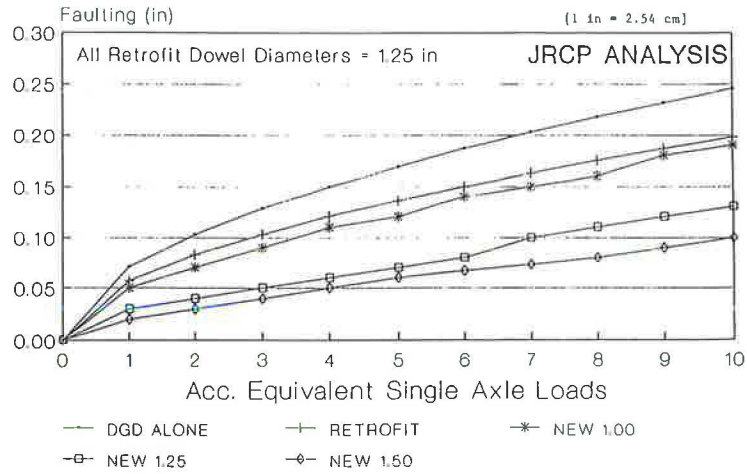
The larger dowels also showed less loss of load transfer in the Illinois I-70 full-depth repair study (7). Figures 13 and 14 compare joint faulting of new JPC and JRC pavements built with dowels of various diameters with joint faulting of similar rehabilitated pavements (either diamond grinding alone or diamond grinding along with retrofit dowel load transfer restoration). These figures indicate that retrofit dowels reduce faulting; however, they do not do so to the same level as they do in newly constructed pavements. This probably occurs because the aggregate interlock is much less for an older pavement than for new construction.
