Collapse of a Segmental Post-Tensioned Concrete Bridge

R. J. WOODWARD

This paper describes an investigation into the collapse of a single-span, segmental post-tensioned concrete bridge. The structure consisted of precast units stressed together both longitudinally and transversely. It was built in 1953 and collapsed at approximately 7:00 A.M. on December 4, 1985. There had been no evidence of distress before failure, and there was no traffic on the bridge when it collapsed. The investigation showed that the bridge had deteriorated because of corrosion of the tendons where they passed through the segmental joints. Corrosion had occurred because the tendons had been inadequately protected at the joints, and this had enabled chlorides to enter the ducts. It is believed that de-icing salts were the major source of chlorides, although it is possible that dune sand had been included in the mortar used to fill the transverse joints. The results cause concern about the condition of other post-tensioned concrete bridges in which tendons pass through joints.

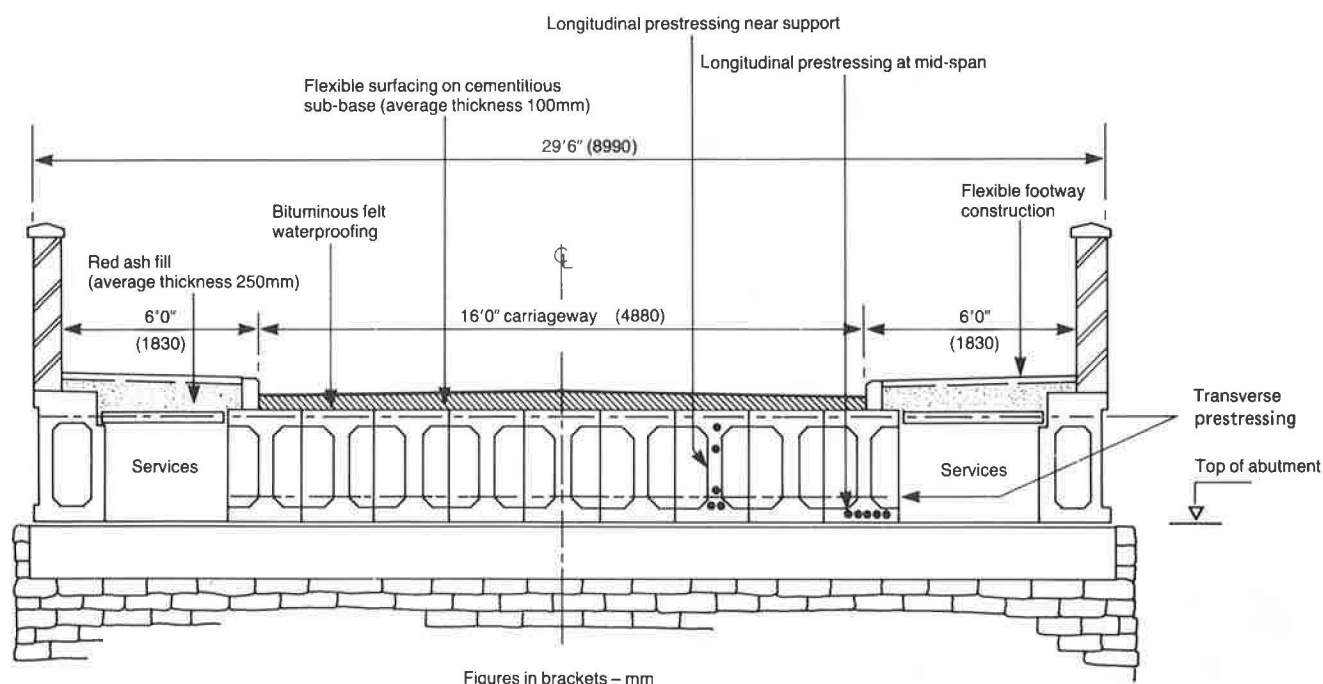
FIGURE 1 Cross section of Ynys-y-Gwas bridge (1953-85).

The bridge had a single span of 60 ft (18.3 m) that sat on bearing paper on mass concrete abutments. It consisted of nine longitudinal I-beams, two box section edge beams, and two slabs 5 ft (1.52 m) wide that spanned the gap between the I-beams and the edge beams (see Figure 1). The I-beams carried an 18-ft (5.49-m) carriageway, and the slabs and edge beams carried 6-ft (1.83-m) sidewalks and parapet walls. There were service voids under the sidewalks between the outer I-beams and the edge beams.

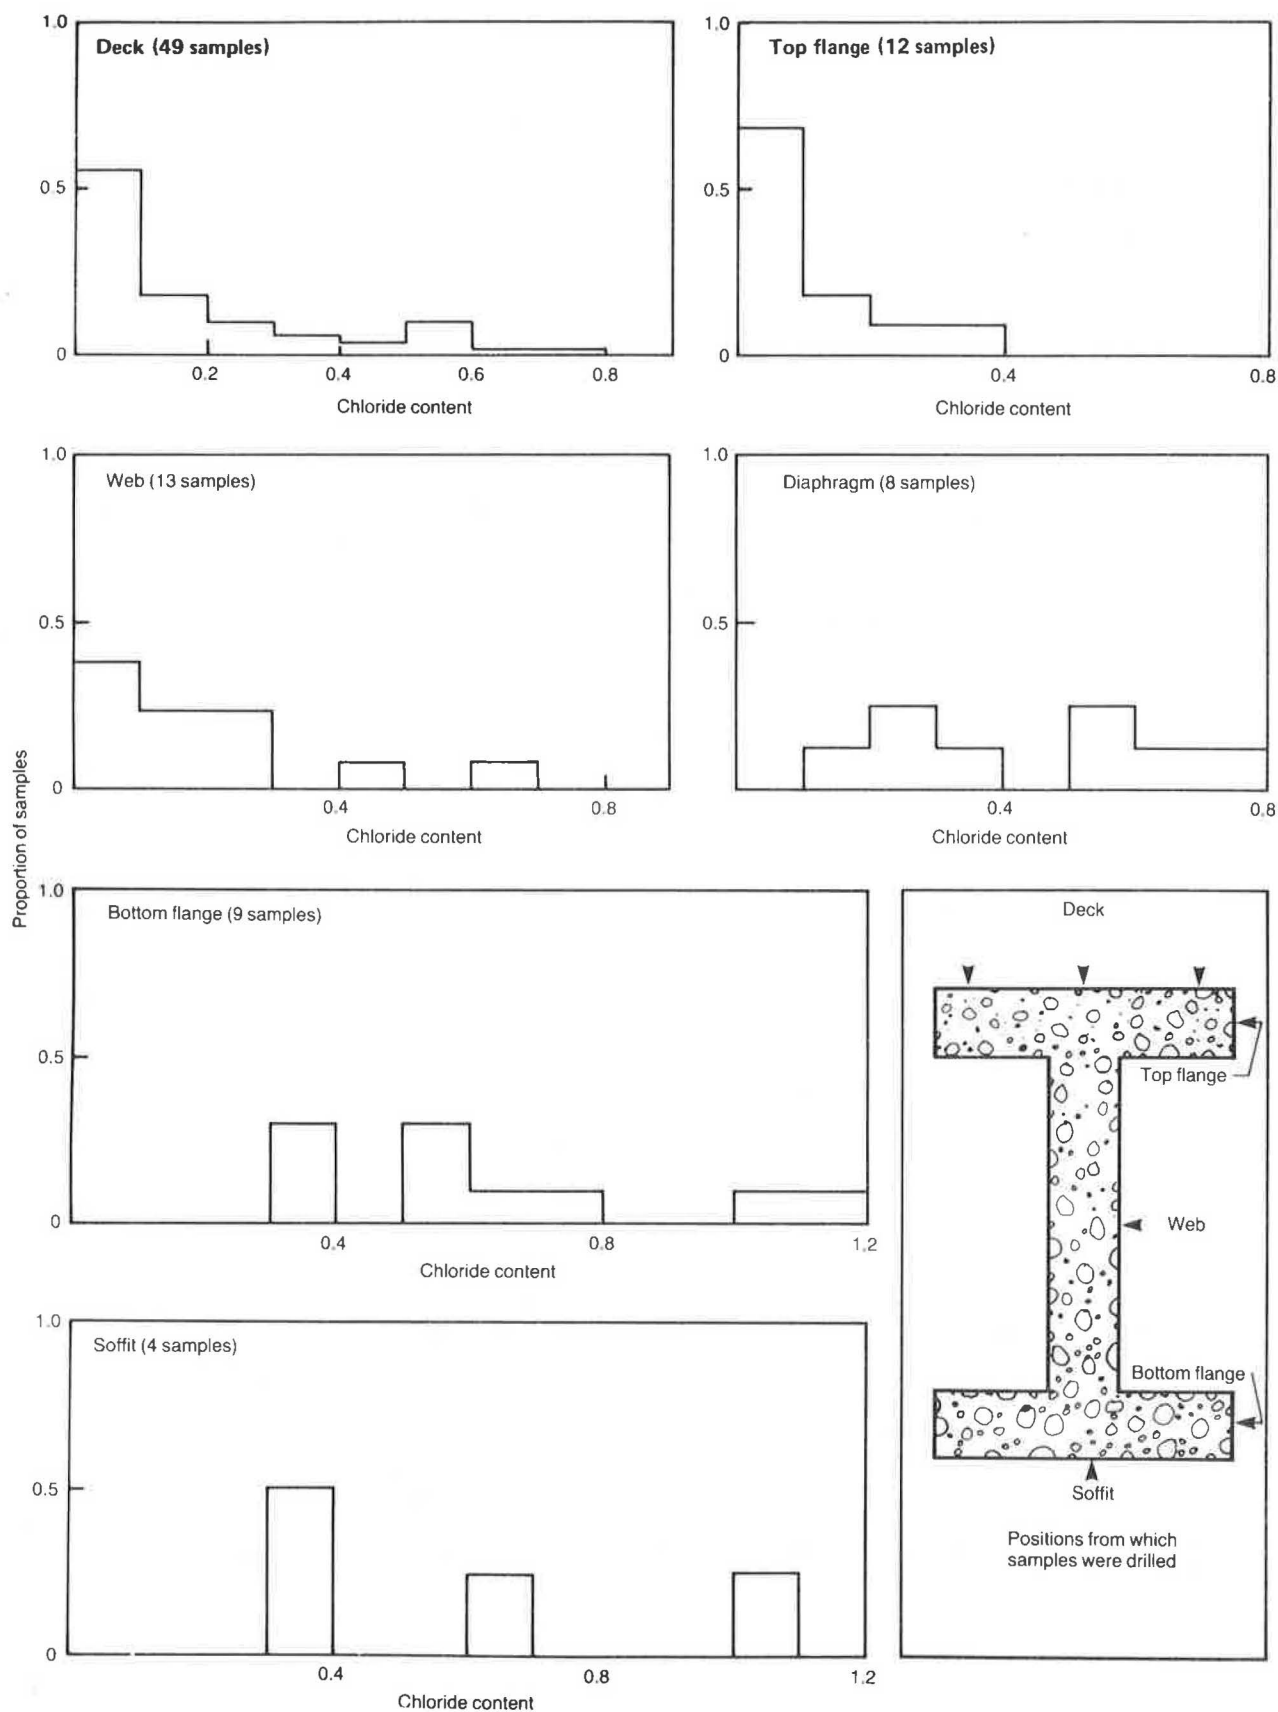
FIGURE 10 Normalized frequency distributions of chloride content (percent by weight of cement)—I-beam surface concrete.

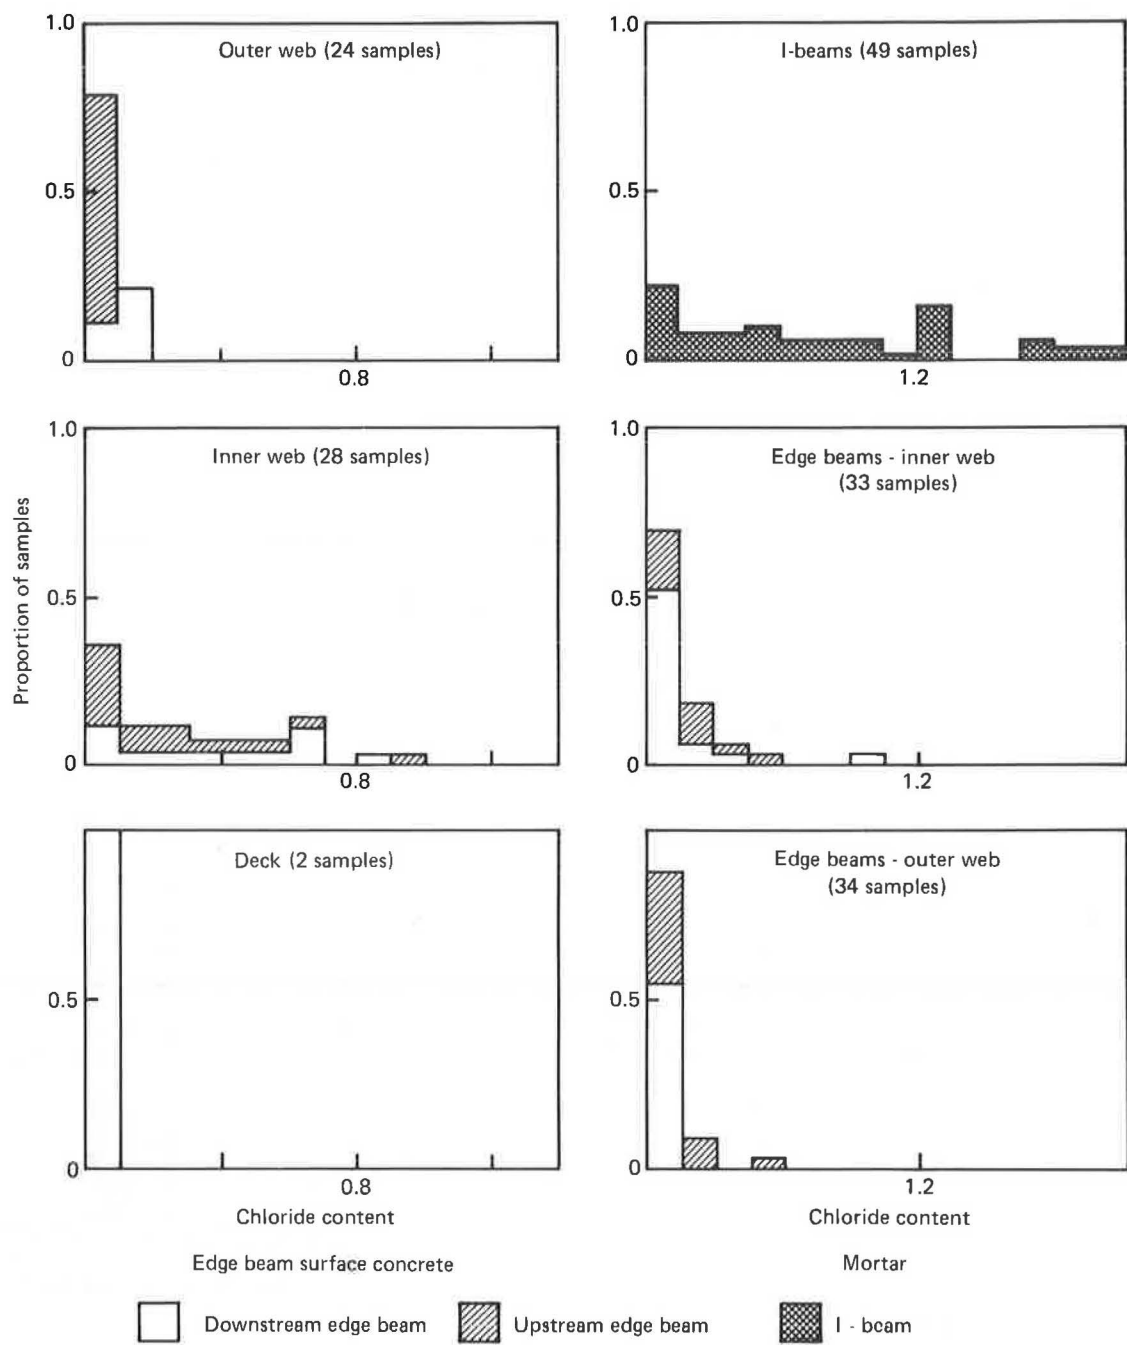
edge beam joints for measurement of chloride concentration. They were obtained by drilling horizontally into the mortar at different depths from the deck. The results are summarized in Table 2, and Figure 11 plots normalized frequency distributions of chloride concentration. Samples were also taken from the mortar cover over three anchorages. They contained 0.06 percent, 0.27 percent, and 0.66 percent chloride by weight of cement, respectively.

FIGURE 11 Normalized frequency distributions of chloride content (percent by weight of cement) in the edge beam surface concrete and mortar.

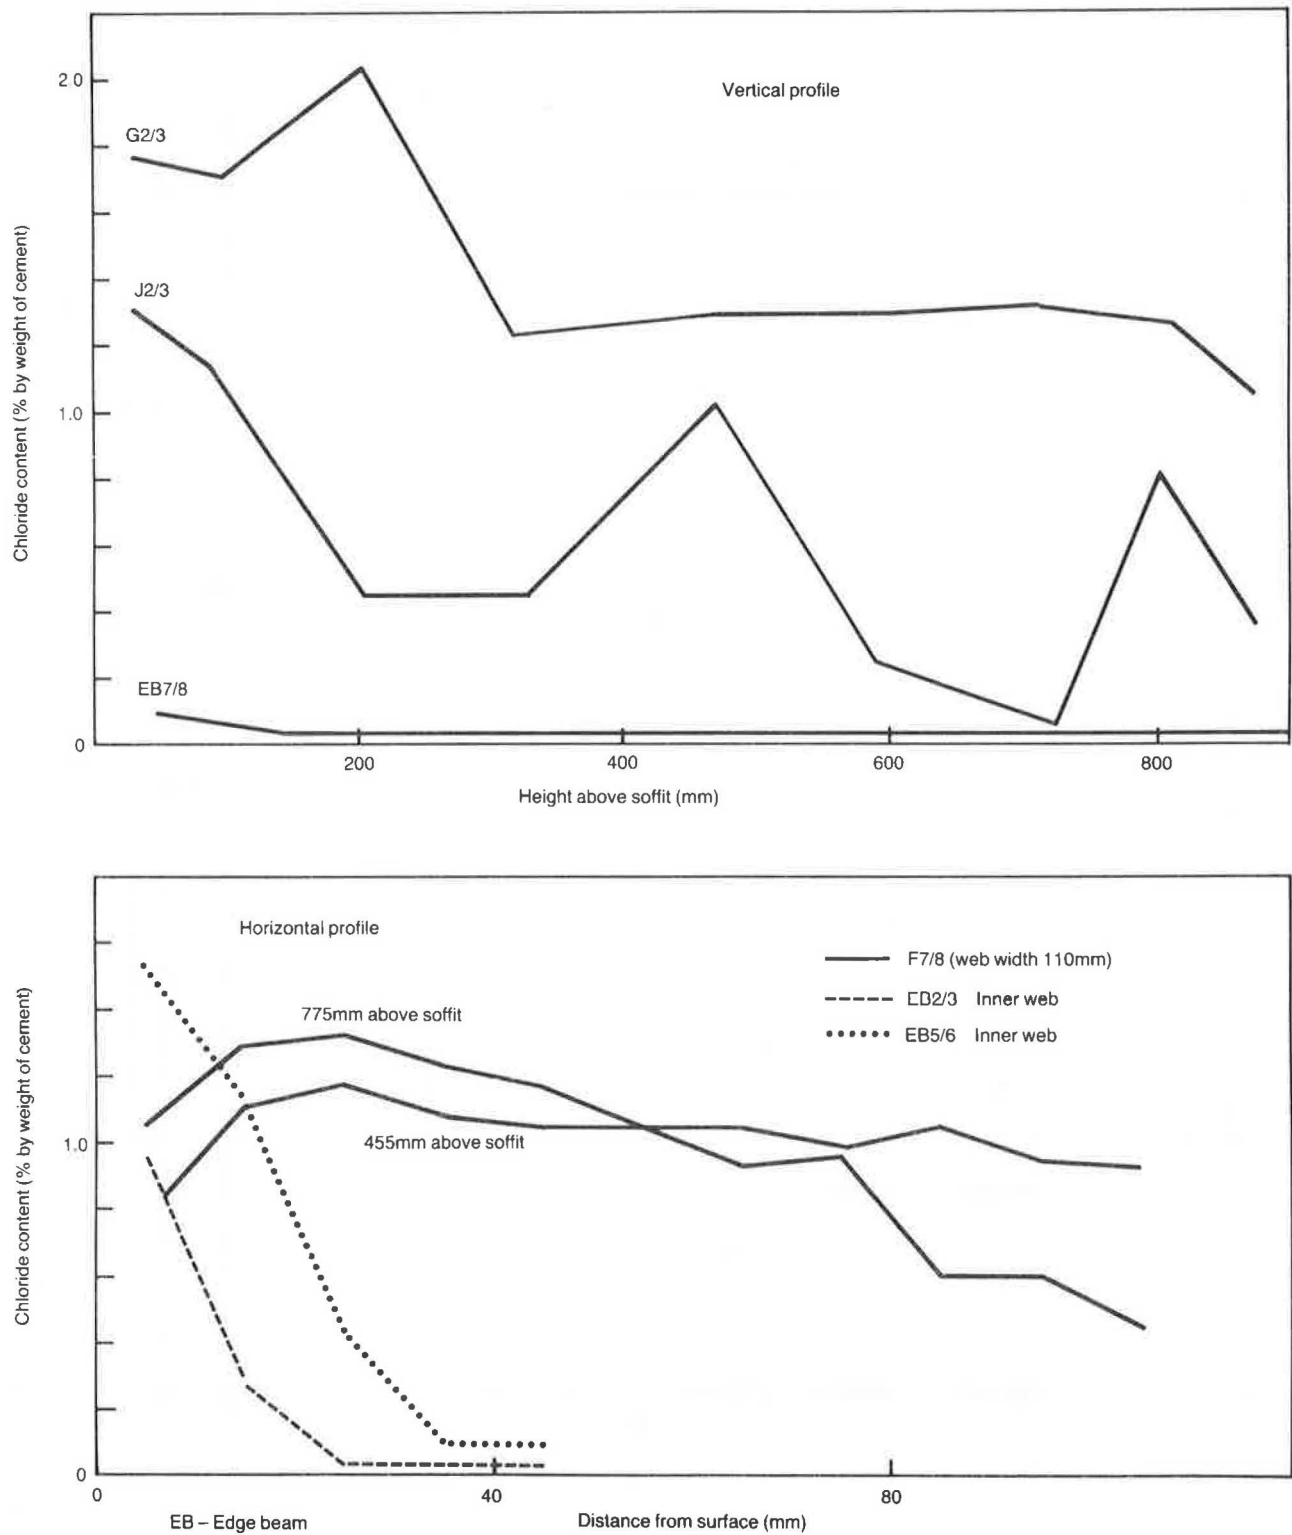
The profile measurements showed a decrease in concentration with increasing depth from the surface. This demonstrates that the chlorides had entered the concrete since construction. At some positions they had reached a depth of more than 30 mm (Figure 13).

FIGURE 13 Horizontal and vertical chloride profiles through the mortar.

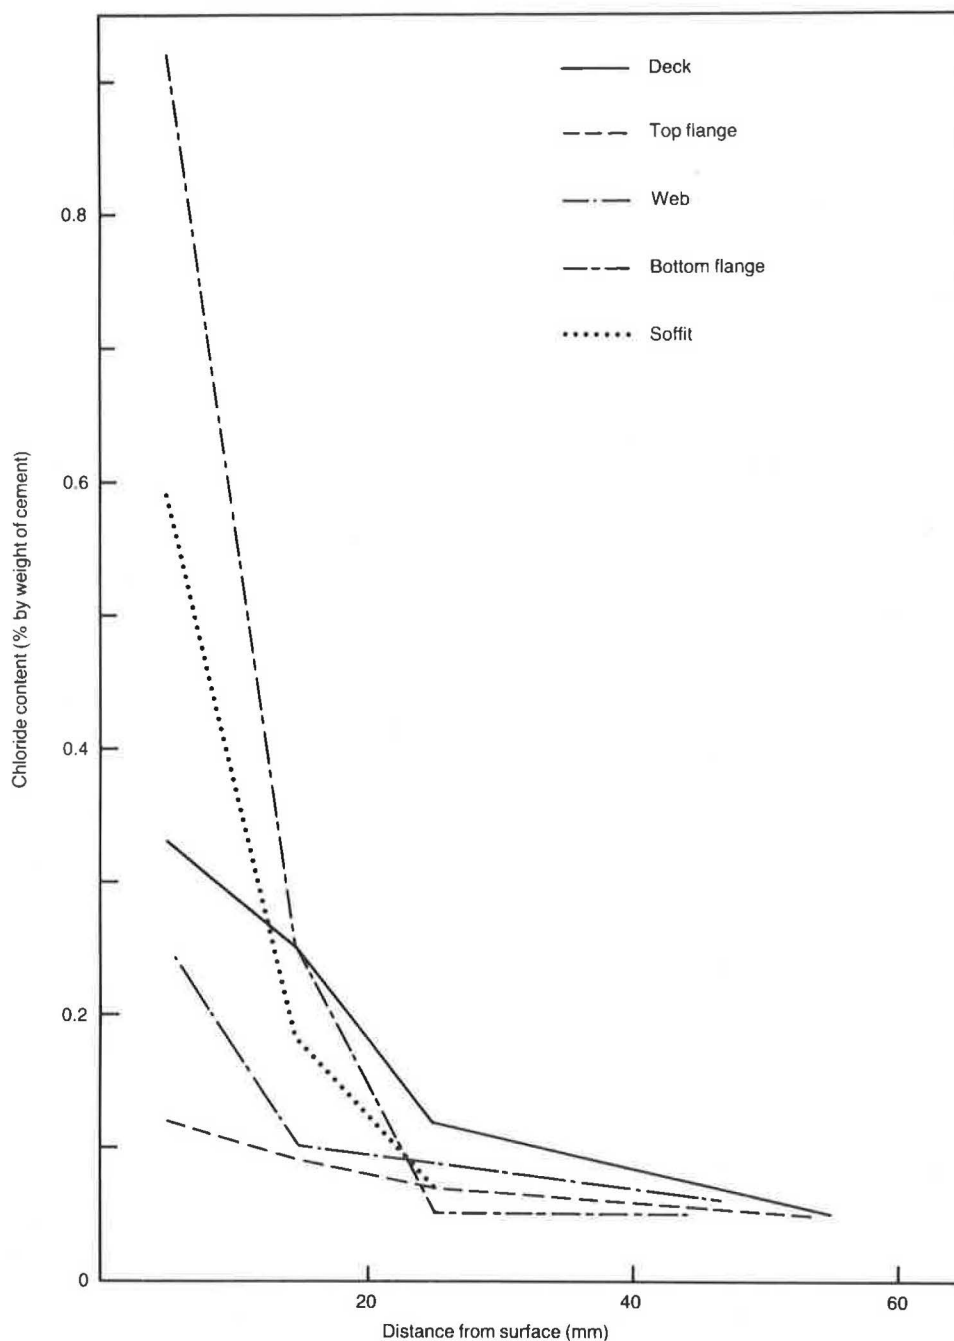
FIGURE 14 Average chloride profiles through concrete.
