# Durability of a Polypropylene Geotextile in an Unpaved Road Structure

I. D. PEGGS, L. G. TISINGER, AND R. BONAPARTE

This paper addresses select durability characteristics of a continuous-filament, nonwoven geotextile commonly used in transportation-related applications. Two samples of the geotextile were exhumed from the base of an unpaved road structure located at an industrial site in East Texas. The two samples had been in service for 12 and 13 years, respectively. The samples, together with an unused reference sample manufactured at the same time as the exhumed samples, were subjected to a series of destructive mechanical tests, structural analyses, and examinations via scanning electron microscopy. The mechanical tests included measurements of grab-tensile strength and elongation, burst strength, puncture strength, trapezoid-tearing strength, as well as individual fiber strength and elongation. The exhumed samples retained in excess of 70 percent of their initial strength and elongation properties. The microstructural analyses included differential scanning calorimetry and infrared spectroscopy. The results of these tests indicated that some polymer degradation had occurre

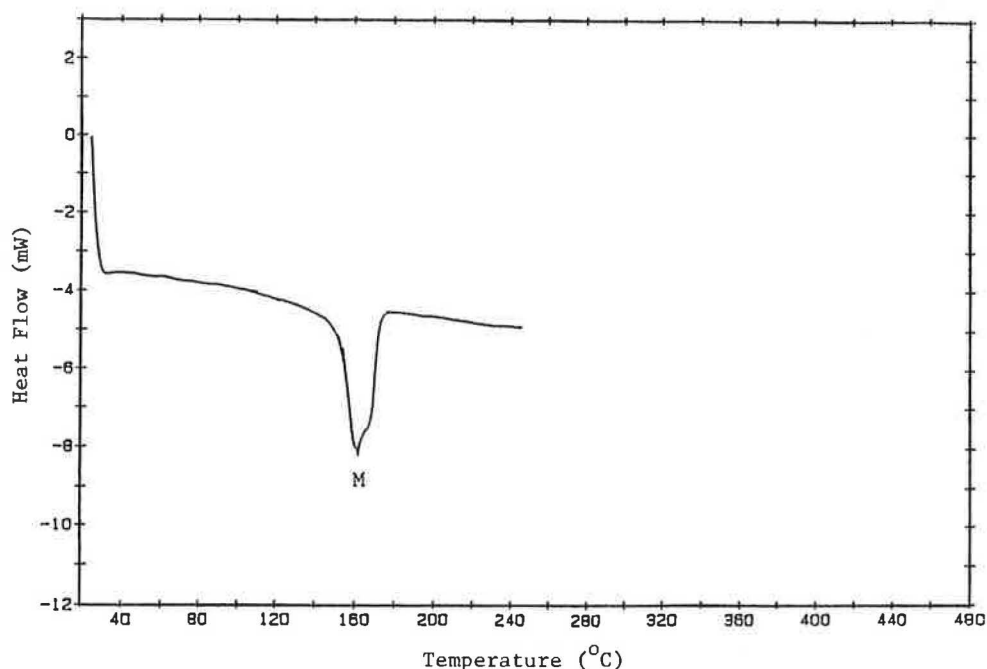
FIGURE 1 Melting endotherm (*M*) for archive polypropylene geotextile.

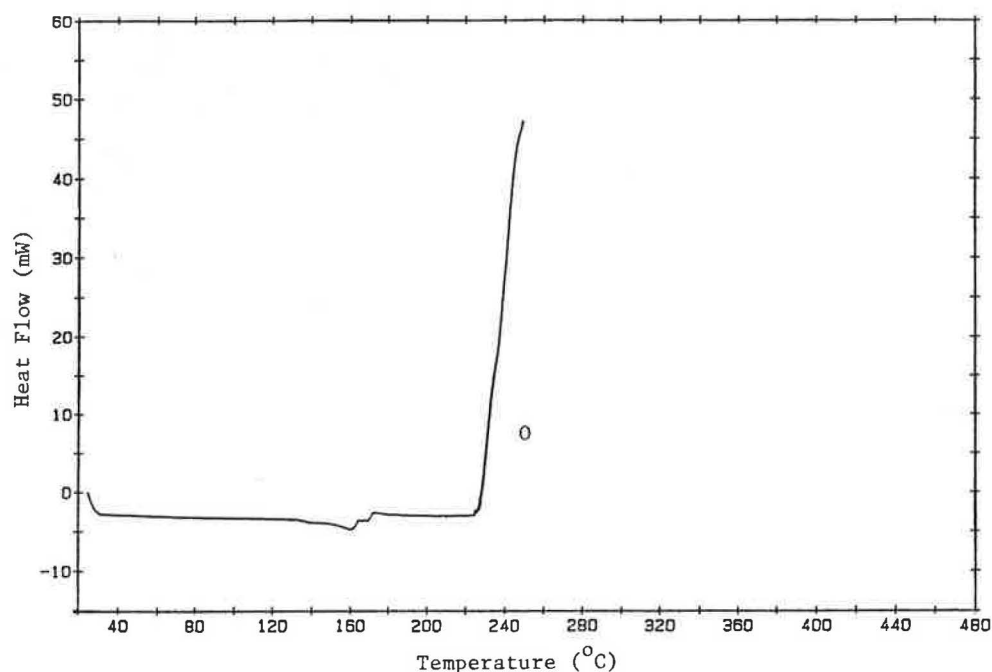
FIGURE 2 Oxidation exotherm (*O*) for archive polypropylene geotextile.

The oxidative induction temperature is the temperature at which reaction of a material with oxygen occurs. The DSC analysis is conducted with the specimen in a reactive atmosphere (air or oxygen), and the oxidative induction temperature value is the temperature at the onset of the exotherm, approximately 232°C in Figure 2. This parameter gives an indication of the oxidative stability of a material (i.e., the effectiveness of the antioxidant package).

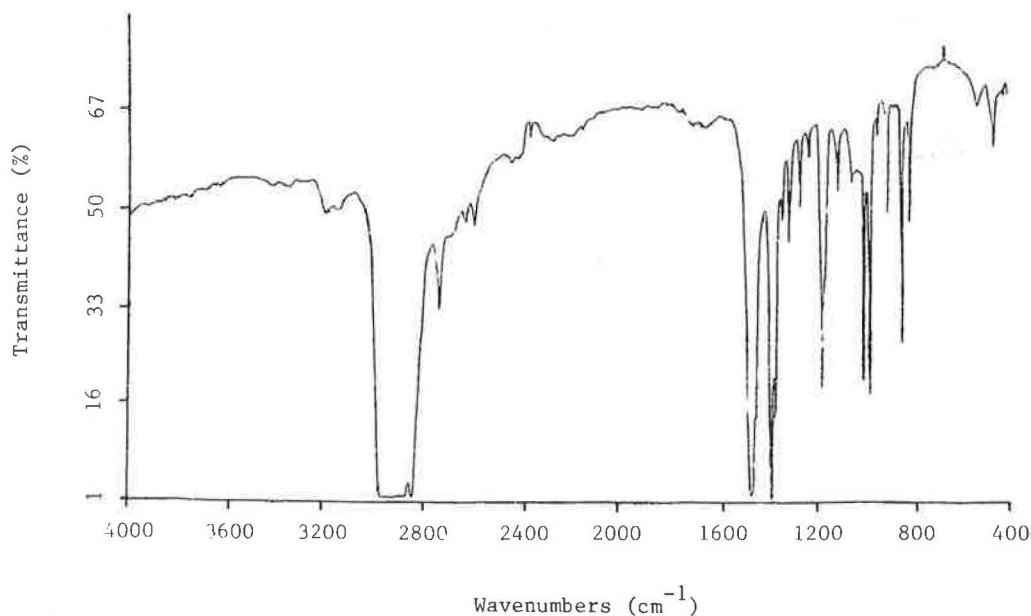
FIGURE 3 Typical IR spectrum for polypropylene geotextile.

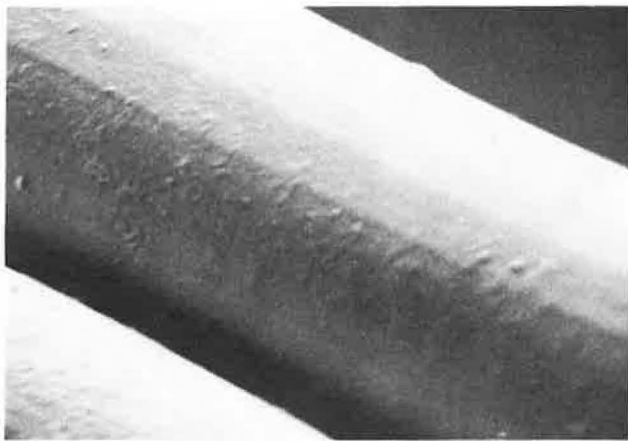
The original as-manufactured geotextile (the 1975 reference sample) and the individual fiber surfaces (from sample 13) are shown in Figure 6. The individual fibers (occasionally a few are bonded together in a parallel fashion) are distributed more or less randomly to produce a planar isotropic structure. The surfaces of the individual fibers are generally very smooth,

**FIGURE 6** Surface of reference geotextile fiber ( $\times 975$ ).

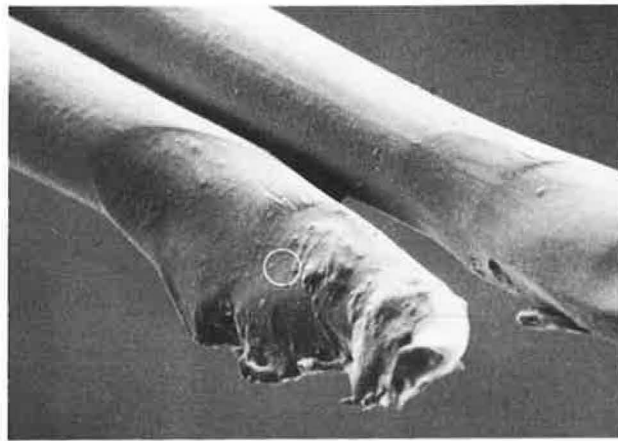
Fibers that had failed in tension showed a significant amount of elongation with a characteristically ductile final fracture. The surface of the fiber adjacent to the final fracture region was smooth, as seen in Figures 8 and 9.

**FIGURE 8** End of fractured reference geotextile fiber ( $\times 325$ ).

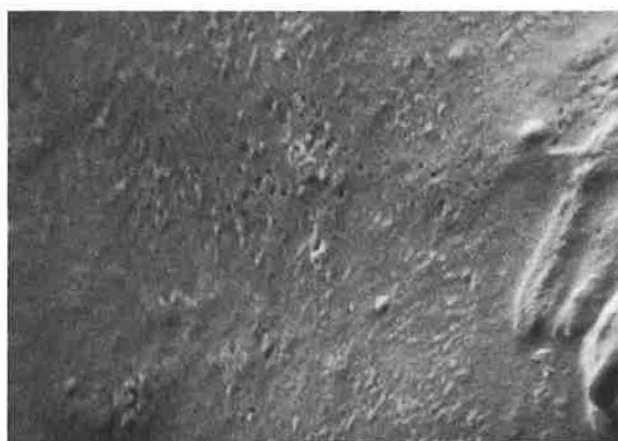
**FIGURE 9** Surface of fiber in area circled in Figure 8 ( $\times 1950$ ).

erence material shown in Figures 8 and 9. The only difference is the presence of the soil particles that have contributed to the roughness of the polypropylene surface adjacent to the fracture.

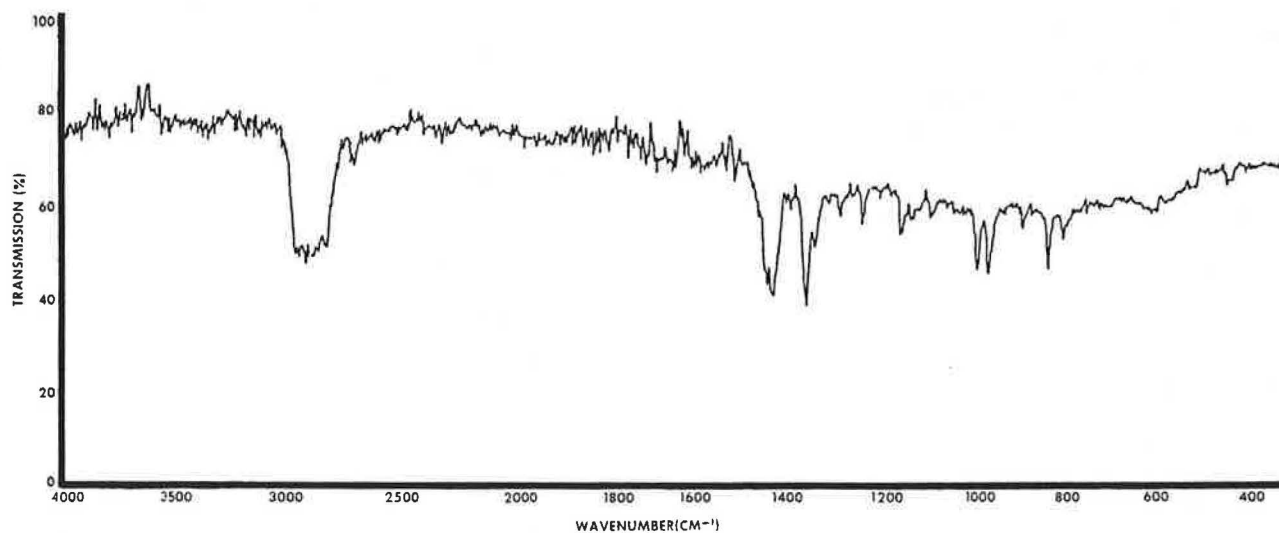
Table 6 lists the characteristic spectral bands of the reference sample and exhumed sample 13 obtained from the IR analysis. Figures 17 and 18 show infrared spectra for the reference and exhumed geotextiles, respectively. Five specimens from each of the reference and exhumed samples were analyzed.

FIGURE 17 IR spectrum for the reference polypropylene geotextile.
