# Inspection of the Substructure of the Chesapeake Bay Bridge-Tunnel Above and Below the Waterline

DONALD R. GRABER

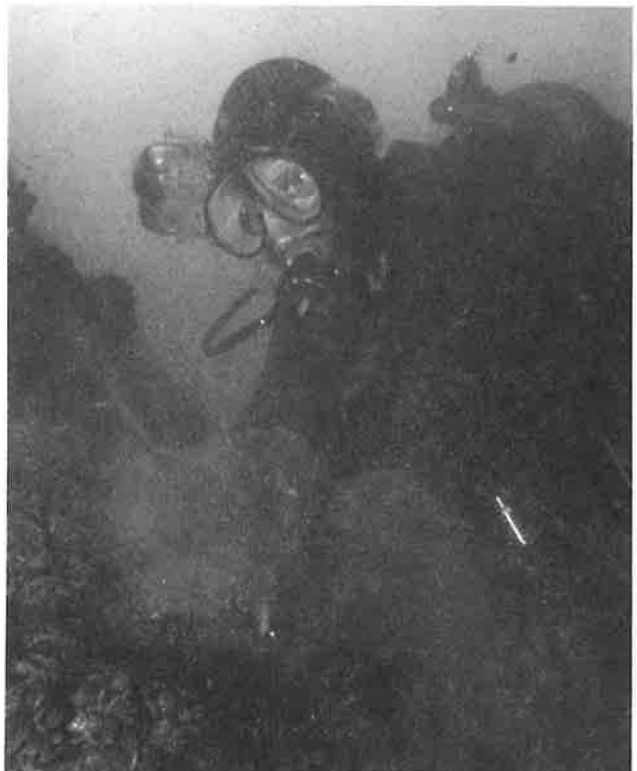
in part because the piles were encrusted with heavy biological fouling up to 3-ft thick as shown in Figure 14. This biological fouling consists of barnacles, oysters, mussels, and coral. Figure 15 shows an underwater inspector cleaning a pile. Bands 1 ft high were cleaned around the circumference of the piles to look for damage. These bands were located at the waterline, mudline, and at two intermediate points. Typical underwater cracks can be seen in Figure 16.

FIGURE 15 Underwater inspector cleaning pile.
