Crack Detection at Cover Plate Ends and Welded Splices Using Ultrasound Technology

PATRICK D. ZURASKI

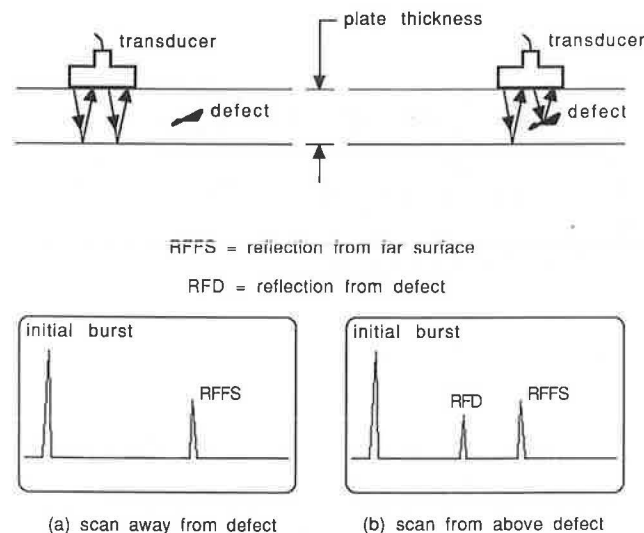
FIGURE 2 Typical oscilloscope traces for ultrasound scans.

Voltage traces are viewed on a cathode-ray oscilloscope. The screen shown in Figure 2(a) corresponds to an ultrasound scan conducted away from the interior defect. Only the initial voltage burst and echo from the bottom surface of the plate appear. When the transducer occupies a position above the

defect, an additional voltage "spike" appears corresponding to reflection of sound from the defect, as shown in Figure 2(b).

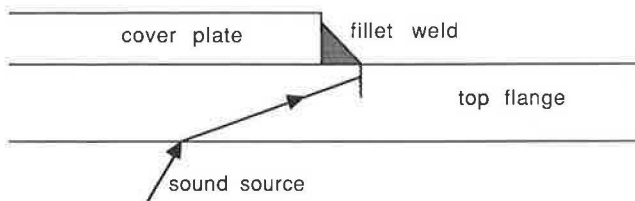
FIGURE 3 Sound path at oblique angle to fatigue crack in beam flange.

The strongest indication of cracks and line-type flaws is obtained when the sound is directed at right angles to the defect. That optimum orientation is not possible, however, for a fatigue crack located at the toe of a cover plate weld (Figure 3). The crack is nearly vertical and the sound must be transmitted toward the crack at an oblique angle, as shown. The sound is shown as being directed from the bottom surface of the top flange because it is typical construction practice to embed the top flange within the concrete deck, with only the bottom surface exposed.

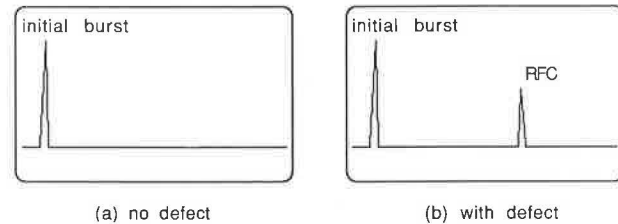
FIGURE 5 Oscilloscope activity with shear waves.

For shear waves transmitted into plates containing no defects, only one spike, the initial voltage burst, appears on the oscilloscope screen. Nothing is directed back to the transducer because the sound wave is totally reflected at the plate surfaces (metal-air interfaces) (4), as shown in Figure 5(a). For a plate containing a crack, a second spike appears because sound is directed back toward the transducer from irregular features (very small, intermittent concave surfaces) along the

side face of the crack. This is shown in Figure 5(b) (although the minute concave surfaces do not appear because of the scale of the figure).

The horizontal distance between spikes in Figure 5(b) corresponds to the elapsed time between the initial sound transmission and subsequent reception. The time may be easily converted to the horizontal distance between the index point of the transducer and the location of the defect because the angle of the sound path and velocity of the shear wave in steel are known. In fact, by utilizing a calibration block containing precision-machined "defects" at accurately known depths and adjusting the sweep settings on the oscilloscope, one may directly read actual distance on the horizontal axis of the screen.

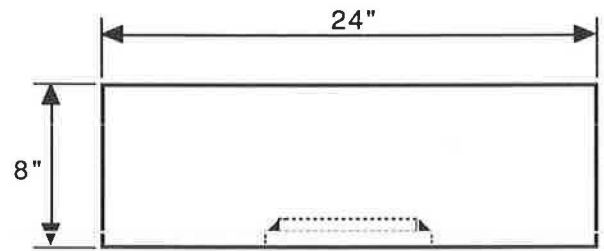
FIGURE 7 Cover plate specimen cast within concrete.

a central position within a block of concrete 2 ft wide by 3.3 ft long by 8 in. deep (Figure 7). After being cured, the block was turned over to provide access to the plate. The ultrasound transducer was moved over the exposed plate surface and indications of cracks were obtained that essentially matched the results from the previous examination of the plate that had been conducted without the covering of concrete.

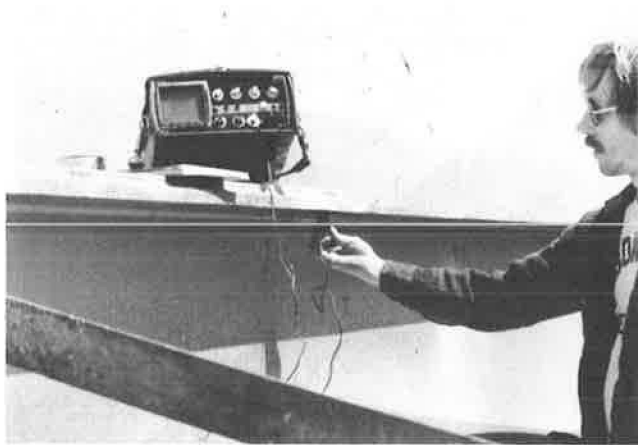
FIGURE 11 Inspection at end of welded cover plate: ultrasound instrumentation.

Even though no cracks were detected at the ends of the cover plates, indications (spikes) did appear on the oscilloscope screen during the examination. It was discovered that certain undulations in the surface of the weld (sometimes referred to as "rollovers"), shown schematically in Figure 12 and in a
