# Corrosion and Its Influence on Strength of Steel Bridge Members

JOHN W. FISHER, BEN T. YEN, AND DAYI WANG

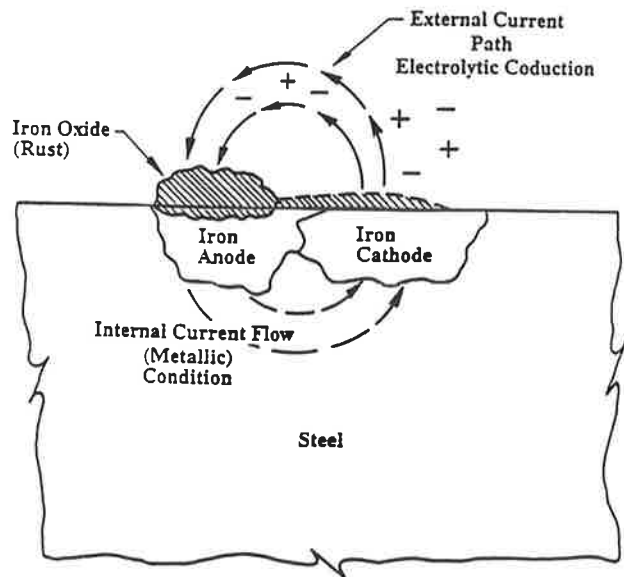
Figure 6 Schematic of Corrosion Cell (Battery)

The rusting process of steel (or iron) is two-fold involving the chemical change of iron to iron oxide and secondly the electrical process of current flow. Hence, it is an electrochemical process similar to the conditions that develop in a battery<sup>(1,2)</sup>.

The corrosion battery requires oxygen and an electrolyte. For the corrosion conditions generally observed at bridge members, the electrolyte is a solution in water of salts or other chemical compounds, which are capable of conducting electrical current. The current carrying capacity of the electrolyte is due to the presence of electrically charged particles called ions. Ions are formed by the splitting of salts or caustic chemical dissolved in water into mobile, electrically charged fragments. These electrically charged fragments are present in great numbers, and readily conduct current. Ions cannot carry current under dry conditions, so the presence of water

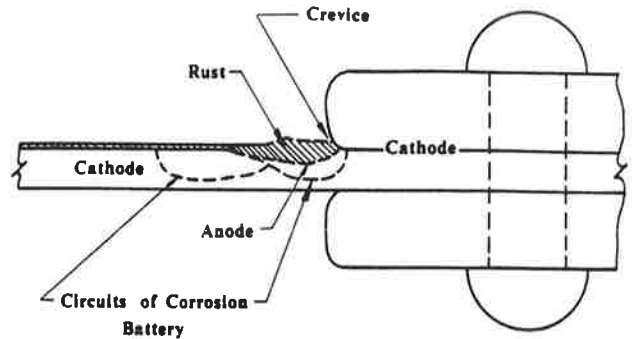
Figure 7 Crevice Corrosion Cell Created at Web-Connection Interface

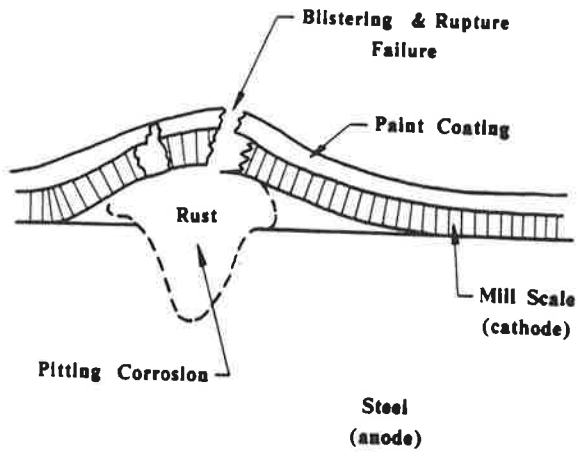
Figure 8 Corrosion Cell at Break in Mill Scale

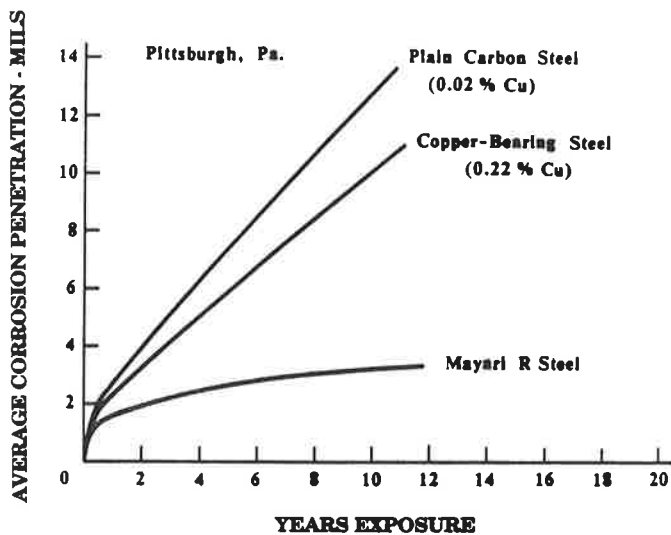
Under general atmospheric exposure, structural steels experience an average corrosion penetration, as illustrated in Figure 10. This shows a plot developed by Horton in 1965 comparing the corrosion of plain carbon, copper-bearing and Mayari R steel (A588) in the Pittsburgh area<sup>(3)</sup>.

Figure 10 Corrosion of Steels in Industrial Atmosphere

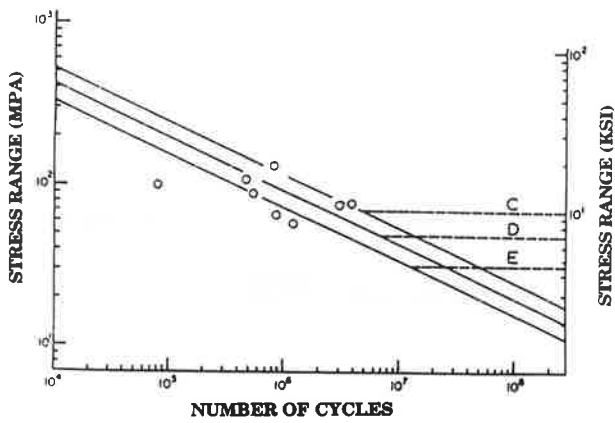
The fatigue test data of the corroded flange angles are plotted in Figure 14. The stress range is based on the net section of the corroded section. The stress range at the corroded net section varied from 8.3 ksi (57.2 MPa) to 14.1 ksi (97.2 MPa). Also plotted in Figure 14 are the results of the three girders that developed fatigue cracks at corrosion notches in Ref. 5. These three members were subjected to higher stress range levels at the corrosion "net area." The stress range varied from 12 ksi (82.7 MPa) to 18 ksi (124.1 MPa). All three girders had cover plates, as can be seen in Figs. 12 and 13. One of the girders cracked at the end of a cover plate. The other two girders developed cracks in the cover-plated section where the corrosion notches in the sections were severe.

The test results plotted in Figure 14 demonstrate that the most severely corroded section provides a fatigue resistance comparable to Category E. Three of the test girders provided fatigue lives bounded by the Categories D and E AASHTO and AREA resistance curves. Those girders with a loss of thickness equal to about 50% of the flange thickness ap-

Figure 14 Fatigue Strength of Corrosion Reduced Element

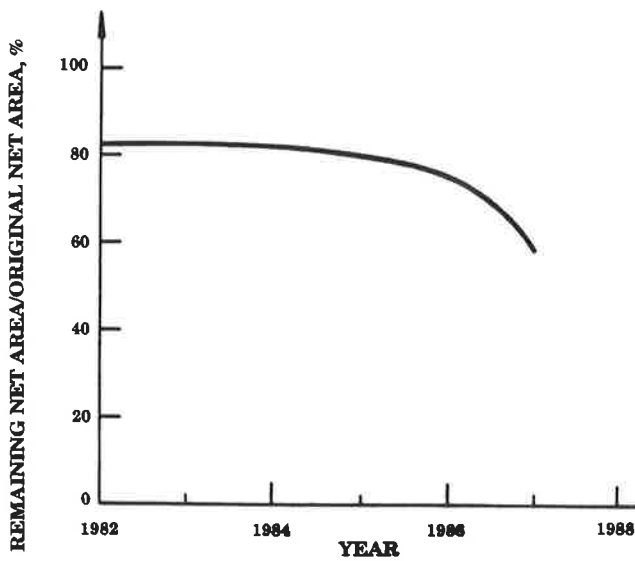
Two hangers with severe corrosion loss (39 to 41%) were removed from the Grand Narrows Bridge in Nova Scotia. This structure had experienced severe and rapid corrosion penetration in a large number of the truss and floor system members. In 1983 it was decided to stop maintaining the structure, because of the possibility of constructing a new structure jointly with the Highway Authority<sup>(6)</sup>. Inspections were carried out yearly between 1979 and 1987<sup>(7)</sup>. Extensive pitting and crevice corrosion was observed in most of the bridge members. The structure is in a severe marine environment and experienced an acceleration in pitting corrosion in most of its members, as illustrated in Figures 1 and 2. These local pitting holes quickly enlarged and resulted in complete loss of the outstanding leg in local areas. Figure 15 shows how the ratio of remaining net area to the original net area changed at the corroded region for the period between 1982 and 1987. An examination of samples by CN Rail verified that pitting corrosion had indeed developed. With the aggressive marine atmosphere at Grand Narrows, the rate of pitting penetration can be up to 100 times faster than the general corrosion rate. Hence, unprotected 3/8 in. plate could be perforated in less than three years. The local effect is not quite as severe on the total cross-section, as can be seen in Figure 15.

Figure 15 Ratio (%) of Remaining Net Area to Original Net Area as Function of Exposure Time

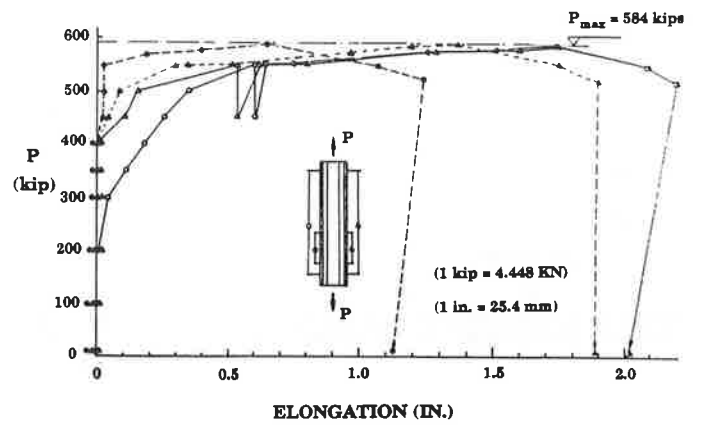
Six strain gages were mounted on each specimen near midheight: one gage on each of the angles and two on the web. Also attached to each specimen were four LVDT's for the measurement of overall elongation and elongation of the corroded portion. Both specimens failed by excessive elongation and local cracking of the angles at the corroded region. Figure 17 shows the load-elongation plots from the LVDT data. The overall elongation at maximum load was about 1.75 in. (44.5 mm). At termination of the test, the deformation was about 2 in. (50.8 mm) for the 16 ft. (4.9 m) measurement length of the specimens. Figures 18 and 19 are examples of the cracked flange angles of specimens No. 1 and 2. Testing was continued until the applied load dropped substantially below the maximum load. The maximum applied loads,  $P_{max}$ , are listed in Table 1, together with the computed reference forces and the section properties.

At the maximum applied load, strains at some of the gages were close to the yield level. One gage was subjected to very high strain because it was adjacent to the corroded area and sensitive to bending. The hangers were severely corroded in the region just above the floor beam connection. Measurement of remaining thickness of the components indicated a measured net cross-section area,  $A_{nm}$ , of 11.3 in.<sup>2</sup> (7290 mm<sup>2</sup>) and 10.8 in.<sup>2</sup> (6968 mm<sup>2</sup>) for hangers No. 1 and 2, respectively (Figure 20). Based on these net areas and the average measured ultimate strength of the hanger components, the predicted ultimate net section tensile strength would be 666 kips (2960 kN) and 610 kips (2711 kN), respectively. The corresponding maximum applied test loads were 638 kips (2836 kN) and 584 kips (2596 kN). These values are compared in Table 1.

Figure 17 Load-Displacement Relationship of Hanger No. 2

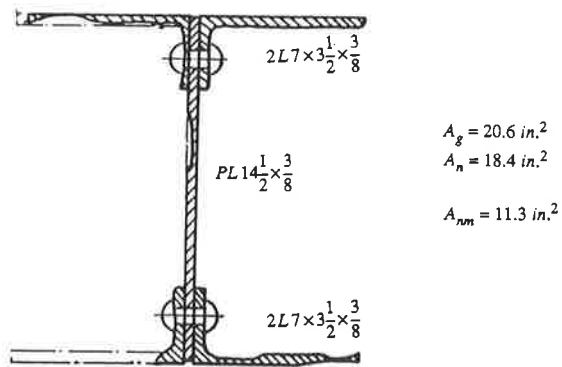
Cross-section of Hanger No. 1

Fig. 20 Remaining Cross-Sectional Area
