Crash Tests of a Retrofit Thrie Beam Bridge Rail and Transition

DORAN L. GLAUZ, ROGER L. STOUGHTON, AND J. JAY FOLSOM

Two crash tests each were performed on a Thrie beam bridge rail and on the adjoining transition section to the approach guardrail. The bridge rail was designed (a) as a retrofit to replace the rail portion of an inadequate bridge rail supported on W6X15.5 steel posts at 6 ft 3-in. spacing, or (b) as a completely new barrier installed using resin capsule anchors to attach the posts to the edge of an existing bridge deck. The transition uses the same rail element, a 10-gauge Thrie beam, supported on standard wood posts. The tests performed approximated those required for a PL-1 bridge rail outlined in the 1989 American Association of State Highway and Transportation Officials *Guide Specifications for Bridge Railings*. The bridge rail was struck by a 5,400-lb pickup truck at 44.9 mph at an angle of 21 degrees and a 1,830-lb car at 48.7 mph at an angle of 18¼ degrees. The transition was hit by a 5,400-lb pickup truck at a speed of 44.7 mph at an angle of 18 degrees and a 1,930-lb car at 49.1 mph at an angle of 20¾ degrees. The crash tests satisfied the requirements f

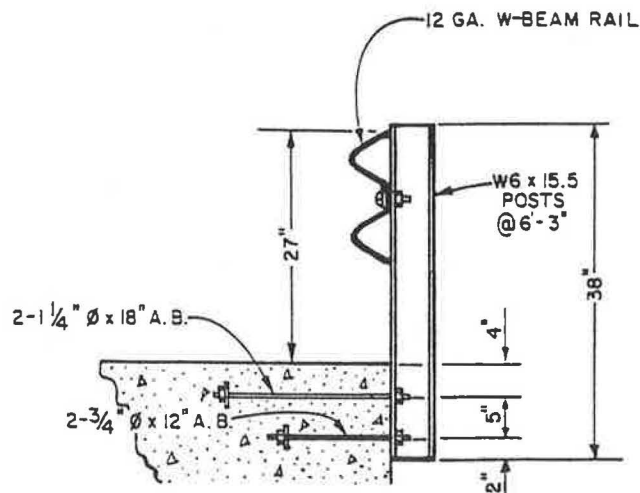
There are many old bridge rails in service that do not meet modern standards of crashworthiness. These are mostly on narrow bridges on rural low-volume roads that have low speed limits. One common type in California, with more than 1,000 now in service, is a W-section metal beam and steel post bridge rail (Figure 1). This railing was crash tested in 1959 with a 4,000-lb vehicle/55 mph/30 degrees test condition (1). The concrete deck failed at the post connection, the rail pocketed and deflected 50 in., and the car was trapped and stood up almost on end. If there had been no earth support beyond the simulated deck, the vehicle would have continued through the rail and off the deck.

FIGURE 1 Metal bridge rail, 1959.

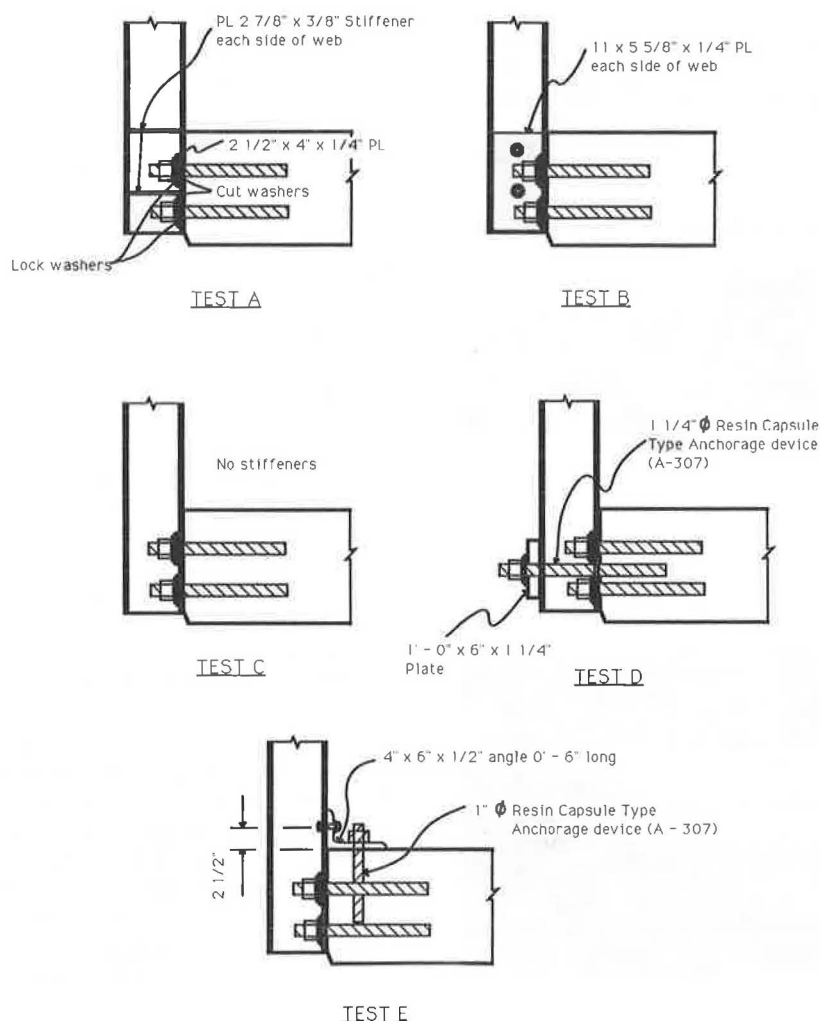
A series of static tests on $W6 \times 15.5$ steel posts were conducted. There were five tests, each on a different bridge rail post design. Post designs for Tests A through E are shown in Figure 18.

The purpose of the tests was to evaluate the effect of eliminating the web stiffeners at the base of the post and alternate post-strengthening schemes. Test A used a post as crash tested, Test B used the preferred alternate strengthening scheme, and Test C used an unstrengthened post. Tests D and E were additional alternate strengthening schemes. The test device consisted of a load frame anchored to the simulated bridge deck, a 75-ton hydraulic jack, a load cell, two linearly variable differential transformers (LVDTs), and a bearing plate. Load was applied 26 in. above the deck surface; the LVDTs measured displacement $4\frac{1}{2}$ in. above the deck (Figure 19).

The test results are summarized in Table 4. Typically the web at the base of the post would buckle upon failure (Figure 20a, b, and c). In Tests A and B the web stiffeners and sandwich plates added sufficient strength so that the top anchor bolts pulled out. Total deformation of test Post A was less than two of the posts in Crash Test 473 (Figure 21).

FIGURE 18 Static tested post designs.

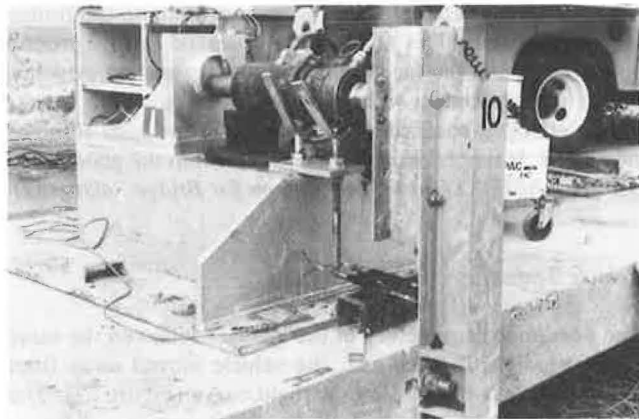
FIGURE 19 Static test setup.

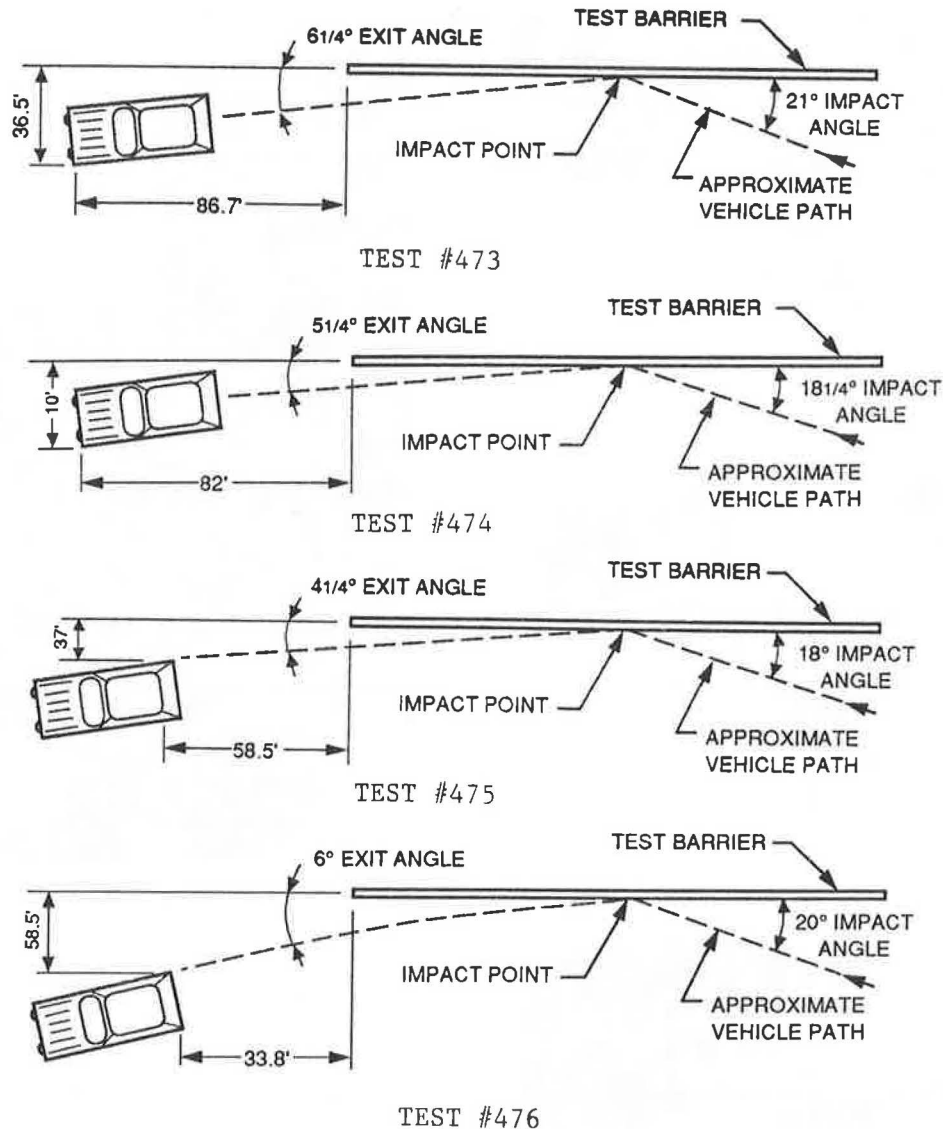
The post impact trajectory of the vehicles followed the same general pattern in each test; the vehicle moved away from the barrier in a straight line or slight curve (Figure 22). The exit angle for each test was low (4 to $6\frac{1}{4}$ degrees), well below 60 percent of the impact angle.

FIGURE 22 Vehicle trajectories.
