# Analysis of Three Concrete Restoration Techniques

B. F. McCULLOUGH, DAVID W. FOWLER, JAMES R. LUNDY, AND  
BROCK E. HOSKINS

Three concrete pavement restoration techniques are described and the field performance of each is evaluated. Two of the three methods are used to restore the condition of continuously reinforced concrete pavements (CRCP) and the other was used to repair failed joints and broken slabs in an old plain jointed concrete pavement (JCP). Each of the techniques and the analysis results are described. A repair technique using polymer concrete to restore load transfer and seal surface cracks in several lane-miles of IH 610 in Houston, Texas, is described. This project, constructed in 1980, was surveyed in 1990. Results indicated that the majority of the repairs were intact after 10 years of heavy traffic. The area encompassing these polymer concrete repairs is currently being rehabilitated using a bonded overlay. One experimental section in the overlay project investigated the effectiveness of methyl methacrylate as a mop on pretreatment of the existing CRCP. Falling weight deflectometer (FWD) measurements taken before and after the treatment, as well as core analy

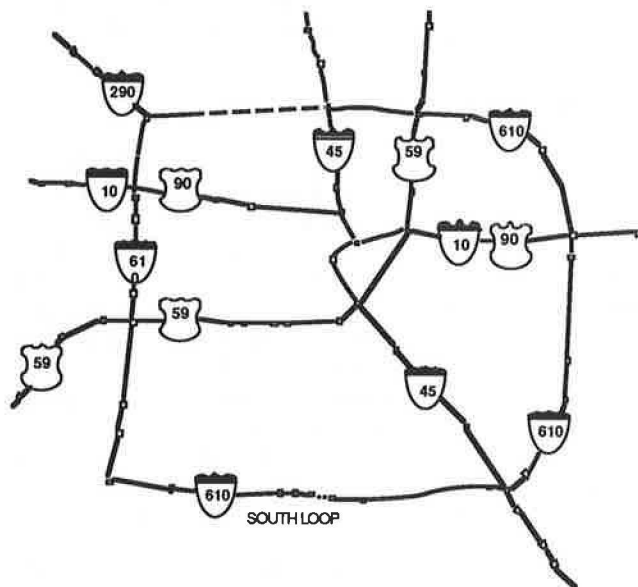
**FIGURE 2** Map of Houston area showing location of repair sites.

The University of Texas at Austin, CTR, and the SDHPT developed and implemented a repair procedure for the uncontrolled longitudinal cracking that was present on IH-610 in Houston (see map shown in Figure 2). An example of this type of cracking is shown in Figure 3. The objective of the repair procedure was to seal the cracks to prevent water intrusion and further corrosion of the reinforcing steel.

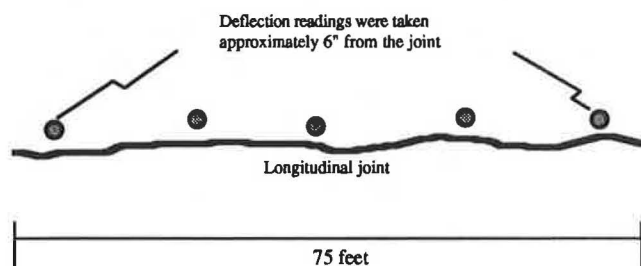
FIGURE 12 Plan view of deflection measurement locations.

Falling weight deflectometer (FWD) measurements were taken in each of these sections after the area had been closed to traffic. Before repair, FWD measurements were taken in February 1989 and, after repair, data were collected in June 1989. The general layout of the data collection at each site is shown in Figure 12. A summary of the influence of the repairs on the measured deflection is presented in Table 2. These results indicate that there has been a substantial decrease in the deflection as a result of the stitching repairs. However, because these measurements were taken at different times of the year under different environmental conditions, it is possible that some of the reduction in deflection could be attributed to seasonal effects rather than the repairs themselves.
