Evaluation of Pumping Pavement on Interstate 77

JOHN S. BALDWIN

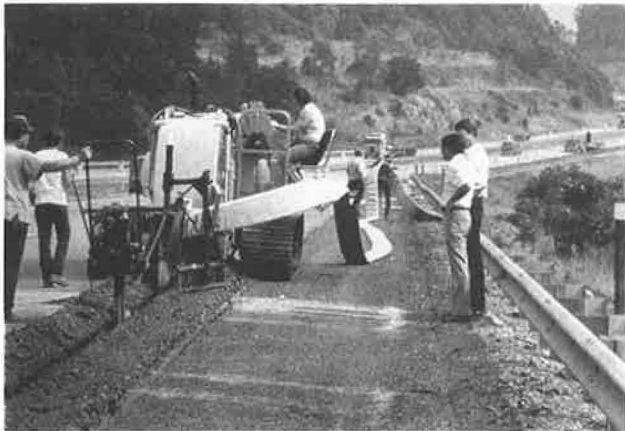
Records indicate that only two brands of prefabricated pavement edge drains were used, namely, Hydraway (Monsanto) and AdvanEdge (Advanced Drainage Systems). Although similar in concept, both products exhibit radically different core designs. The Hydraway core (Figure 3) is basically composed of numerous flexible cylindrical projections or posts from a single flexible base. The AdvanEdge core (Figure 4) resembles a flattened corrugated plastic pipe with slit-type openings in the corrugations on both sides of the panel.

FIGURE 3 Monsanto Hydraway core.
