# Transverse Pipe Underdrains for Highway Groundwater Control: A Case History

JOHN O. HURD AND HERBERT DUNCHACK

Longitudinal pipe underdrains and transverse pipe underdrains spaced at approximately 60-ft intervals were used to provide groundwater control on one section of the Kirtland-Chardon Road highway project in Lake County, Ohio. This area was designated spring area by the geotechnical consultant because of extremely severe groundwater problems in the subgrade. Normal practice is to provide aggregate drains spaced at 50-ft intervals on uncurbed flexible pavements, but the severe groundwater problems on this section warranted additional drainage. Aggregate drains were placed on the remaining uncurbed sections of the project per normal practice. Four years after construction, the pavement in the spring area, where the improved drainage system was provided, is in excellent condition. Severe distress has been observed in the areas with standard drainage that abut the spring area.

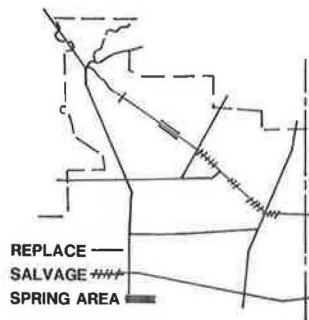
FIGURE 6 Location of salvage sections, replacement sections, and spring area.

The subgrade soils in the borings were found to be generally clayey silt, silty clay, and clayey silty sand. At many boring locations, the subgrade soil was moist to wet. Groundwater was observed flowing into the test borings at several locations. One particular steep 1,500-ft section of the highway was designated "spring area" in the foundation consultant's report (1). Water had been observed percolating up through the pavement surface at several locations along this section. The spring area is indicated in Figure 6; Figure 7 shows the steep topography of that section.

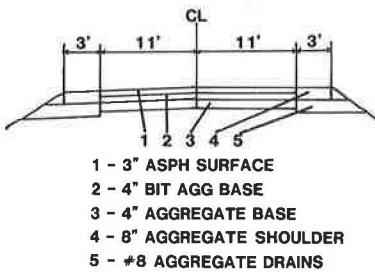
FIGURE 9 Typical section, uncurbed replacement.

area (Figures 8, 10, and 11). Aggregate drains were provided on the other uncurbed sections at 50-ft intervals shown in Figures 9 and 12. (Locations of curbed and uncurbed sections are shown in Figure 2.) Normal practice has been to provide longitudinal pipe underdrains on curb sections and aggregate drains spaced at 50-ft intervals on uncurbed sections for this type of highway (3). In addition, 4-in transverse pipe underdrains were provided in the spring area (Figure 10). The transverse underdrains were spaced such that the top of the trench for each installation was no lower than the flow-line elevation of the next transverse underdrain upstream. Because of the relatively steep highway grades (approximately 4 to 8 percent), transverse drains were required at approximately 50-ft

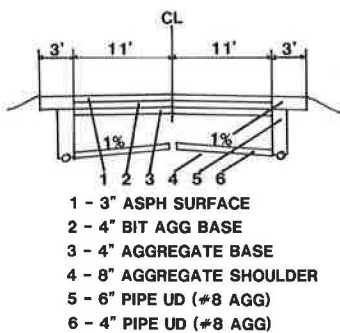
FIGURE 10 Typical section, spring area.

intervals. It was anticipated that nearly all seepage lenses would be intercepted in the spring area by this transverse underdrain design.
