TRANSPORTATION RESEARCH  
**RECORD**

No. 1329

**Geocomposite Pavement  
Drain Systems  
1991**

# Transportation Research Record 1329

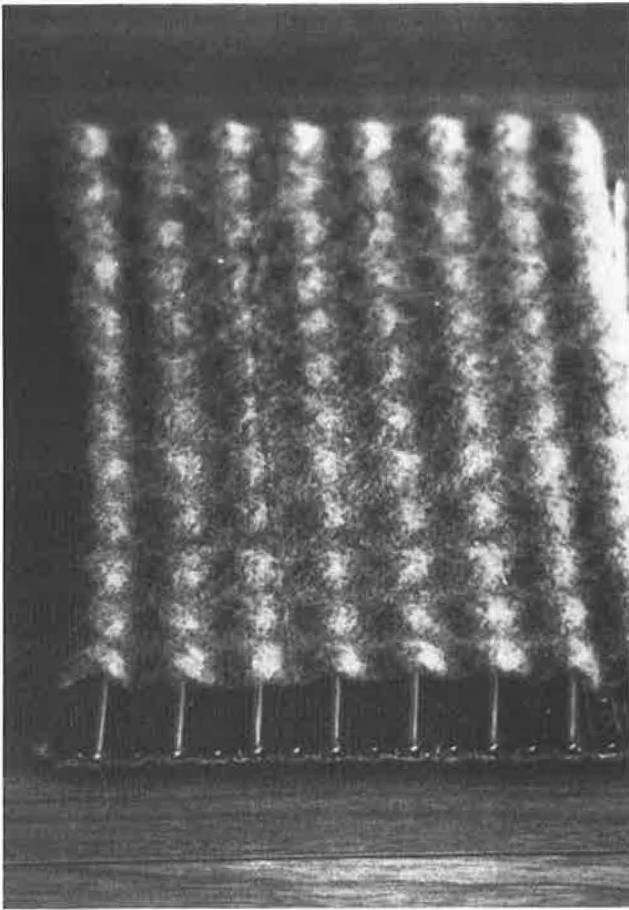
**FIGURE 2** Residual geotextile intrusion after loading to 5 psi in the frame shown in Figure 1.

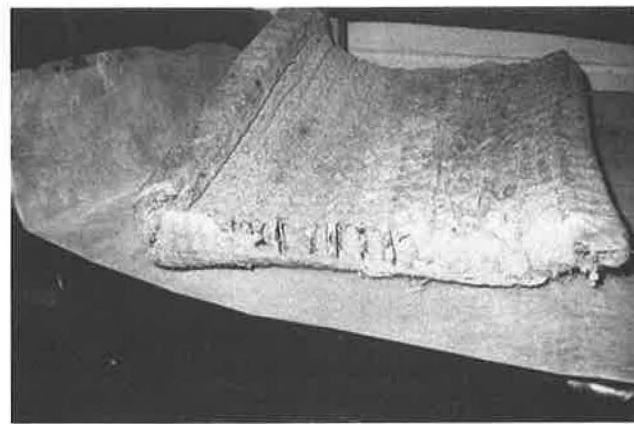
**FIGURE 4** Geocomposite completely plugged by fines from I-65 in Kentucky.

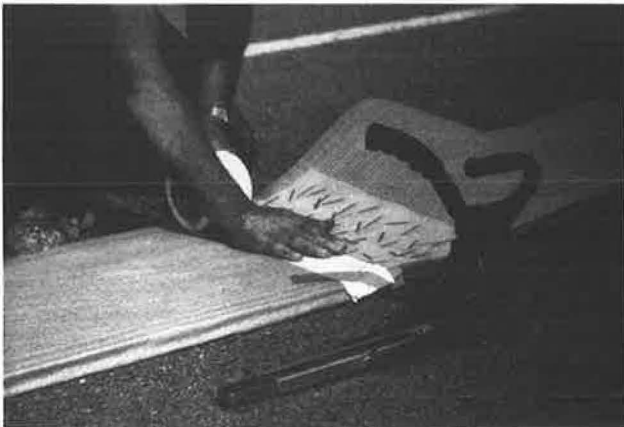
Complete system design requires a minimum of fittings. All that is necessary is a coupling, a side outlet, an end outlet, and an end cap. The most critical of these is the coupling, which must keep the geocomposite sections connected through the installation process without restricting flow through the system. The past practice of stapling (with box staples) and taping sections together damages the core and reduces flow capacity (Figure 5).

**FIGURE 5** Stapled connection in which core has been partially crushed by staple placement.

Any coupling method that infringes on the flow channel, blocking or reducing flow or providing sites for collection and buildup of solids, should not be permitted. Any coupling method damaging the core in any way should not be permitted.

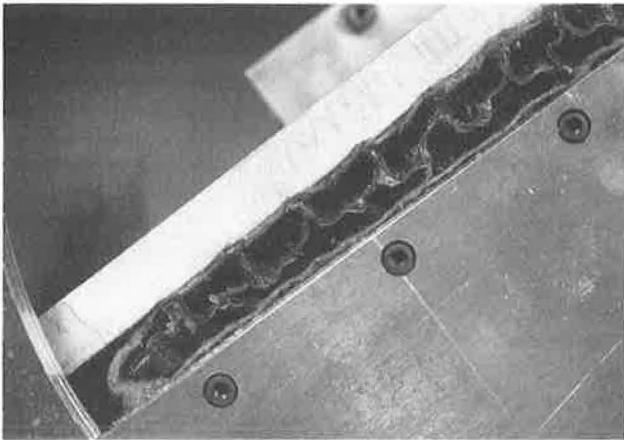
FIGURE 9 Core A: failure mode.

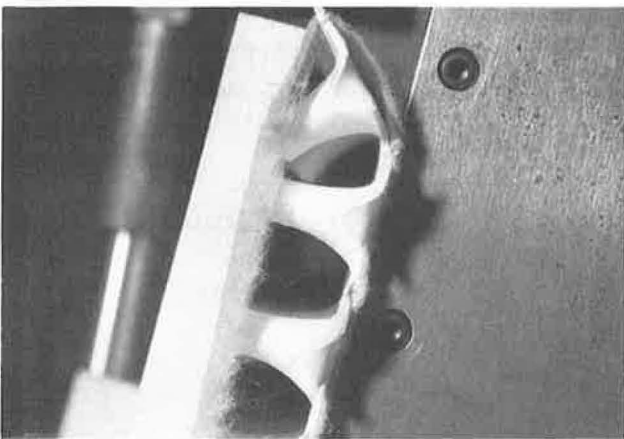
the geotextile pulled at high-angle loading, as shown in Figure 10. Failure of the cusps occurred at the weakest cross section approximately 0.3 in. from the top, as shown in Figure 11. Failure was by collapse or folding of the cusps in the direction of load. Because of the stiff properties of the core, there was no change in loading at 10 percent deflection for 70 degrees and only an 11.5 percent drop for a 50-degree angle. However, the amount of loading to fail the core at 50 degrees dropped by 62 percent from that at 90 degrees (normal). Ultimate core failure occurs at between 28 and 30 percent total deflection.

FIGURE 10 Core B: upper edge rollup.

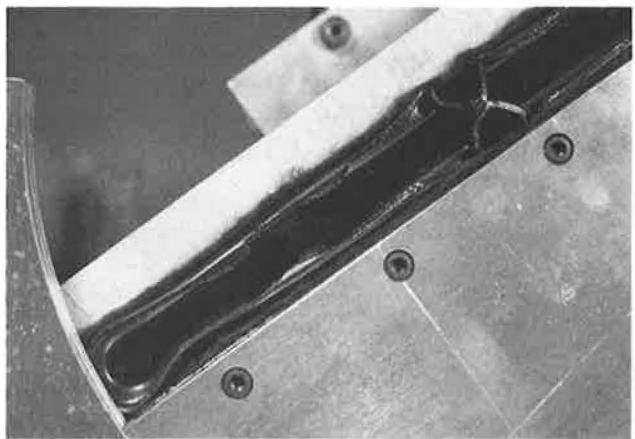
FIGURE 13 Core C: deformation at 20 percent deflection.

at 50 degrees. As with Core B, accurate load deflection readings were not possible at high angles because of surface slippage and stiff core properties. Failure at 50 degrees required less loading (35 percent drop in load) than at 90 degrees. Ultimate failure always occurred at approximately 25 to 30 percent deflection. Figures 12 and 13 show the core before loading and deformation at 20 percent deflection.

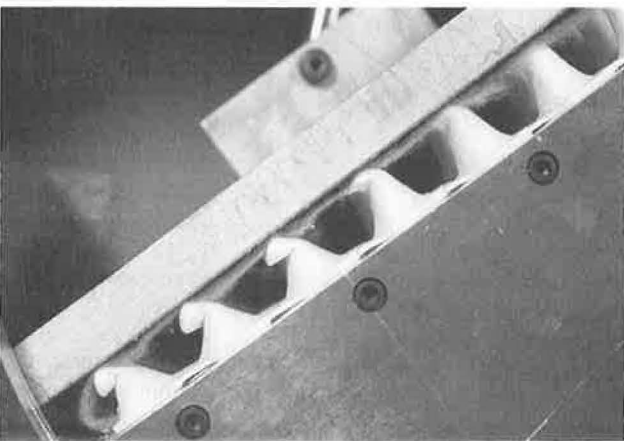
FIGURE 11 Core B: failure mode.

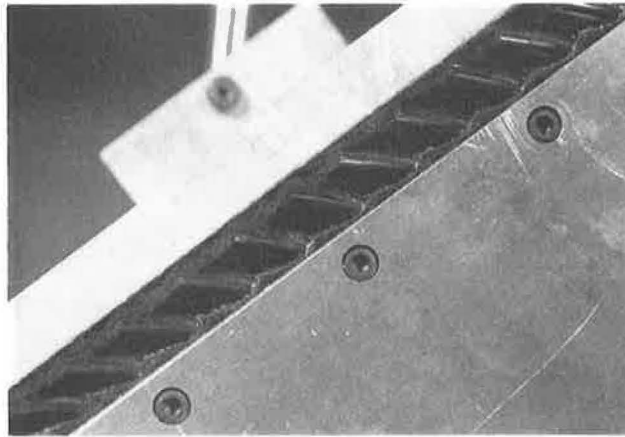
Core D, although exhibiting very high normal loading (16,000 lbf/ft<sup>2</sup>), showed a distinct disadvantage when subjected to angled loading in that the high-profile hollow tubular columns tended to bend and collapse, sometimes instantaneously. At 20 percent deflection (also the failure deflection), Core D showed a significant change in loading values. At 70 degrees, it exhibited an 83 percent drop in load as compared with normal, a 93 percent drop at 50 degrees, and a 96 percent drop at 30 degrees. Most significant, however, even at a low angle of 50 degrees, the ultimate failure load or crush strength dropped from 16,000 to 2,250 lbf, and 85 percent drop in loading. Failure occurred by column foldover, with ultimate base fracture at the connection of column to base (Figures 14-16 show the column collapse mechanism).

FIGURE 14 Core D: failure mode (column bending).

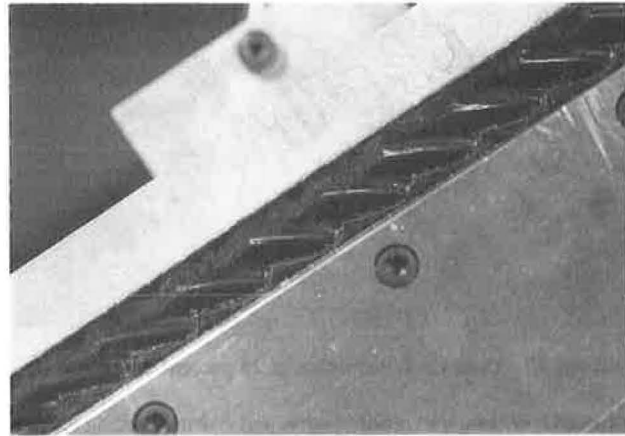
FIGURE 15 Core D: column collapse.

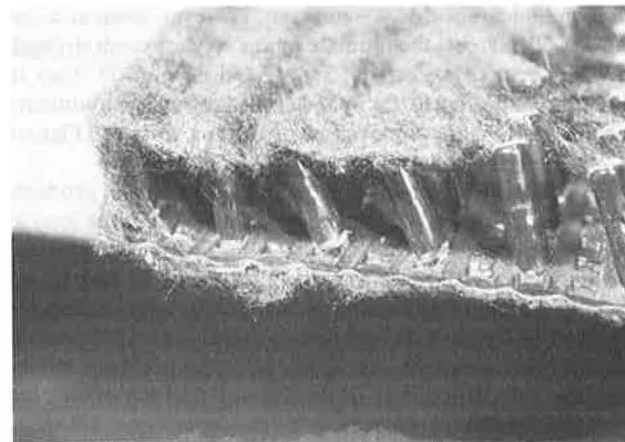
FIGURE 16 Core D: column base fracture.

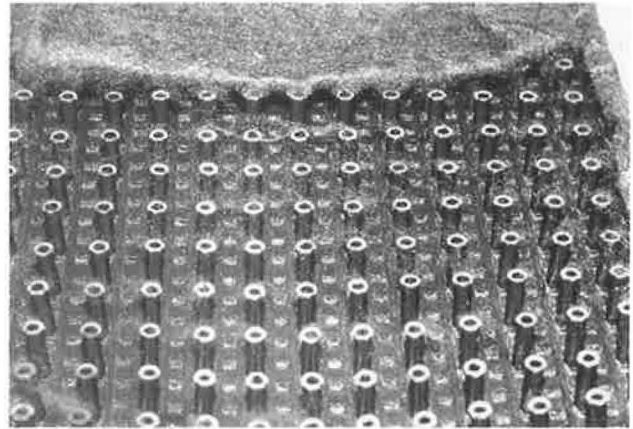
FIGURE 3 Monsanto Hydraway core.

Deformation of the Hydraway core was apparent and is shown in Figure 11. The top row of the support columns was bent downward about 30 degrees and the bottom two rows were bent upward about 45 degrees. In addition, where the edge drain had intersected the base-subgrade interface, there was distortion along a horizontal plane that caused an offset of as much as 1/2 in. between the top and bottom of the product. Although deformed, it appeared that the edge drain would perform satisfactorily if given a proper outlet. Consequently, before the test pit was closed, a trench was cut into the shoulder that linked the test pit with the side of the embankment. The trench was lined with engineering fabric and backfilled with pea gravel. Recent observations indicate that pumping of the shoulder has subsided.

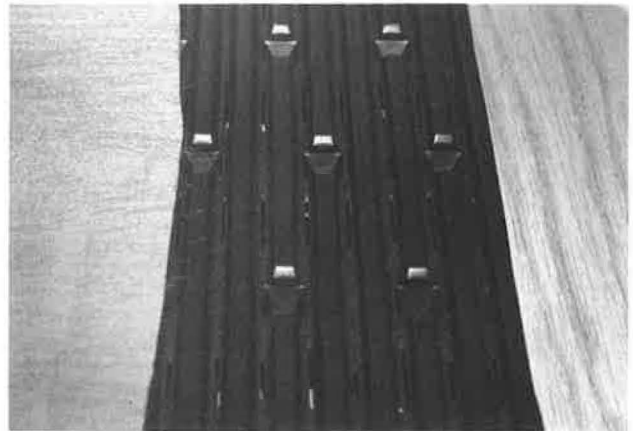
FIGURE 4 Advanced Drainage Systems AdvanEdge core.

- Up to 3 in. of sediment and standing or slowly flowing water was found in the bottom of the flow channel.
- Many of the slit openings, especially in the bottom two rows (of four rows), had been blinded with sediment.

Soil contamination of the edge drain appeared to have a substantial effect on the ability of water to reach the internal flow channel of the AdvanEdge core (Figure 9). It is believed that most of this soil came from the backfill placed during the installation of the edge drain. Examination of the excavated sample revealed that less than 50 percent of the core wall slits remained open. The remainder of the slits were either partially blinded or totally plugged with soil sediment.

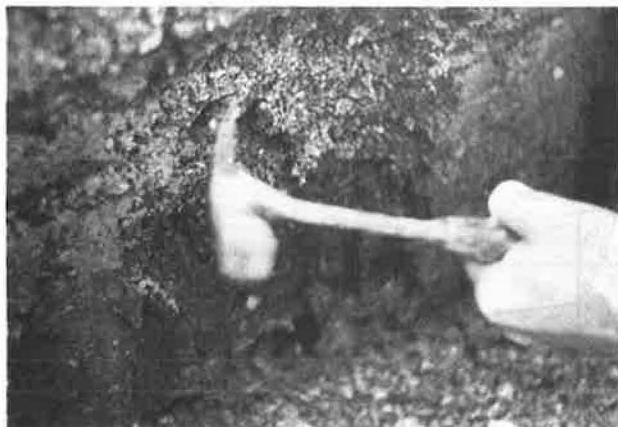
FIGURE 7 Hand excavation of base course, Test Pit 1.

The limestone base course used on this project was extremely dense, so much so that it had to be chiseled out of the test pit with a rock hammer (Figure 7). Although the area was moist, no free water was found in the base course on either side of the edge drain. When the base course was removed from the side of the original pavement slab, however, the crack-and-seat operation caused water to begin flowing from the fractures in the pavement (Figure 8). The base course

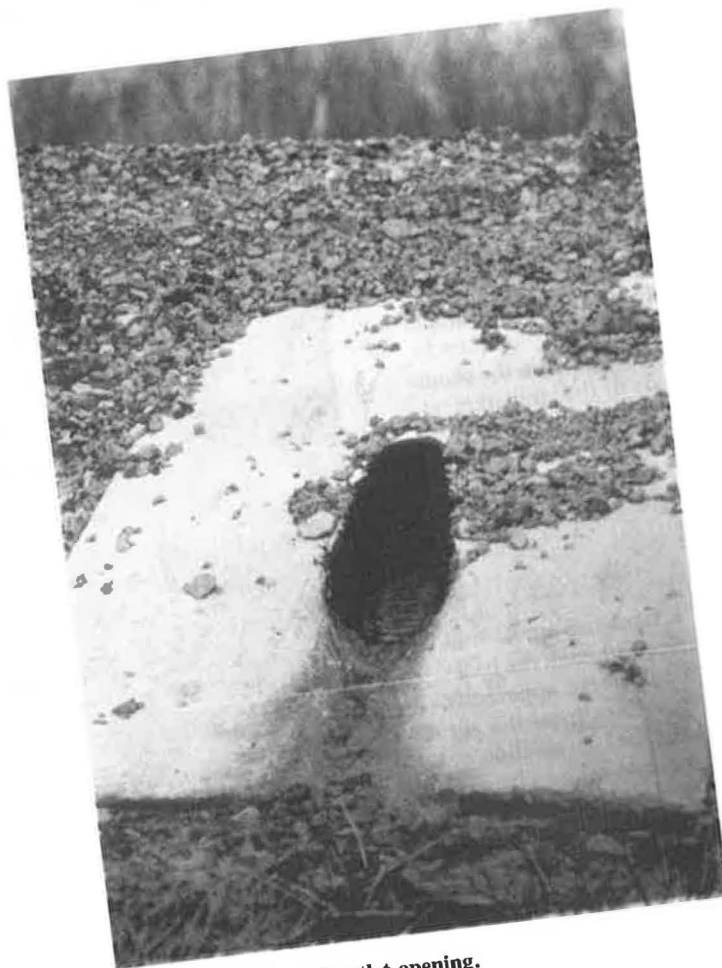
FIGURE 12 Typical outlet opening.

All outlets examined were constructed of 4-in. corrugated plastic pipe. The outlet openings were encased in a concrete headwall as shown in Figure 12. All outlets associated with pumping pavement appeared to be functioning, although soil staining of the outwash was apparent. Occasionally, an outlet was encountered that appeared to have a slight reverse grade, which may have slowed the drainage process. In addition, a

calcium carbonate crystalline growth was observed on several of the rodent screens and in the corrugations on the bottom of the outlet pipes.

2. Outlets should be constructed with smooth-walled rigid pipe to help ensure that the proper outlet grade is maintained.

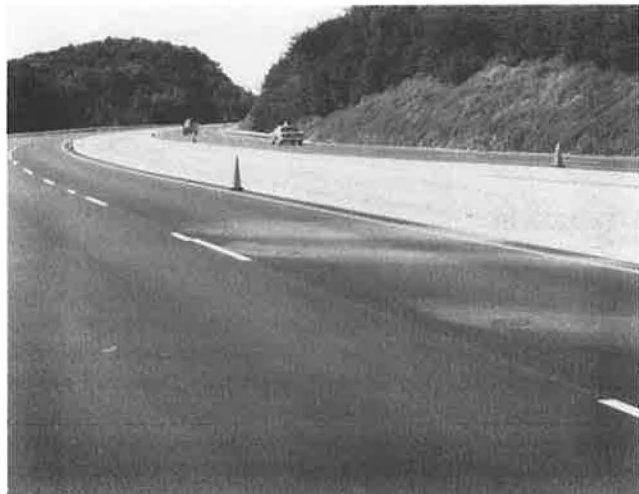
**FIGURE 21** Silt being pumped up at centerline of Mountain Parkway.

However, in 1989 some spot distresses were beginning to appear in the rehabilitation projects completed on the Mountain Parkway in 1988. At some sites, silt was pumping up through the 8-in. asphalt overlay at the shoulder joint and in the middle of the passing lane (Figure 21). Excavation of two of these sites showed evidence of poor construction practices. At one the outlet pipe had not been connected to the headwall and consequently it was completely blocked. At another the outlet pipe was crushed just before it entered the headwall. Of 14 outlet pipes inspected by using the borescope, 11 had

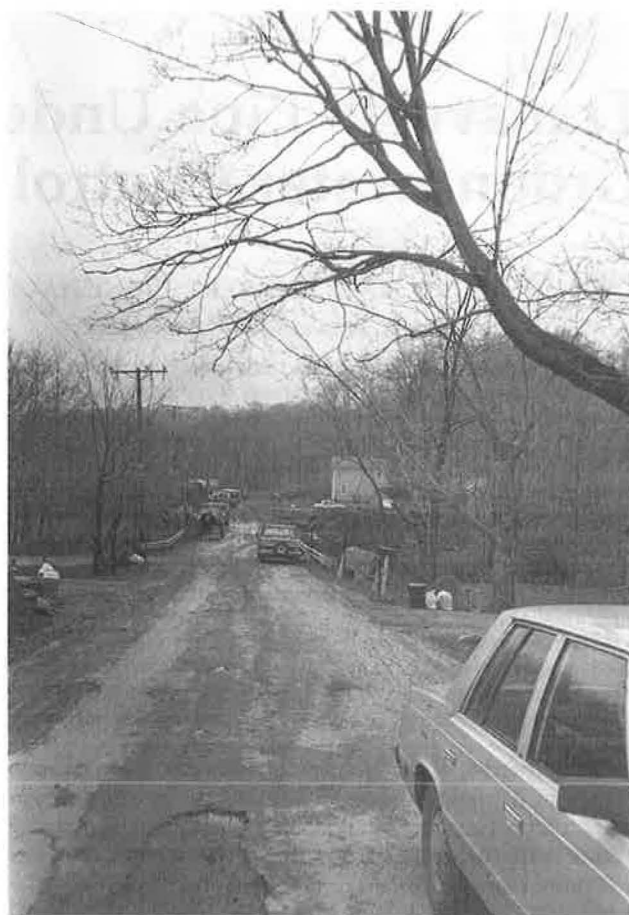
FIGURE 5 Pavement condition before construction.

The severe deterioration of the pavement was attributed in part to the groundwater problems observed (2). Groundwater
