Construction of a Geogrid- and Geocomposite-Faced Soil-Nailed Slope Reinforcement Project in Eastern Canada

COLIN ALSTON

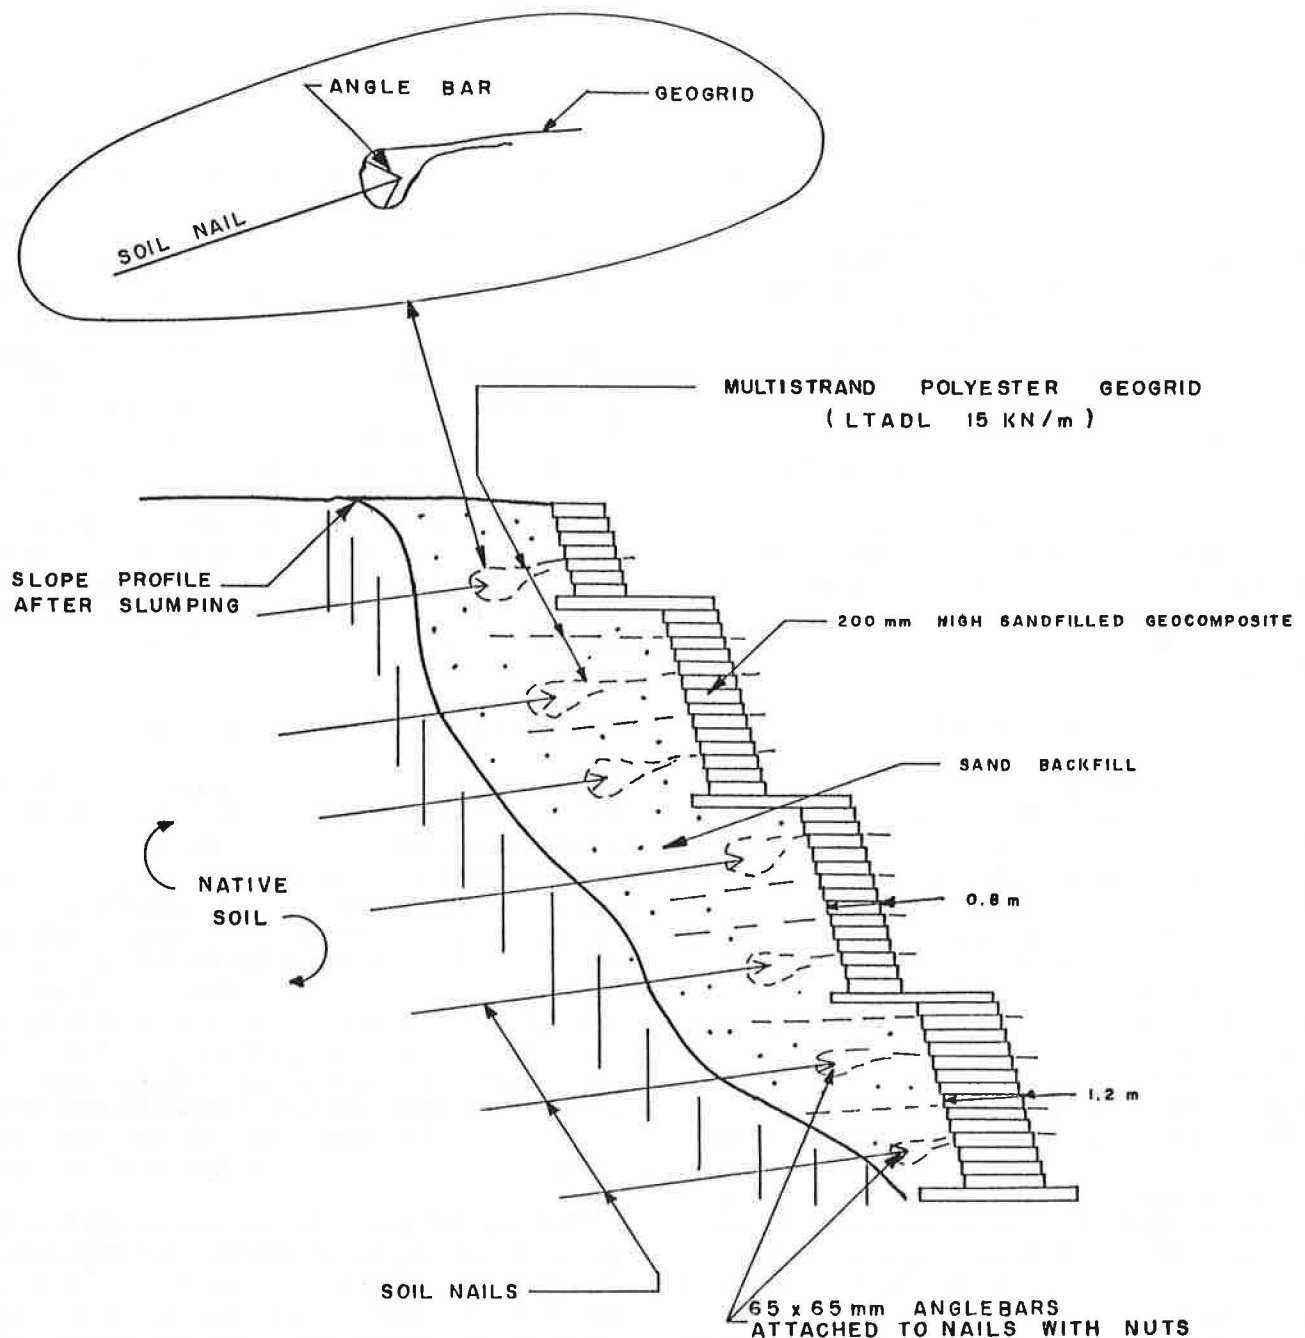
FIGURE 3 Schematic illustration of slope facing construction using geocomposite.

Circumstances necessitated a change in facing membrane design over part of the length of the retained slope. A wet area in the slope face (later found to be a consequence of a leak in the water main buried in the crest of the slope) collapsed continually and progressively, and winter came before the area could be stabilized. The face of this portion of the slope remained unrestrained throughout the winter. The winter of 1988–1989 was severe on the incomplete structure in that there were many freeze-thaw cycles and heavy rains alternated with snow. As a consequence, the completely unprotected portion of the “terraced” slope deteriorated and the face slumped to expose a succession of steep scarp slopes. To reduce additional deterioration of the partly slumped slope through the main spring thaw, a restraining membrane of nonwoven geotextile held in place by a timber grillage connected to the soil nails through the angle bars was applied to the soil face. In the spring, a new face had to be constructed and connected to the soil nail reinforcing system.

The face design selected for reconstruction of the deteriorated area of slope featured a facing of geocomposite (Geoweb infilled with sand) with a geogrid-reinforced granular infill placed between the geocomposite and the face of the scarp slope. The design of this section of face was developed on the presumptions that soil nails stabilized the retained slope and that the geocomposite would be required to support the forces developed in the active wedge of soil; these forces were transferred from the face into a reinforced backfill, and to the nails, with horizontally laid sheets of geogrid. The tensile forces in the geogrid and the active pressure were calculated using the method described by Jones for a sloping reinforced structure (6).

m. The grid was installed at 0.6-m vertical spacings, and every other grid sheet (or every third, depending on vertical positioning) was tied back to the angle bars, which were in turn attached to the soil nails, thereby connecting the geocomposite facing to the soil nail reinforcement system. Pullout resistance of the geogrid at the geocomposite facing was attained by frictional forces (Figure 3).

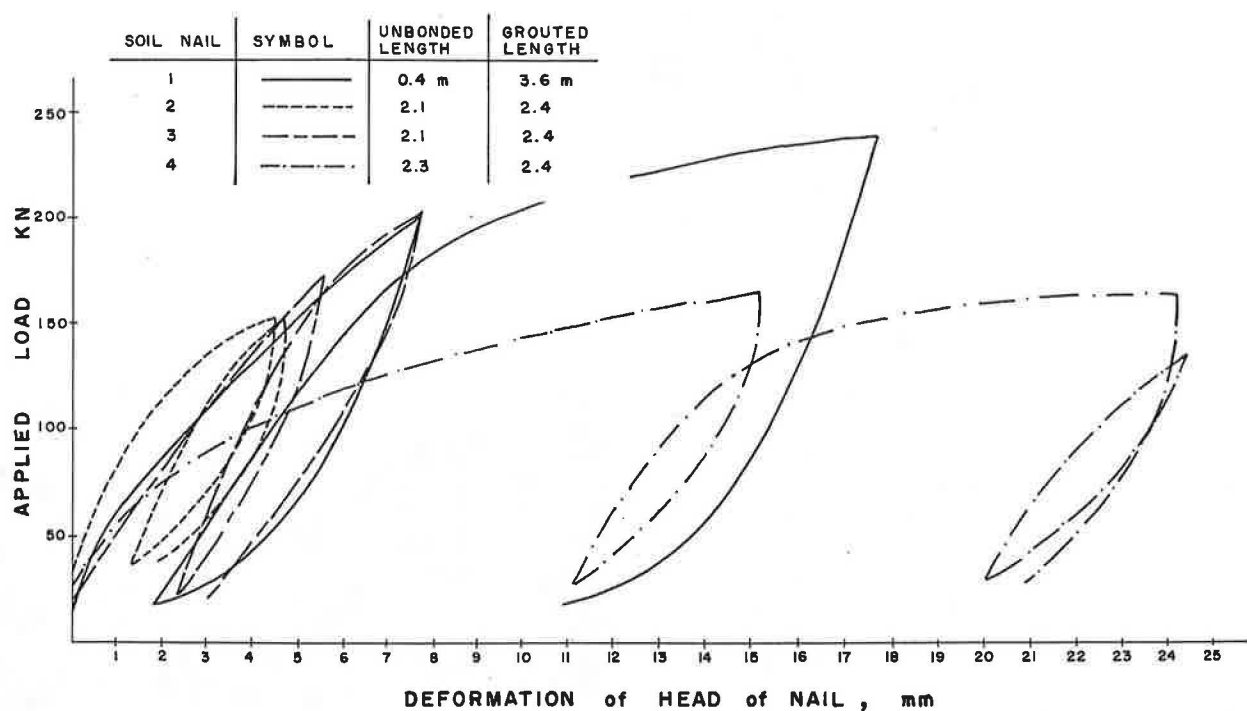
FIGURE 4 Tensile test results for soil nails.

At the design stage, the adhesion between the soil nail and the enclosing soil was evaluated using an adhesion factor applied to the overburden pressure (8). To verify the tensile capacity of the installed nails, cyclic loading tests were carried out on four specially installed test nails. The results for these tests are presented in Figure 4. Tests were carried out more than 7 days after nail installation. The ultimate tensile load capacity of these nails was estimated using the method developed by Chin (9) for evaluating the ultimate load-carrying capacity of a piled foundation that has not been taken to

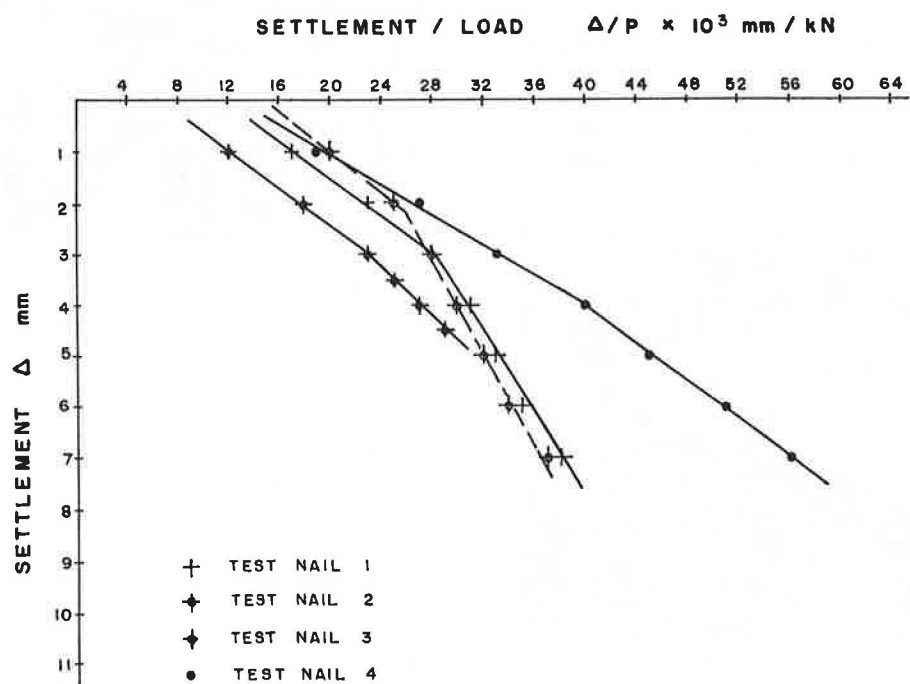
FIGURE 5 Summary of tensile test results for soil nails.

failure. For this analysis, the behavior of the nail was plotted using deflection normalized against tensile load versus deflection of the nail head (Figure 5). The failure load was evaluated from the inverse slope of the plot, and the test results were interpreted to give ultimate adhesions between the grout and the enclosing soil ranging from 225 to 700 kPa. The depth of each of the test nails below the crest and a qualitative estimate of the moisture condition of the soil are given in Table 2. These results illustrate the influence of the moisture condition of the soil on the available adhesion. They also indicate that for the heavily overconsolidated soils found
