Pile Integrity Testing To Determine Storm-Induced Damage

WILLIAM CAMP AND MOHAMED HUSSEIN

Hurricane Hugo made landfall in 1989 near Charleston, South Carolina, causing extensive damage. A pleasure boat marina was exposed to the full force of the storm. The marina consisted of concrete floating docks held in place by 14-in.-square prestressed concrete piles. The 42-ft-long piles had been driven 2 years before, and installation records were not available at the time of the testing (1990). The water depth was between 2 and 10 ft, and the soil conditions consisted of approximately 10 ft of soft mud overlying the Cooper Marl. During the storm, the surge floated the docks to nearly the pile tops and the extraordinary winds and waves pushed the large pleasure boats against the piles. After the storm, it was observed that some piles could be moved several inches laterally simply by pushing on them while standing on the docks, thereby causing the pile integrity to be questioned. Short on time for the new season, the owner was faced with a serious problem with potentially expensive remedies. Low-strain integrity testing performed on each of the 78 piles provided a timely and cost-effective

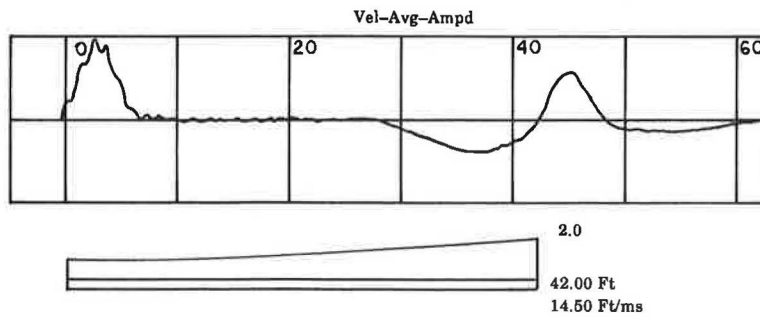
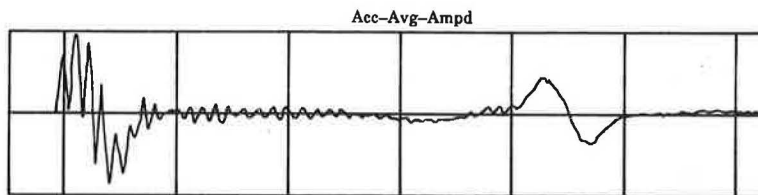
FIGURE 2 Typical PIT results.

Typically, each test consisted of three or more hammer blows. Data from the blows were averaged, amplified, and plotted in the form of pile top velocity and acceleration as a function of pile length. A material stress wave speed of 14.6 ft/msec was used to convert from a time scale to a length scale. A typical result is shown in Figure 2; averaged and amplified pile top velocity and acceleration records are plotted on a length scale and superimposed pile length graphically depicting the applied data magnification.
