# Evaluation and Treatment of Slab Stepping on a Major Runway

DAVID K. HEIN, MICHAEL H. MACKAY, AND JOHN J. EMERY

Severe slab-stepping (slab-faulting) problems have been observed during the past 5 years in the takeoff areas of Runway 06R/24L, the main runway at Lester B. Pearson International Airport in Toronto. The magnitude of this slab stepping of the plain portland cement concrete pavement is such that complaints about roughness were being received and airport management was concerned that the functional service life of this critical facility was being reduced. A comprehensive field evaluation of the slab stepping was undertaken to determine its cause, extent, and severity to develop practical rehabilitation alternatives for Transport Canada to consider. This field program included the treatment, on a trial basis, of a short section of the runway using diamond grinding equipment to remove the slab stepping. In 1989 the trial grinding section was resurveyed and no significant slab stepping was observed. In 1991 a contract was let to complete full-scale precision diamond grinding of the concrete in the takeoff areas of Runways 06R and 24L and on Taxiways Bravo and Echo. Postgri

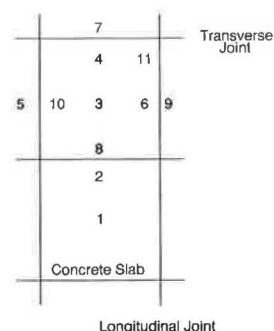
FIGURE 3 FWD testing pattern.

The FWD was used to conduct several tests. Eleven tests were taken per slab to assess representative joint-slab combinations selected on the basis of the pavement condition and precise survey data. The typical testing sequence for each joint-slab combination is illustrated in Figure 3.

Three load levels were employed: 40 kN, 75 kN, and 105 kN. The FWD velocity transducers were positioned such that one was on either side of the joint at distances of 200 and 300

mm from the point of load application. Load transfer and voids detection were indicated using a simple procedure developed for concrete pavements by Shahin et al. (1).
