Performance Level 2 Tests on the Missouri 30-in. New Jersey Safety-Shape Bridge Rail

JAMES C. HOLLOWAY, RONALD K. FALLER, BRIAN G. PFEIFER,
EDWARD R. POST,* AND DAN E. DAVIDSON

Safety-shape bridge rails are substandard if they are less than 32 in. high, according to Section 2.7.1.2.2 of the AASHTO *Standard Specifications for Highway Bridges*. However, a substandard bridge rail may remain in operation if it passes a safety performance evaluation by full-scale crash testing. Therefore, Nebraska and Kansas pooled their efforts with Missouri to determine whether a 32-in. standard New Jersey safety-shape bridge rail would still provide a satisfactory safety performance if a 2-in. overlay were placed on the adjacent bridge deck. To evaluate the performance of this bridge rail, the Midwest Roadside Safety Facility conducted three full-scale vehicle crash tests on the Missouri 30-in. New Jersey safety-shape bridge rail. Test MS30-1 was conducted with an 18,011-lb single-unit straight truck at 16.1 degrees at 52.5 mph. Test MS30-2 was conducted with a 1,759-lb small automobile at 20.0 degrees at 62.5 mph. Test MS30-3 was conducted with a 5,460-lb pickup truck at 20.0 degrees at 63.5 mph.

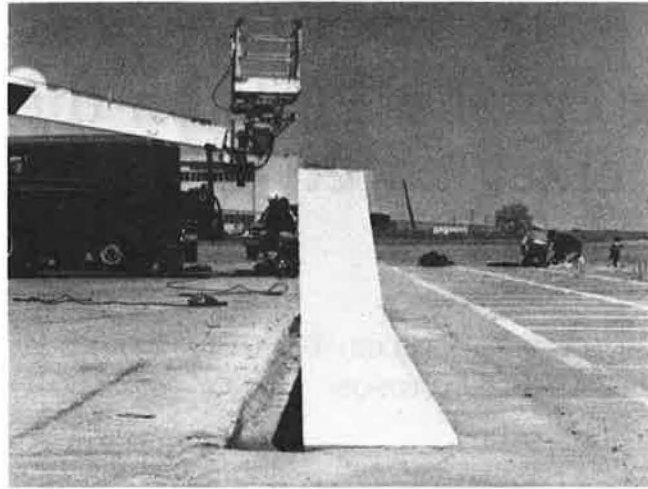
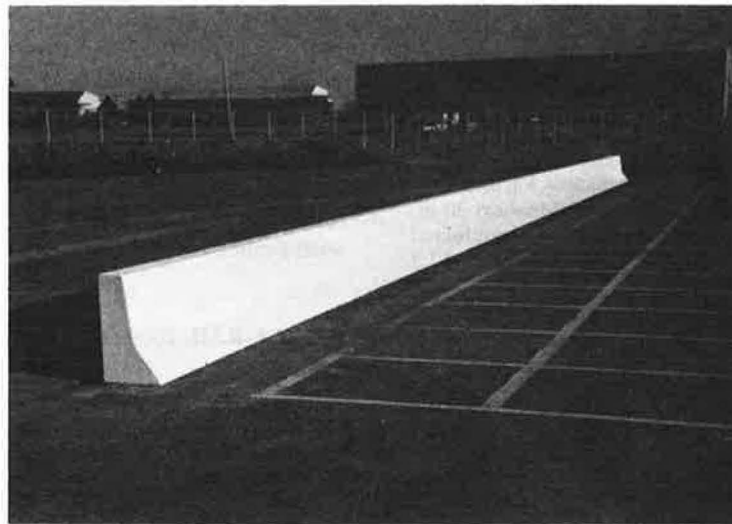
FIGURE 2 Missouri 30-in. New Jersey safety-shape bridge rail.

are shown in Figure 2. The 30-in. bridge rail was constructed by reducing the lower vertical face from 3 in. to 1 in. This construction procedure was accomplished by recessing standard 32-in. steel forms 2 in. below the existing concrete surface. The base width of the installation was 16.0 in., and the top width was 7.0 in.

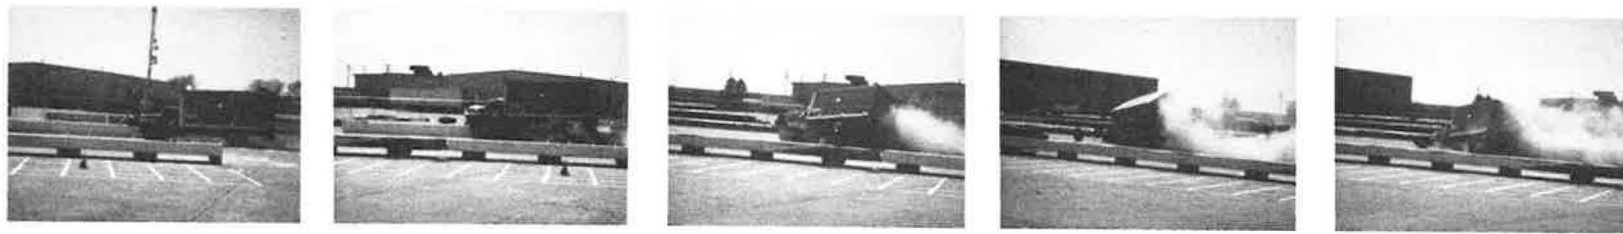
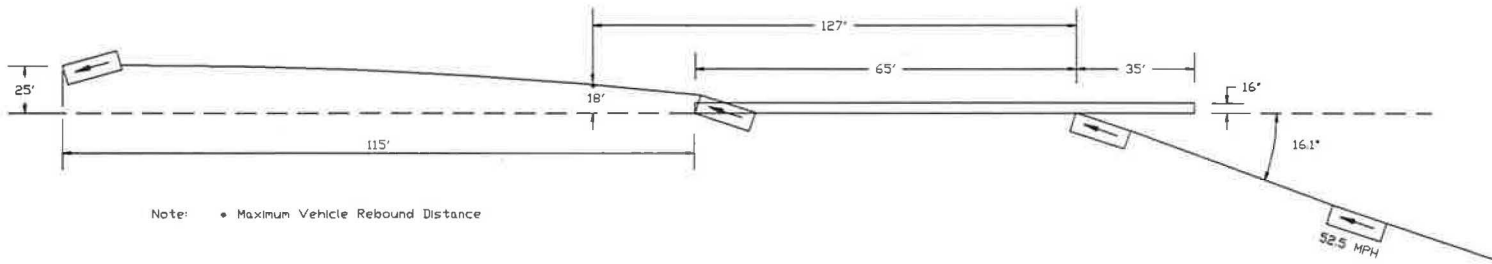
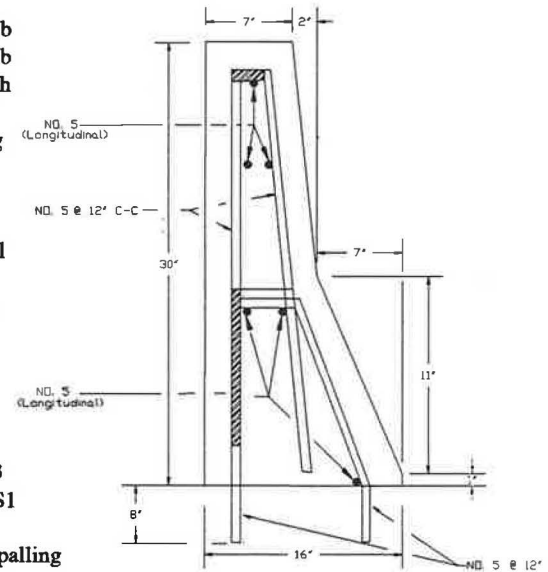
FIGURE 5 Summary and sequential photographs, Test MS30-1.

The longitudinal occupant impact velocity (OIV) was determined to be 11.1 fps, and the lateral OIV was 9.7 fps. The highest 0.010-sec average occupant ridedown decelerations were 2.1 g (longitudinal) and 3.0 g (lateral). The results of the occupant risk, determined from accelerometer data, are summarized in Figure 5 and Table 2.

A summary of the test and sequential photographs are shown in Figure 5. Additional sequential photographs are shown in Figure 6. The performance of the bridge rail was determined to be satisfactory for this test.

- Vehicle Model 1986 Ford F-700
- Vehicle Weight
 - Test Inertia 18,011 lb
 - Gross Static 18,011 lb
- Vehicle Impact Speed 52.5 mph
- Vehicle Exit Speed NA
- Vehicle Impact Angle 16.1 deg
- Vehicle Exit Angle NA
- Vehicle Snagging None
- Effective Coef. of Friction NA
- Vehicle Stability Marginal
- Occupant Impact Velocity
 - Longitudinal 11.1 fps
 - Lateral 9.7 fps
- Occupant Ridedown Deceleration
 - Longitudinal 2.1 g's
 - Lateral 3.0 g's
- Vehicle Damage
 - TAD 1-RFQ-3
 - VDI 01RFWS1
- Vehicle Rebound Distance 18 ft
- Bridge Rail Damage Minor Spalling

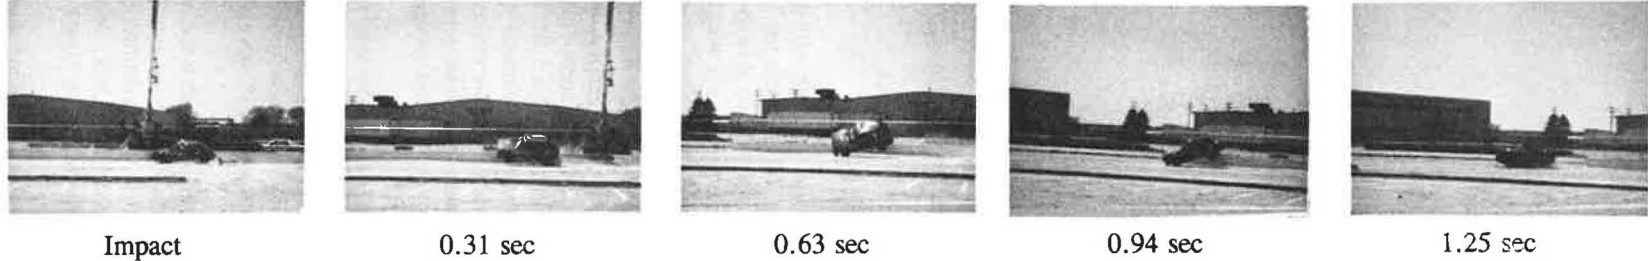
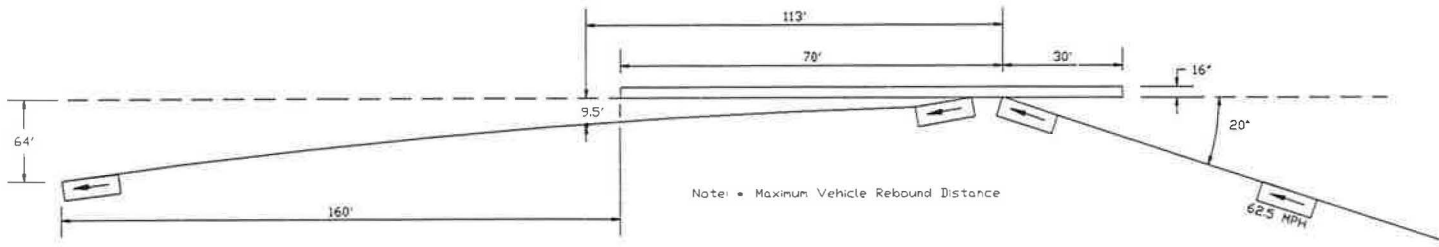
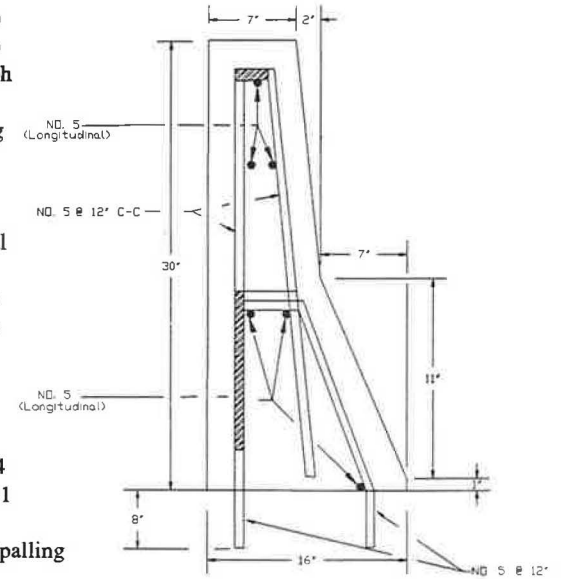
FIGURE 8 Summary and sequential photographs, Test MS30-2.

The longitudinal OIV was determined to be 11.9 fps, and the lateral OIV was 26.5 fps. The highest occupant ridedown decelerations were 5.5 g (longitudinal) and 9.0 g (lateral). The results of the occupant risk, determined from film anal-

ysis, are summarized in Figure 8, and Table 2. Because of technical difficulties in obtaining accelerometer data, the occupant risk values were determined from film analysis.

A summary of the test and sequential photographs are shown in Figure 8. Additional sequential photographs are shown in Figure 9. The performance of the bridge rail was determined to be satisfactory for this test.

- Vehicle Model 1984 Dodge Colt
- Vehicle Weight
 - Test Inertia 1,759 lb
 - Gross Static 1,759 lb
- Vehicle Impact Speed 62.5 mph
- Vehicle Exit Speed 55.0
- Vehicle Impact Angle 20.0 deg
- Vehicle Exit Angle 6.6 deg
- Vehicle Snagging None
- Effective Coef. of Friction 0.11
- Vehicle Stability Marginal
- Occupant Impact Velocity
 - Longitudinal 11.9 fps
 - Lateral 26.5 fps
- Occupant Ridedown Deceleration
 - Longitudinal 5.5 g's
 - Lateral 9.0 g's
- Vehicle Damage
 - TAD 1-RFQ-4
 - VDI 01RFES1
- Vehicle Rebound Distance 9.5 ft
- Bridge Rail Damage Minor Spalling

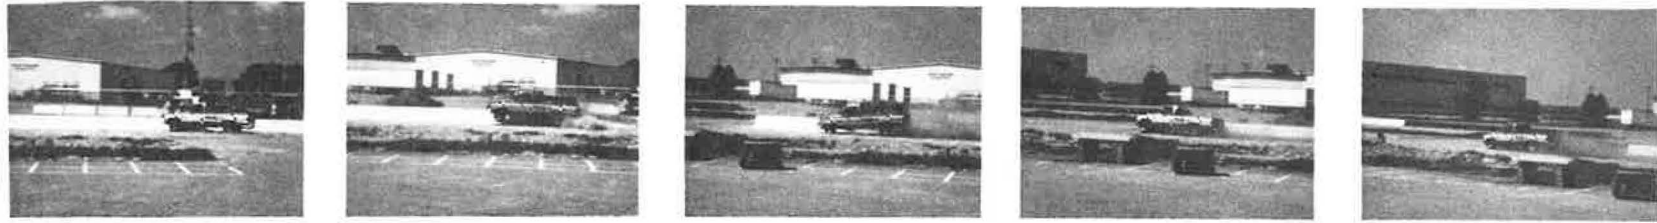
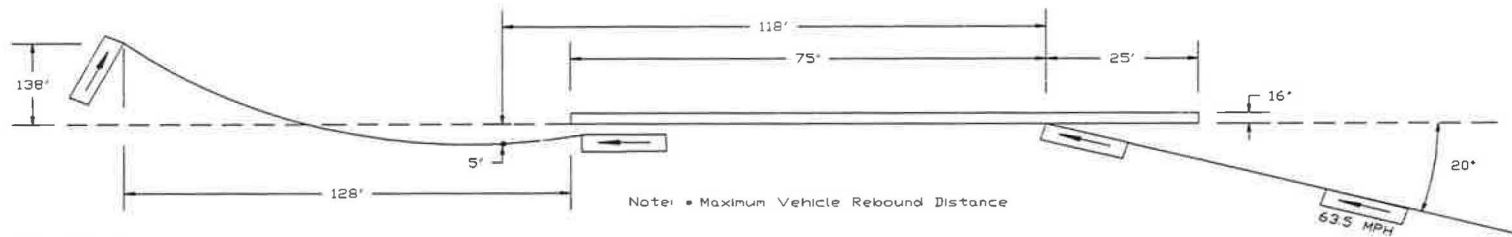
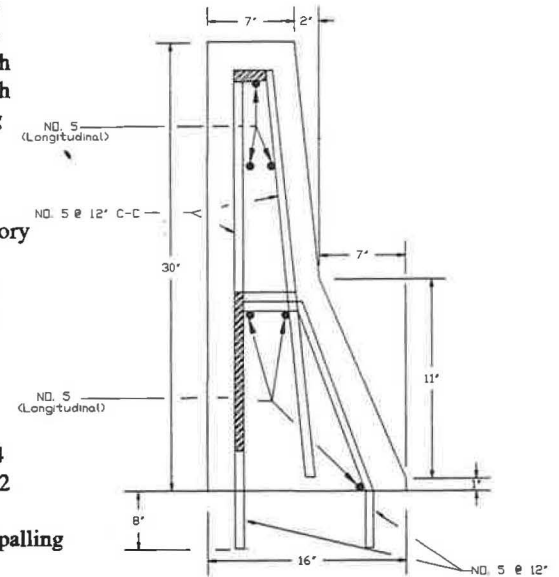
FIGURE 11 Summary and sequential photographs, Test MS30-3.

The longitudinal OIV was determined to be 16.6 fps and the lateral OIV was 14.2 fps. The highest 0.010-sec average occupant ridedown decelerations were 6.0 g (longitudinal) and 6.6 g (lateral). The results of the occupant risk, determined from accelerometer data, are summarized in Figure 11 and Table 2.

A summary of the test and sequential photographs are shown in Figure 11. Additional sequential photographs are shown

- Vehicle Model 1984 Chevy Silverado
- Vehicle Weight
 - Test Inertia 5,460 lb
 - Gross Static 5,460 lb
- Vehicle Impact Speed 63.5 mph
- Vehicle Exit Speed 49.1 mph
- Vehicle Impact Angle 20.0 deg
- Vehicle Exit Angle 6.0 deg
- Vehicle Snagging None
- Effective Coef. of Friction 0.37
- Vehicle Stability Satisfactory
- Occupant Impact Velocity
 - Longitudinal 16.6 fps
 - Lateral 14.2 fps
- Occupant Ridedown Deceleration
 - Longitudinal 6.0 g's
 - Lateral 6.6 g's
- Vehicle Damage
 - TAD 1-RFQ-4
 - VDI 01RFES2
- Vehicle Rebound Distance 5 ft
- Bridge Rail Damage Minor Spalling

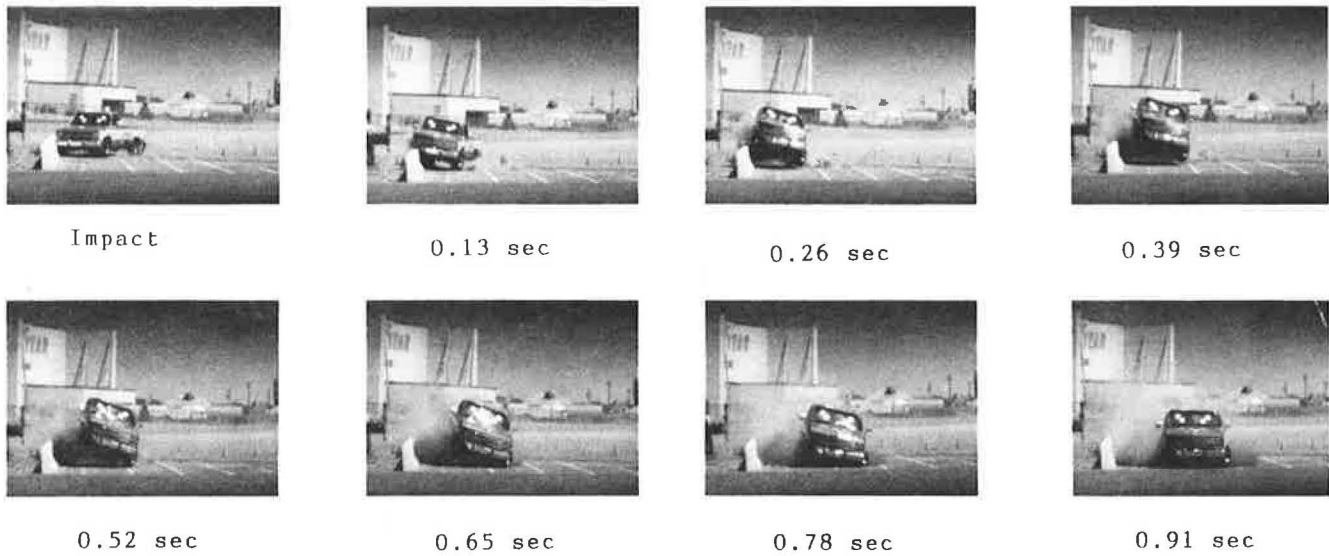
FIGURE 12 Parallel time sequential photographs, Test MS30-3.

in Figure 12. The performance of the bridge rail was determined to be satisfactory for this test.
