Damage to Aircraft Parking Ramps from Jet Oils and Auxiliary Power Units

MICHAEL C. McVAY, CHARLES W. MANZIONE, AND JAMES G. MURPHY

The precise cause for concrete damage observed in the vicinity of parked B-1 and F/A-18 aircraft has been determined. The combination of downward-directed auxiliary power unit (APU) blast and spilled aircraft oils are responsible for the scaling observed at these sites. Laboratory tests confirmed that ester-based lubricating oils and hydraulic fluids are chemically reacting with the hydroxyl component from the calcium hydroxide or the calcium silicate hydrate in the concrete and destroying the bond. The cyclic heating of the pavement by the APU greatly accelerates the reaction and facilitates the mixing and refluxing of aircraft fluids with the aqueous calcium hydroxide present. Laboratory techniques are demonstrated that duplicate the chemical reactions occurring in the field and allow for quick and accurate assessment of new materials before field testing. In addition, hydrolysis of lubricating oils and hydraulic fluids was replicated in a controlled laboratory experiment within 5 weeks, eroding a 10-cm (4-in.) concrete slab that was kept partially

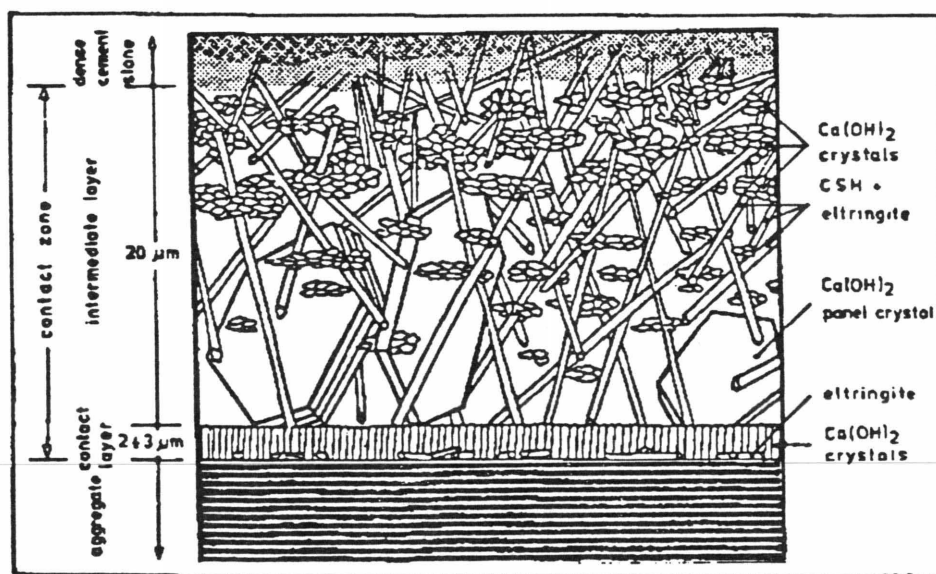
FIGURE 5 Model of paste-aggregate interface (9).

Figure 5 illustrates the contact between the cement mortar (calcium silicate hydrate) and the aggregate in an early stage of the hydration process (9). With time and increased hydration the intermediate layer is overlapped by more of the panel-shaped calcium hydroxide crystals and the cement mortar. Zimbelmann states that the load transfer between the cement mortar and the aggregate is provided mainly by the large hexagonal platelets of calcium hydroxide (9). Both the contact layer around the aggregate and the large platelets of calcium hydroxide are probably being consumed in the hydrolysis process.

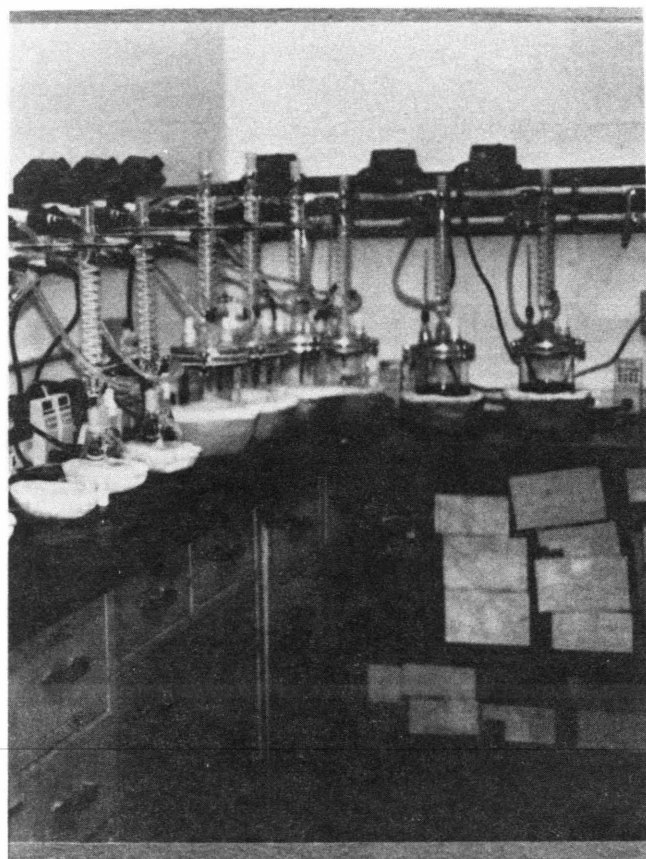
The laboratory setup included the use of Erlenmeyer flasks (for crushed material) and kettles (for solid pieces) that could simulate (in reaction vessels) the mixing and refluxing of oils and water that takes place in the field at elevated temperatures (Figure 6). Up to 24 vessels could be used simultaneously; each vessel could independently test a different material at controlled temperatures. After the material hydrolyzed, the

FIGURE 6 Laboratory setup to replicate field damage.

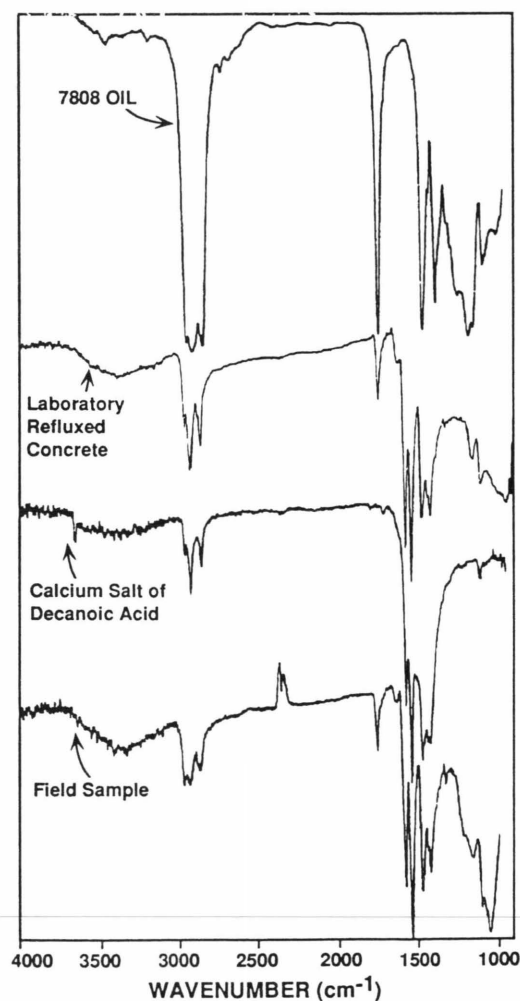
FIGURE 7 FTIR spectra for laboratory and field samples.

Tests initially compared field scalings with laboratory concrete made from finely crushed quartz aggregate and a water-cement ratio of 0.5. The vessel contained 10 percent concrete, 20 percent oil, and 70 percent water by volume. After five 24-hr days of refluxing, FTIR analysis of the hydrolyzed products formed are shown in Figure 7. The characteristic peak of calcium hydroxide shown in the laboratory sample was absent in the field scalings, indicating that it had been consumed by carbonation or ester hydrolysis. In addition, the acid spectra from both the laboratory and field samples matched. The lab sample shows approximately twice as much transmittance as the field sample, indicating twice the number of salts. This verified that the experimental technique was performing as designed. Therefore, any material could be quickly and accurately assessed for ester hydrolysis.
